**Stray Voltage Study**  
**Truxtun Park Marina Final Report**  
**City of Annapolis, Maryland**

**Project Number 24E-08-27000**

**July 18, 2024**

**ENGINEERING DESIGN TECHNOLOGIES, INC.**

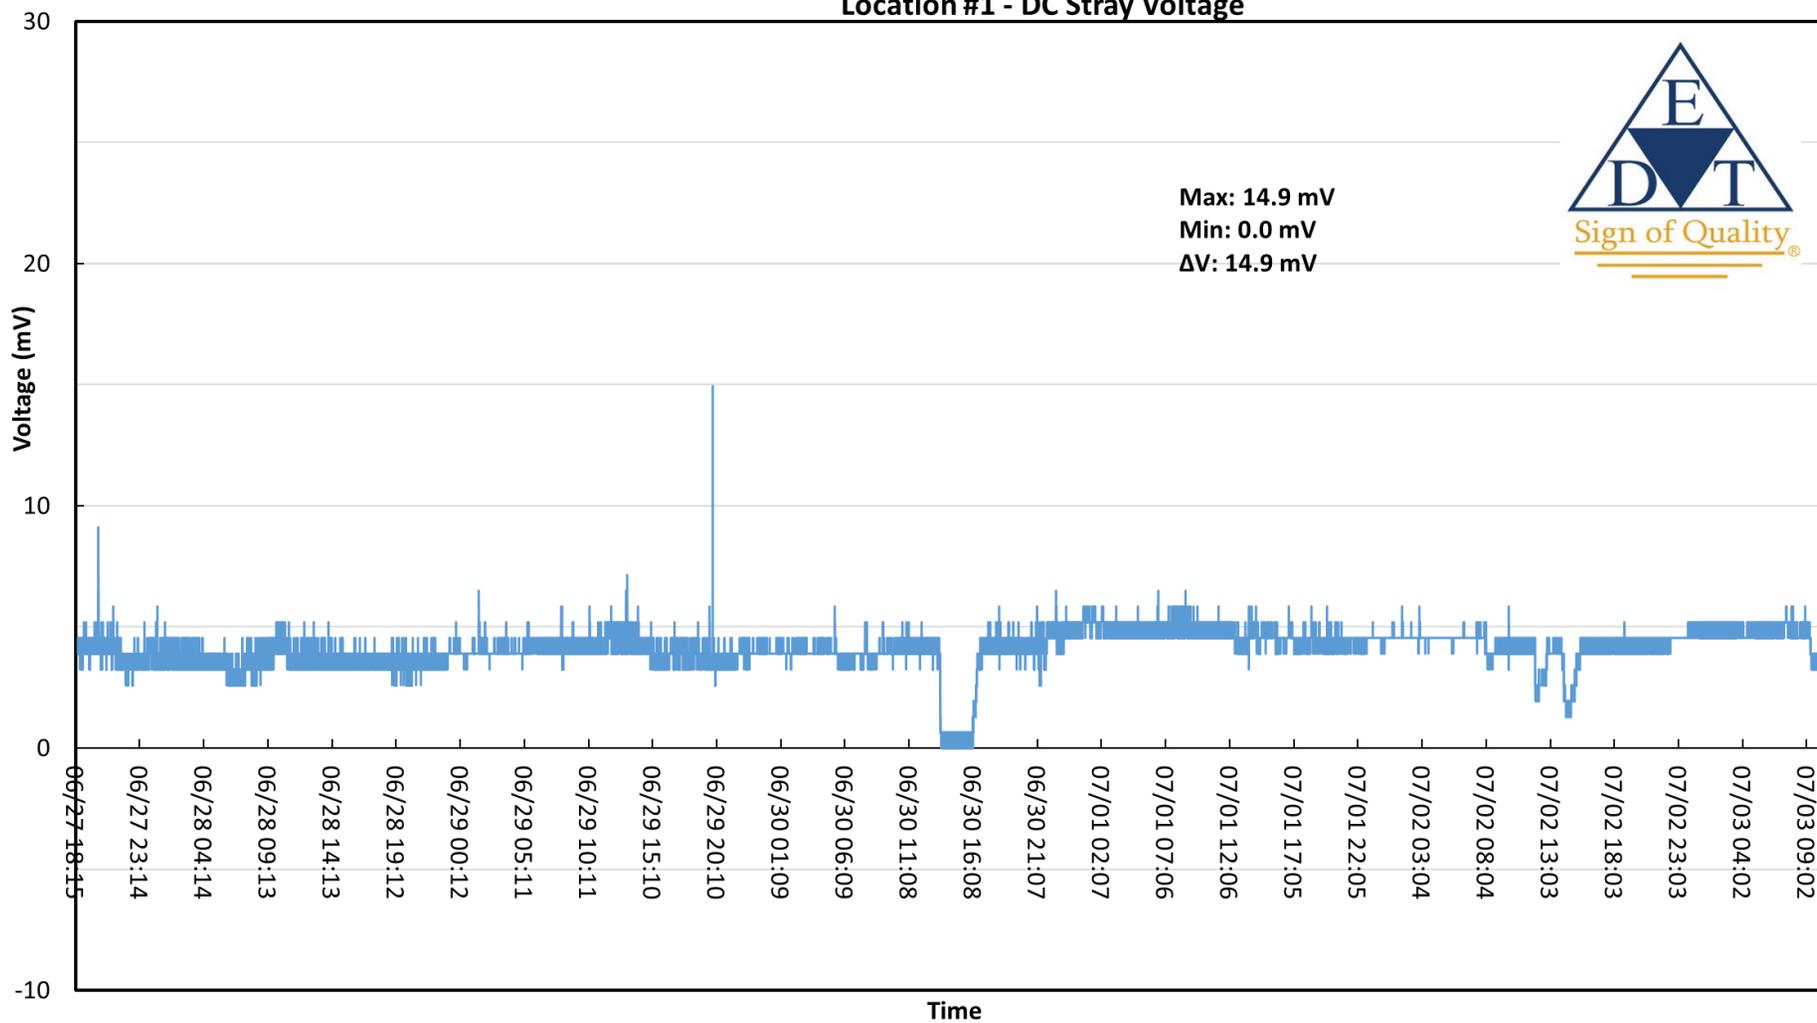
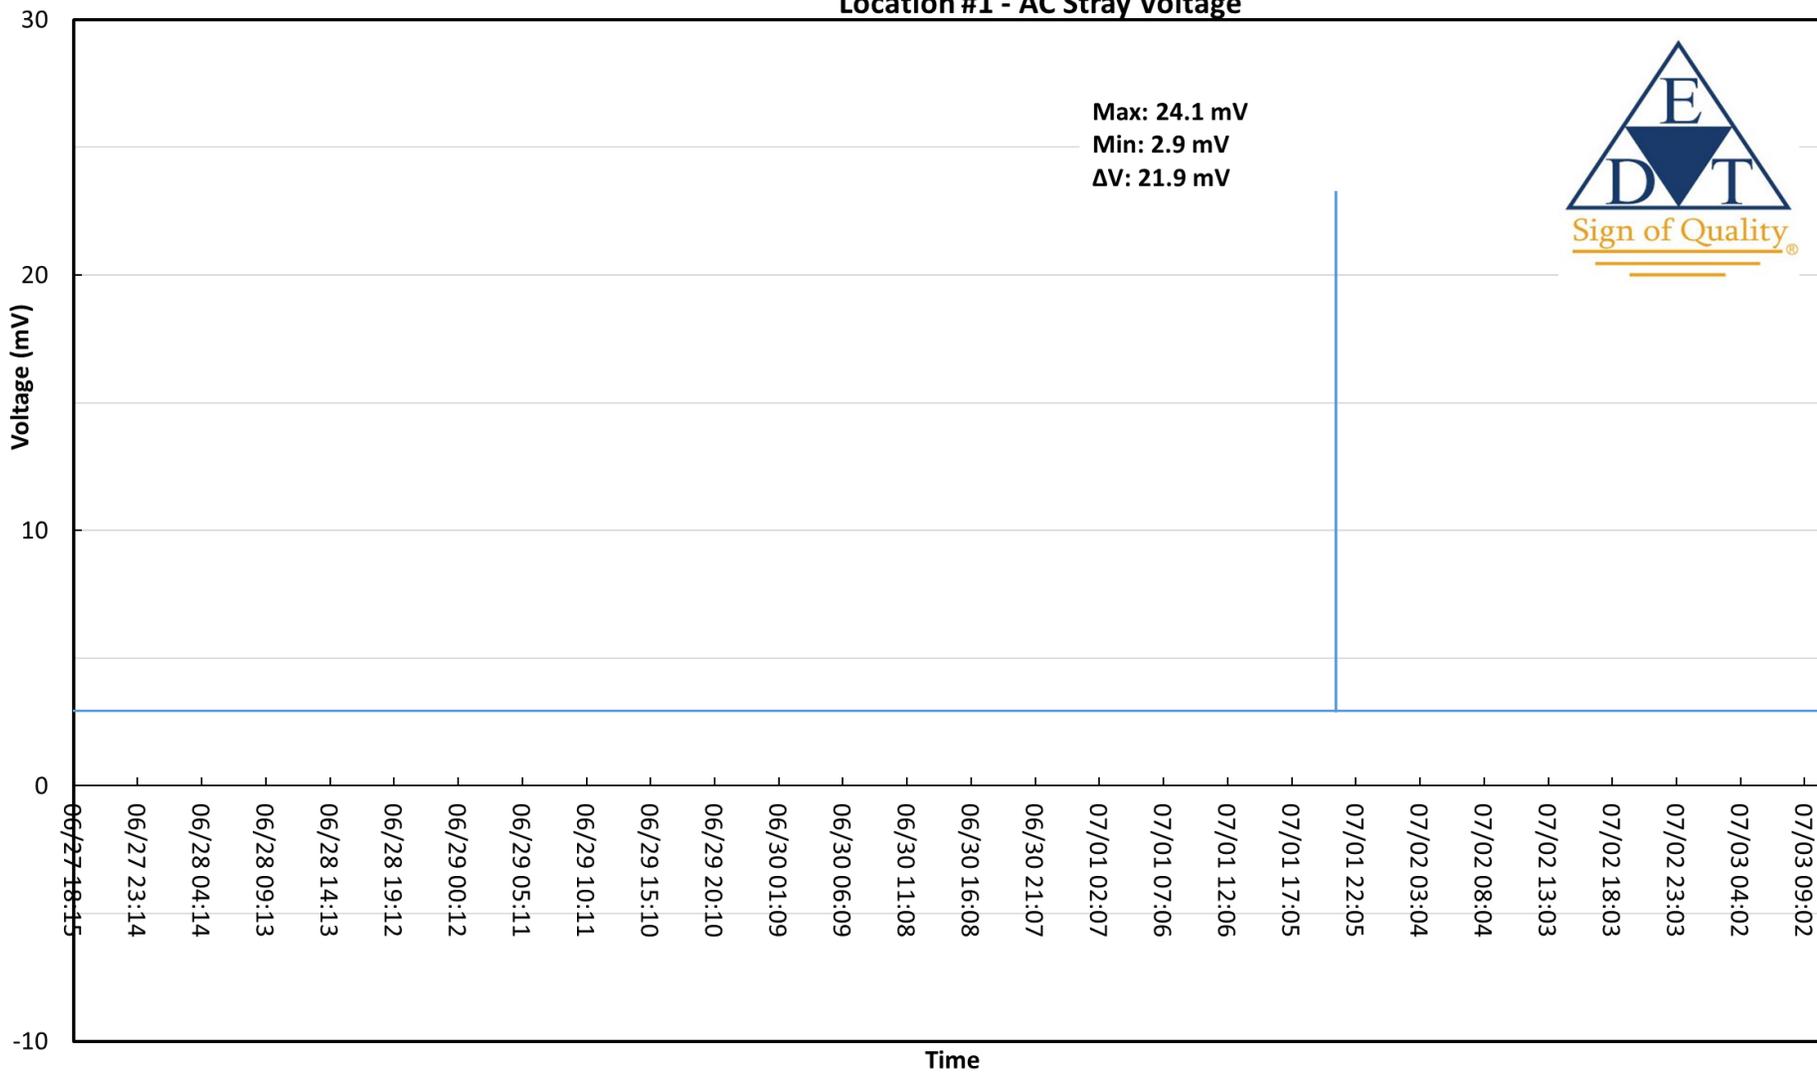
### Location #1 - DC Stray Voltage

The data loggers recorded 5 days, 17 hours, 8 minutes of AC and DC voltage readings every second at locations #1-4 as seen in the map in **Appendix A**. This data has an accuracy of +/- 3mV due to the chosen 20Vpeak setting and the calibration. For test #1, a minimum AC voltage of 2.9mV and a maximum of 24.1mV was recorded, and a minimum DC voltage of 0 and a maximum of 14.9mV was recorded (See **Appendix B**).

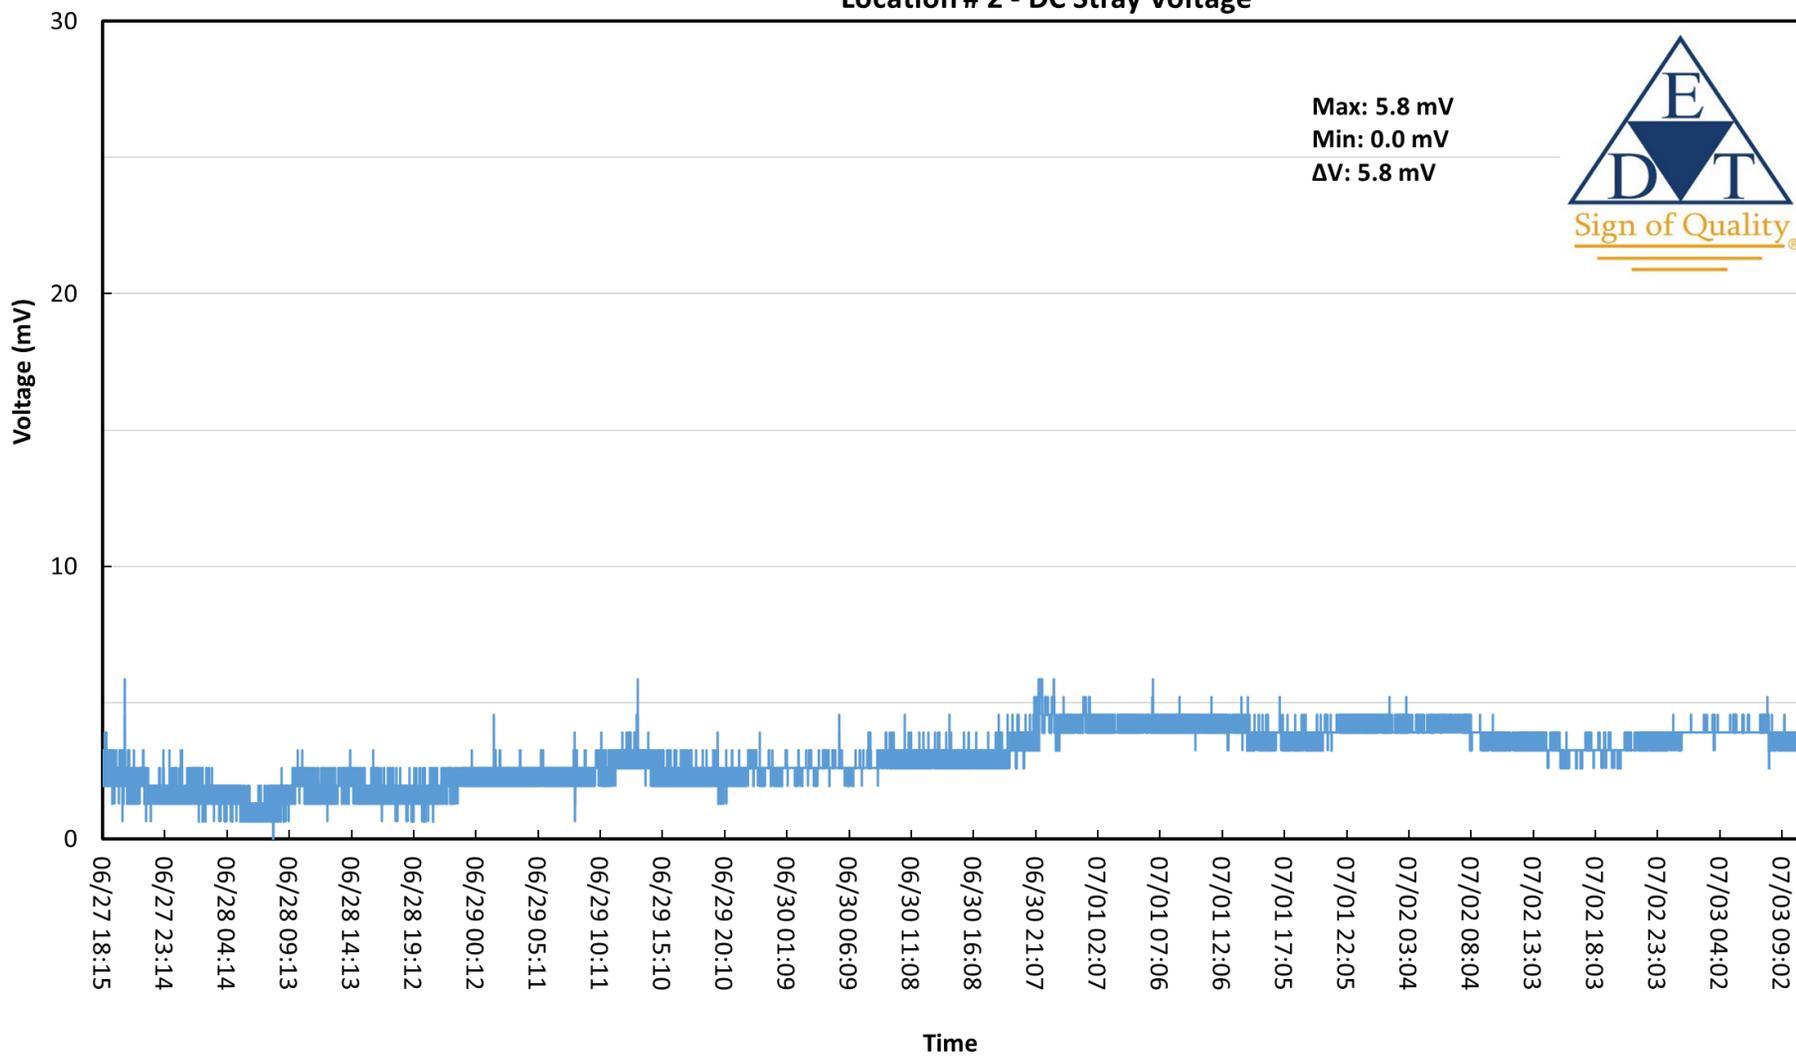
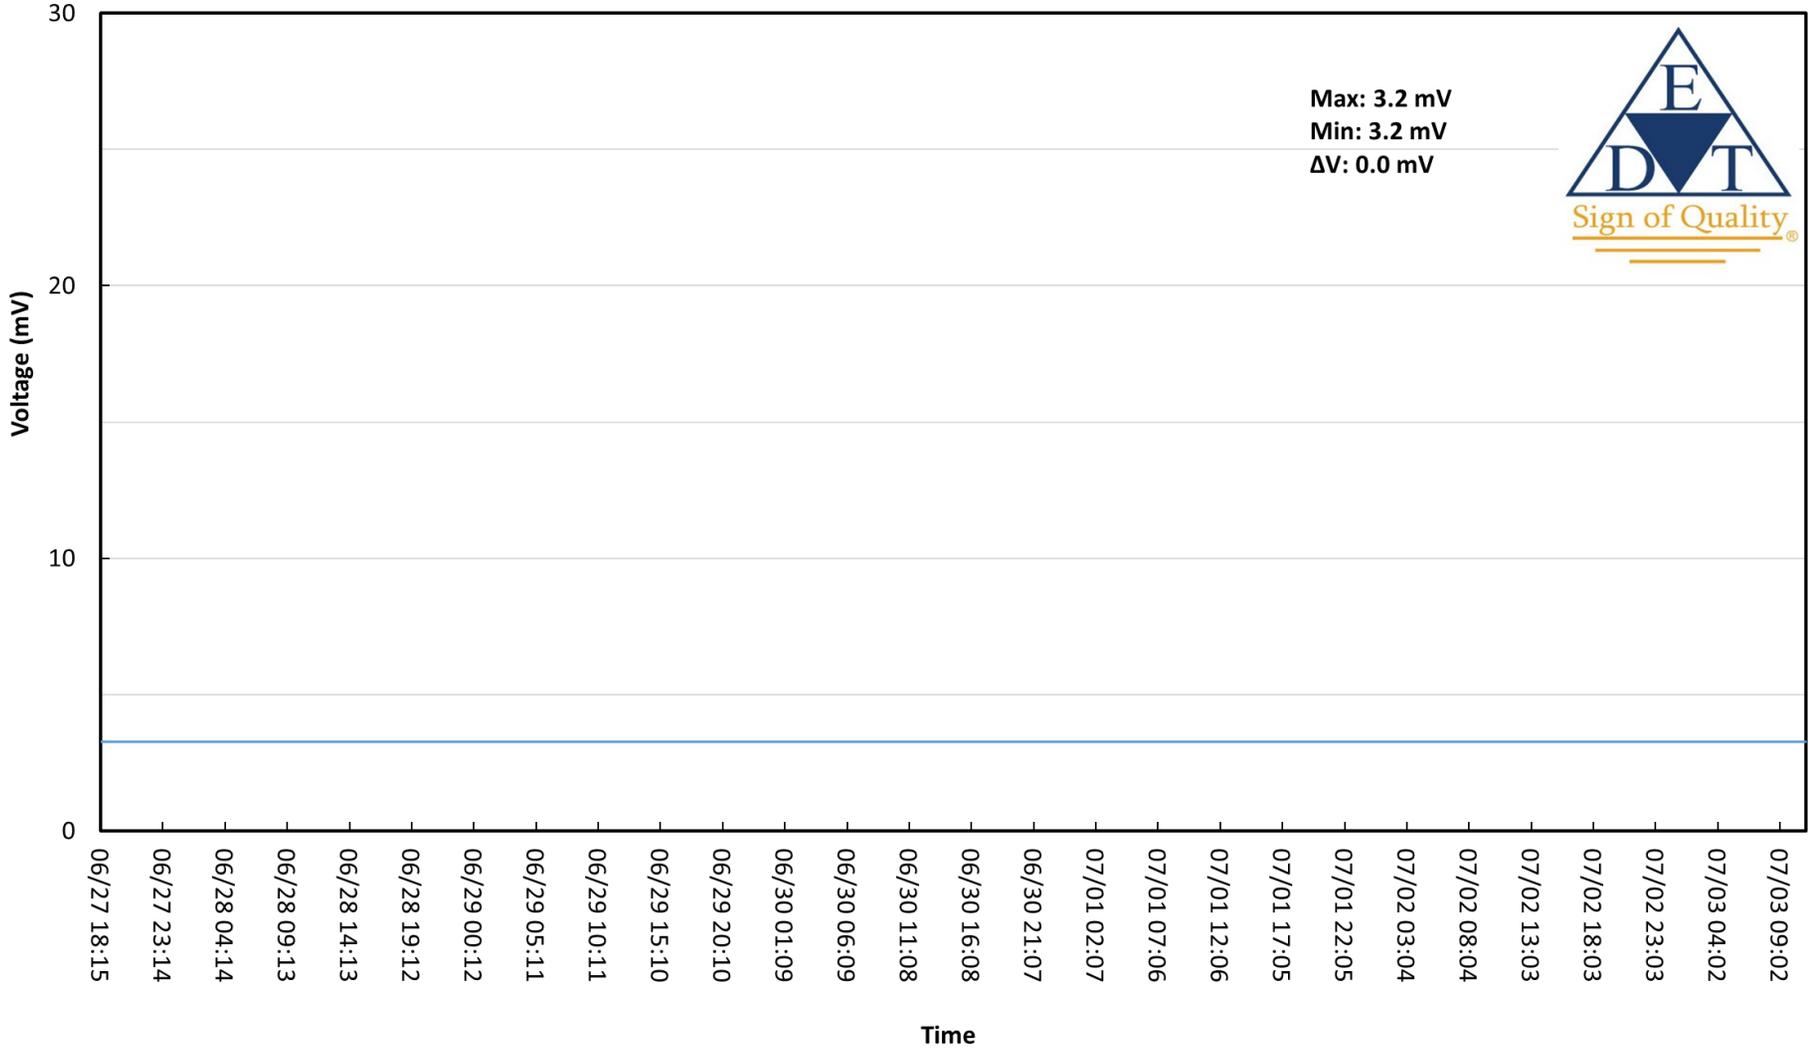
### Location # 2 - DC Stray Voltage

For test #2 which was perpendicular on the surface of the water at the dock to test #1, the minimum AC voltage of 3.2mV and the maximum AC voltage of 3.2mV were recorded. The minimum DC voltage of 0.0 and the maximum of 5.8 mV were recorded (See **Appendix B**).

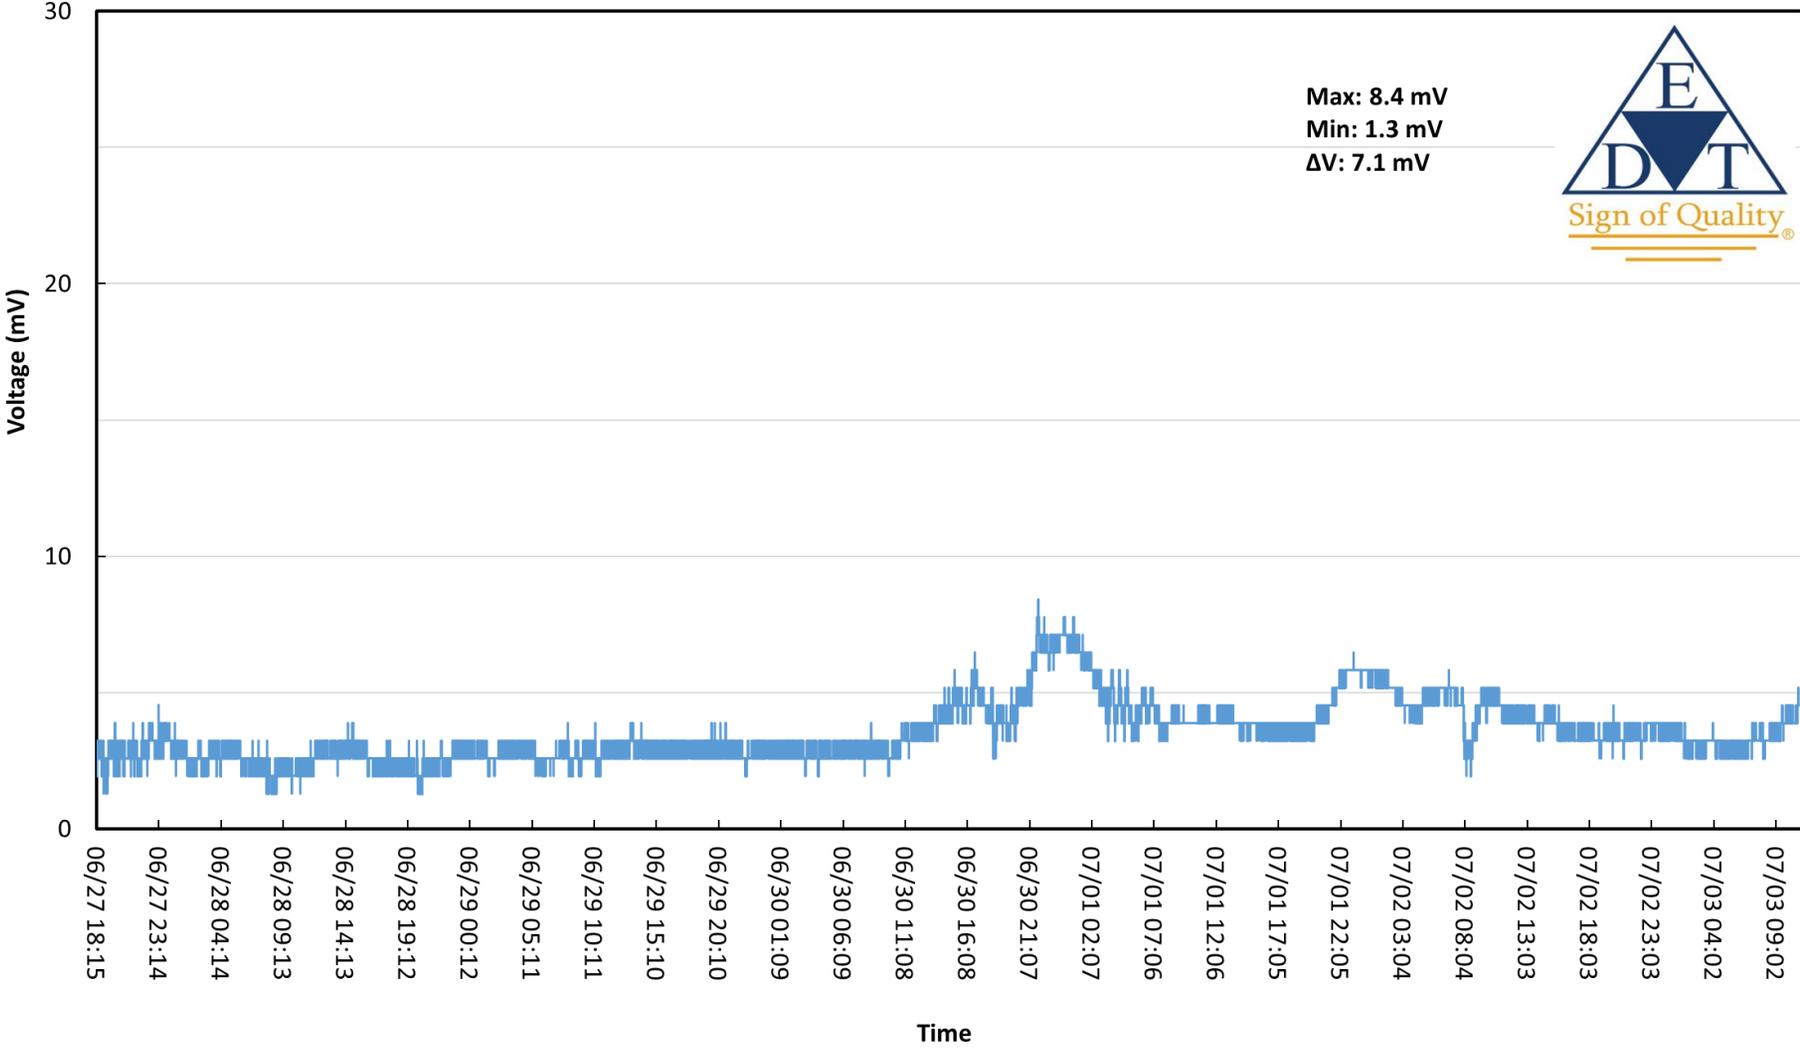
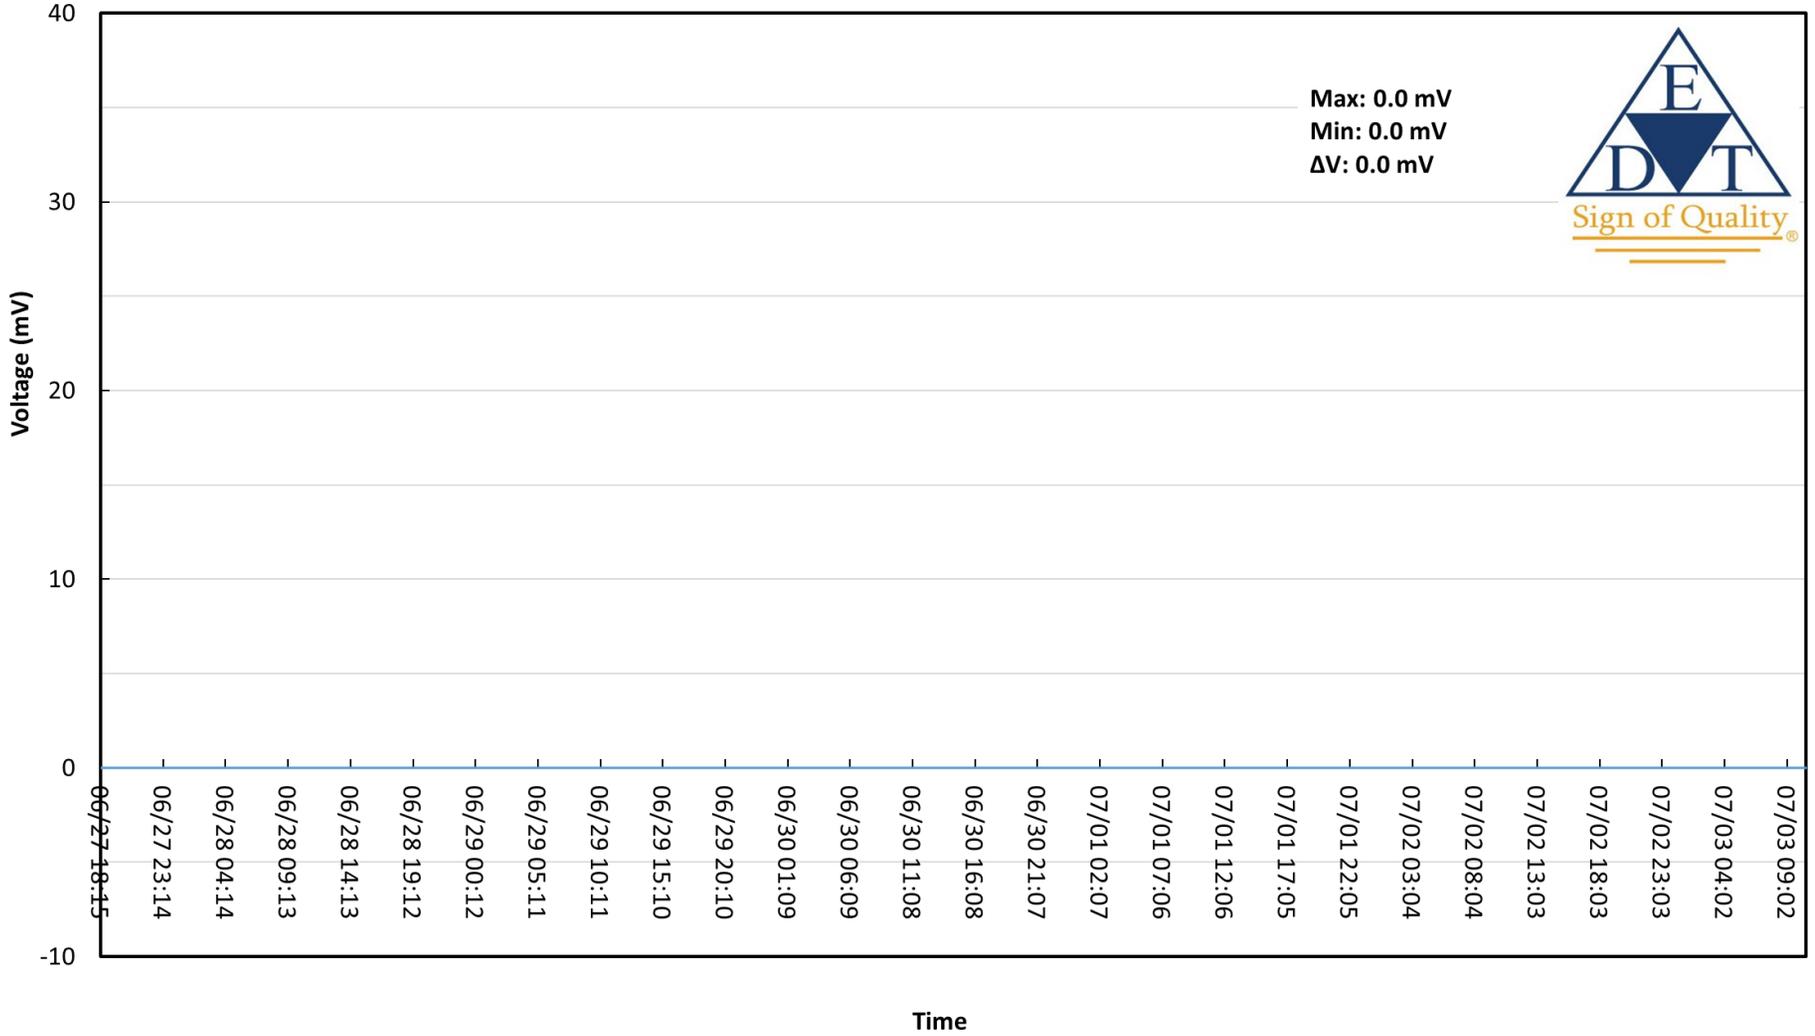
Location #3 - (Vertical) DC Stray Voltage

For test #3 which spanned the height of the water column at the dock, all the readings recorded AC voltage differences of 0.0mV. The minimum DC reading was 1.3mV and the maximum DC reading was 8.4mV (See **Appendix B**).

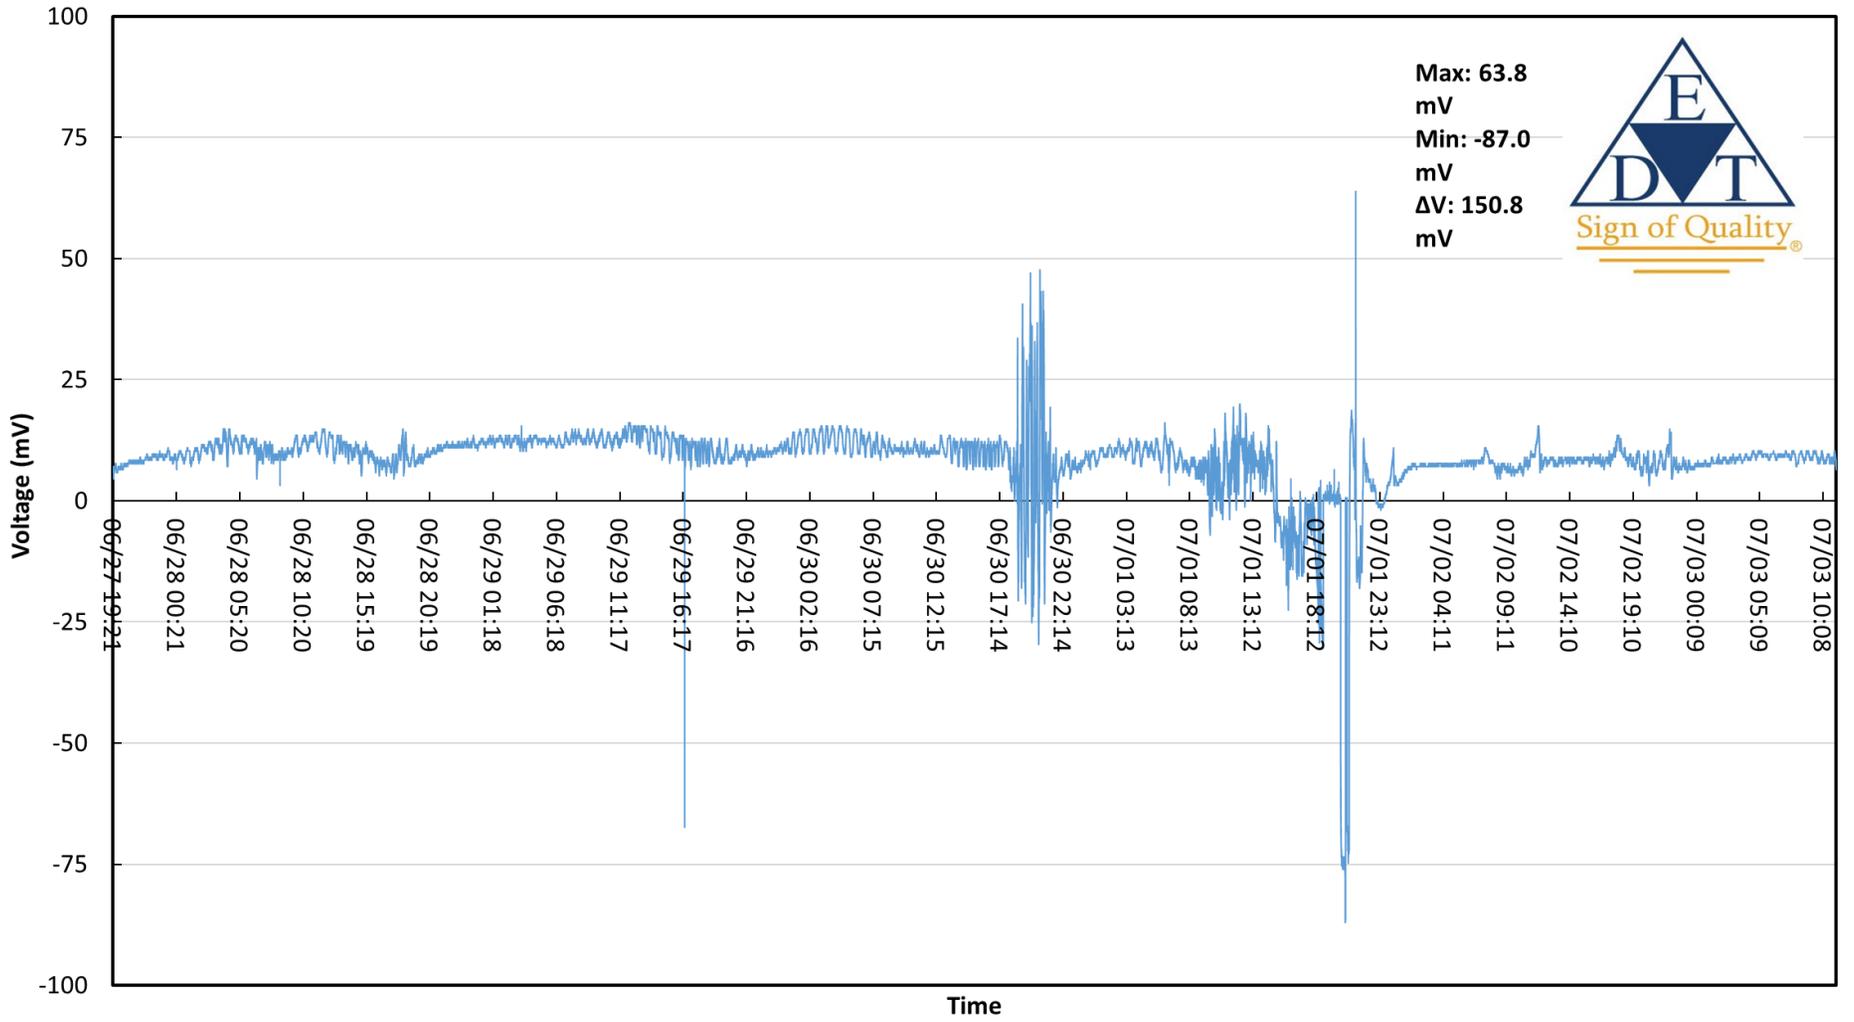
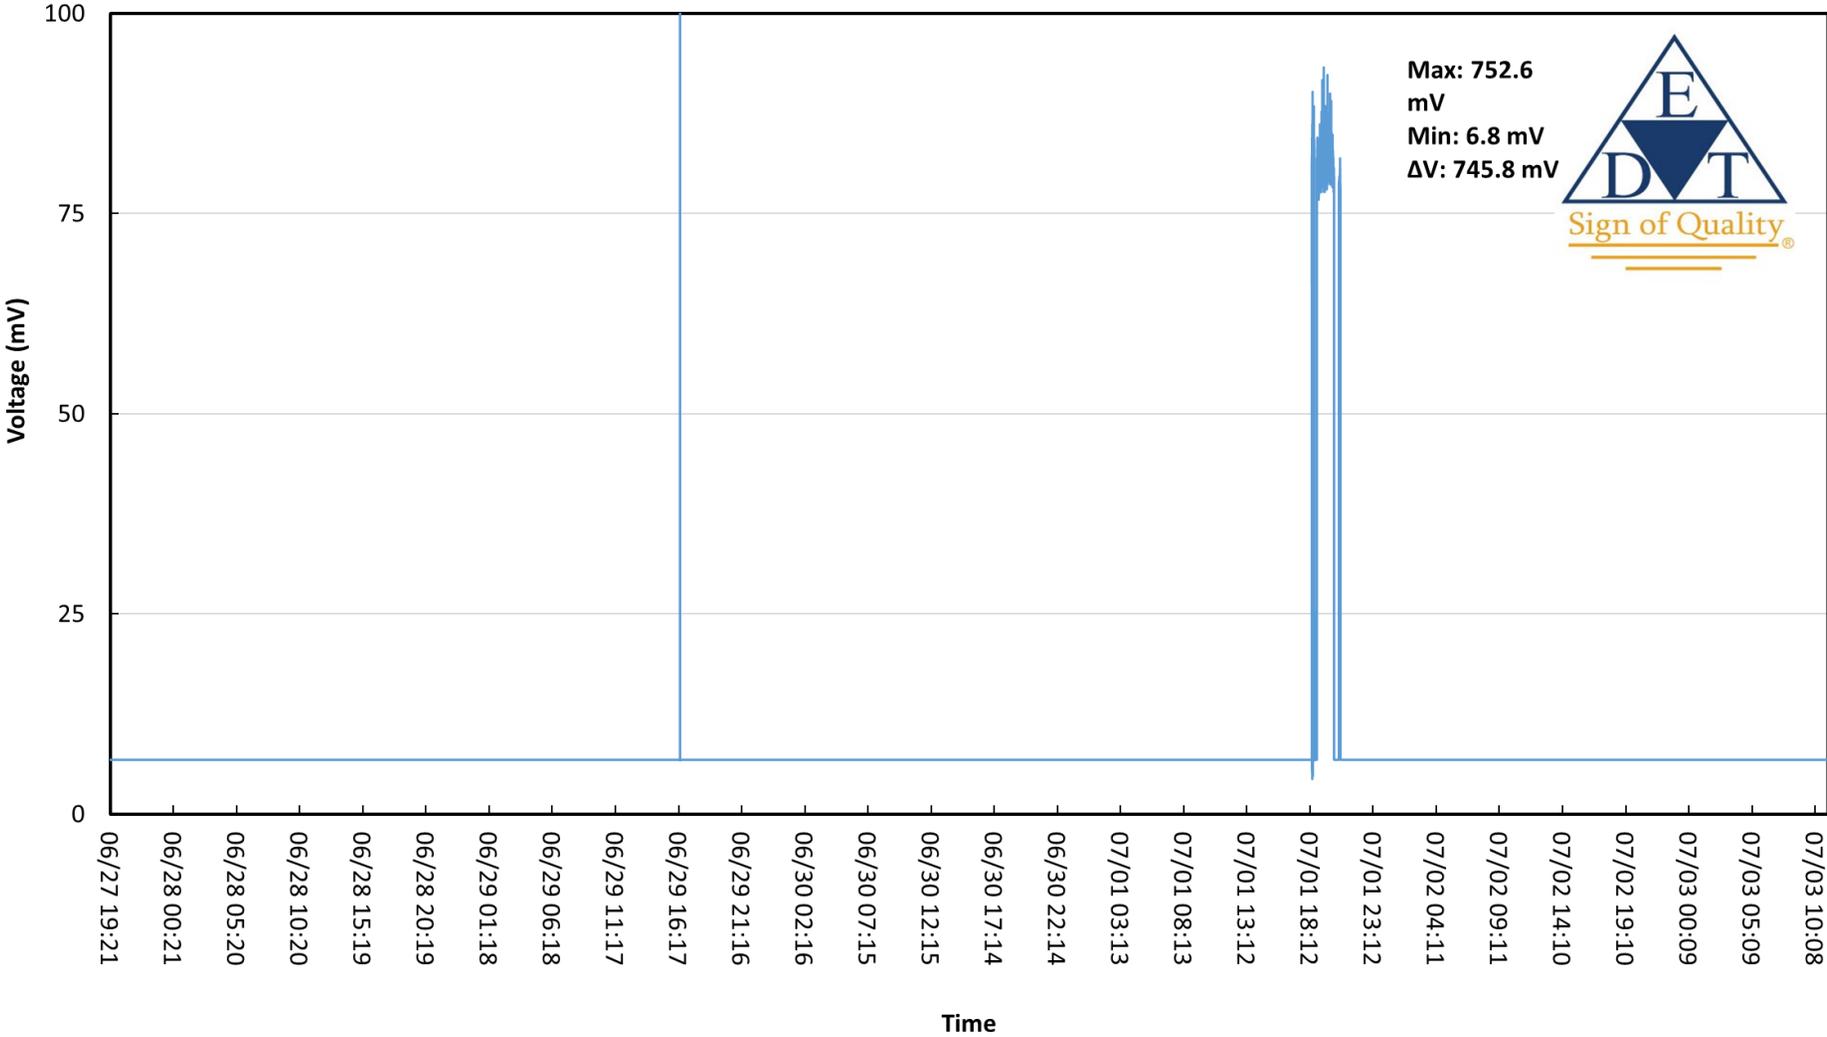
### Location #4 (Rickety Bridge) - DC Stray Current

For test #4 which was installed on the "Rickety" foot bridge at the end of Pump House Road, the minimum AC reading was 6.8mV and the maximum was 752.6mV (a spike lasting about 2 seconds). The minimum DC reading was -87mV and the maximum reading was 63.8mV (See **Appendix B**).

The tests performed in the water over various periods of time at Truxtun Park indicate the voltages from the long-term test were mostly zeroes with one peak of 752.6mV which occurred for only a few seconds on one out of four concurrent stray voltage tests. Upon review of historical weather data, this

measurement may have been collected as a storm was passing over Annapolis. Besides this reading, all other recorded voltages were well below the barely perceptible limit of 300 mV (See Tables 1 and 2).
