**Stray Voltage Study**  
**Truxtun Park Marina Final Report**  
**City of Annapolis, Maryland**

**Project Number 24E-08-27000**

**July 18, 2024**

**ENGINEERING DESIGN TECHNOLOGIES, INC.**

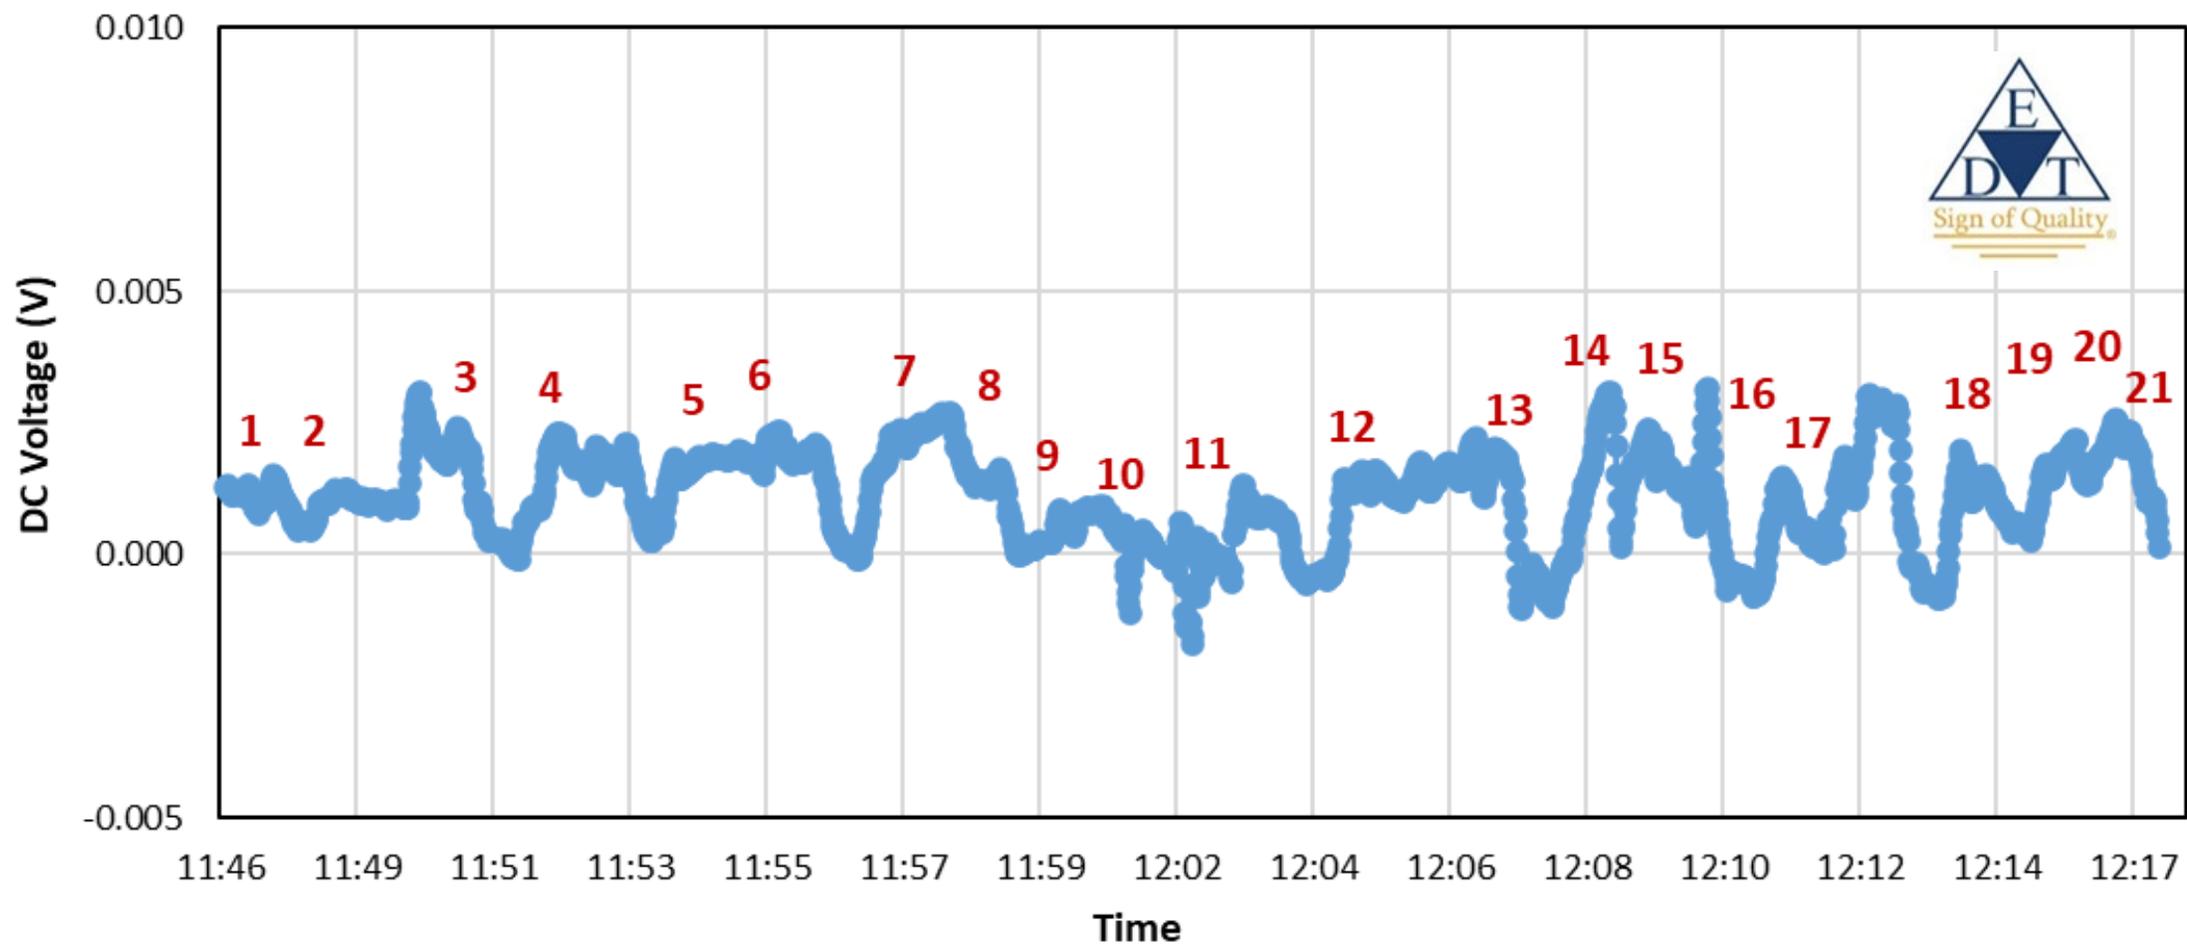
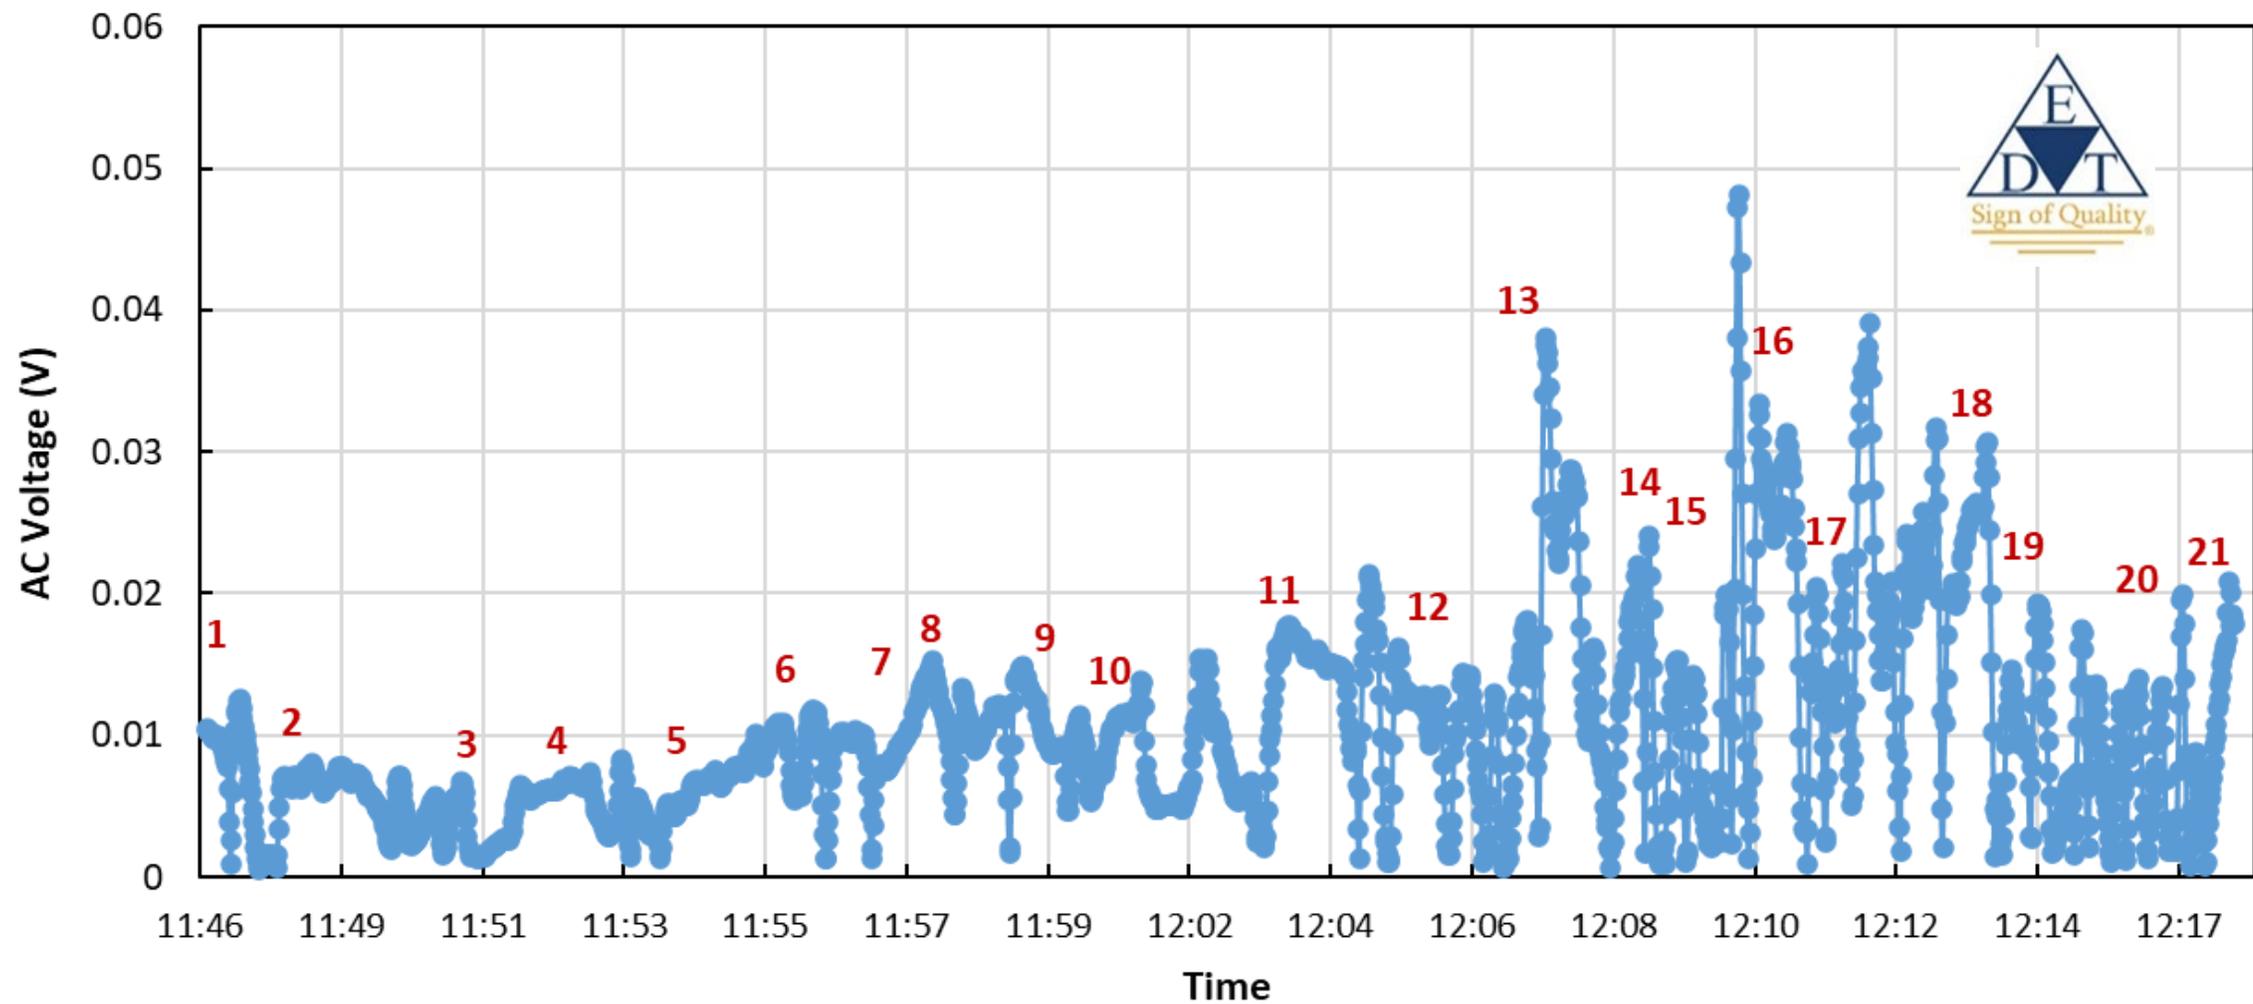
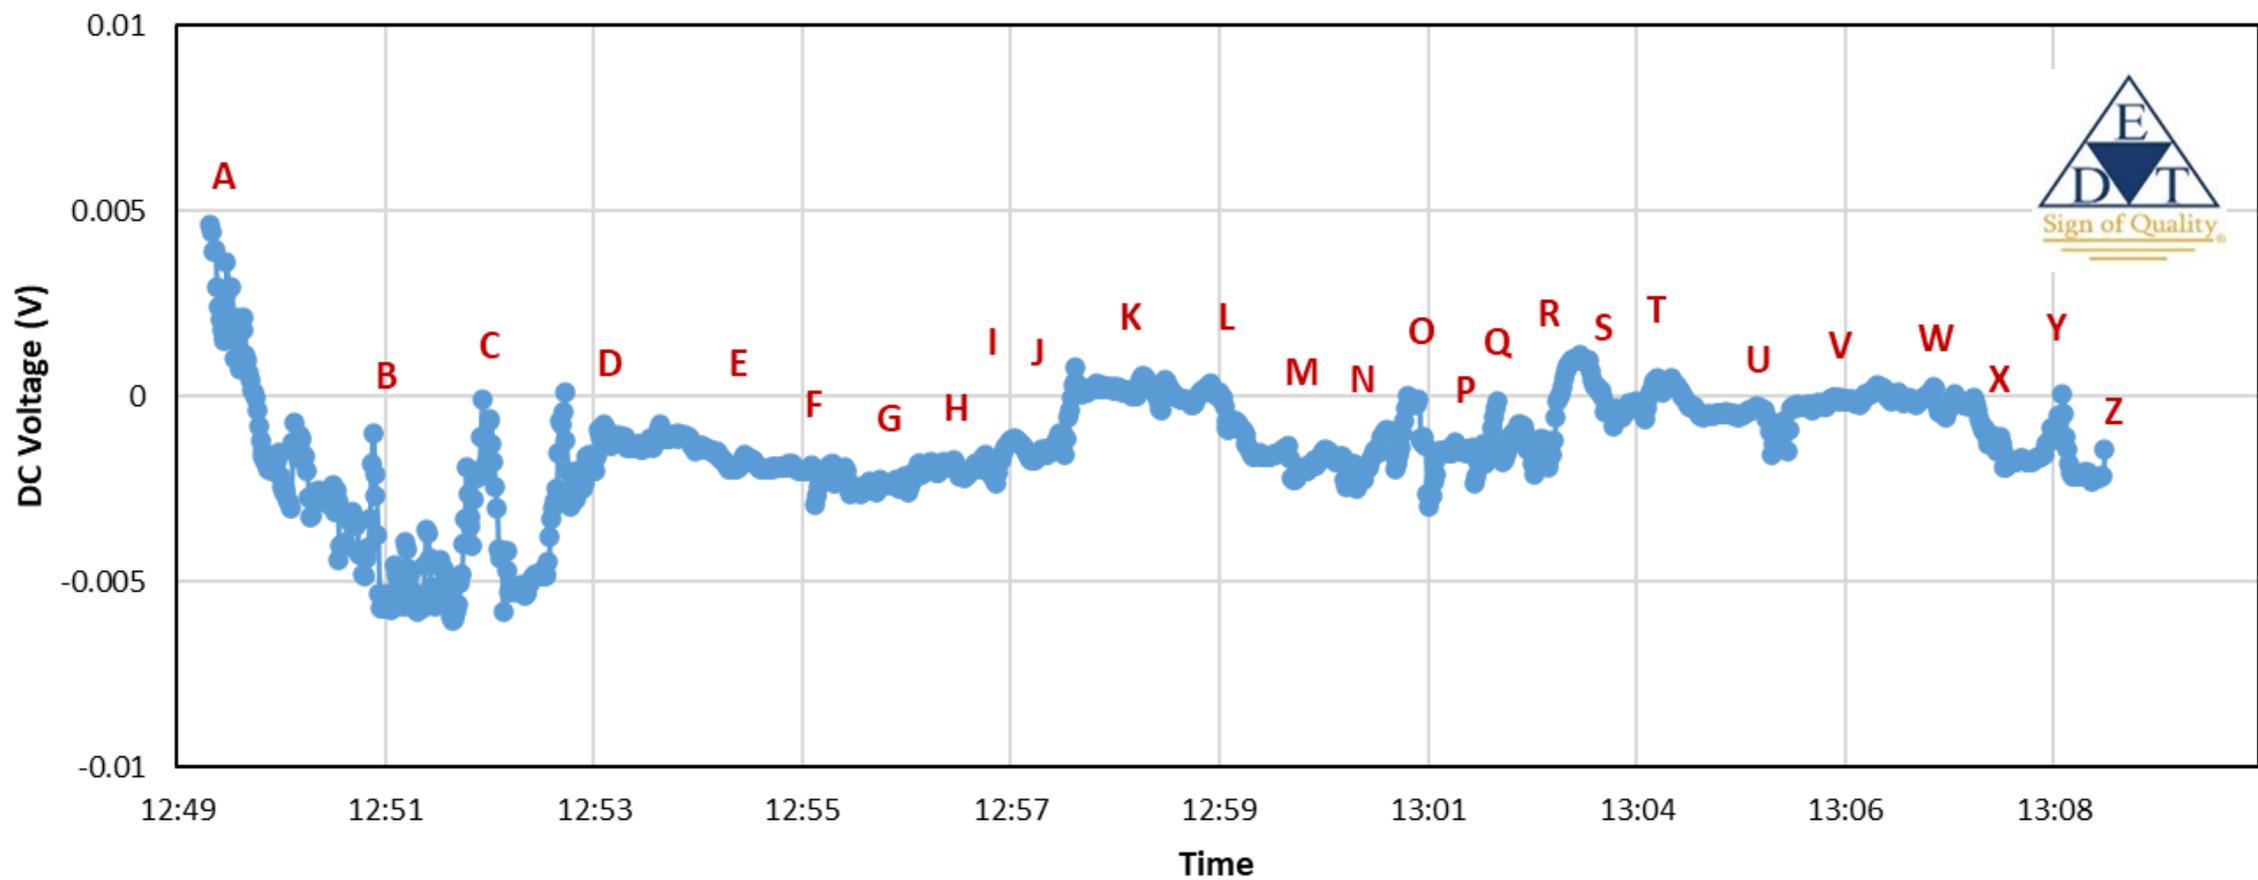
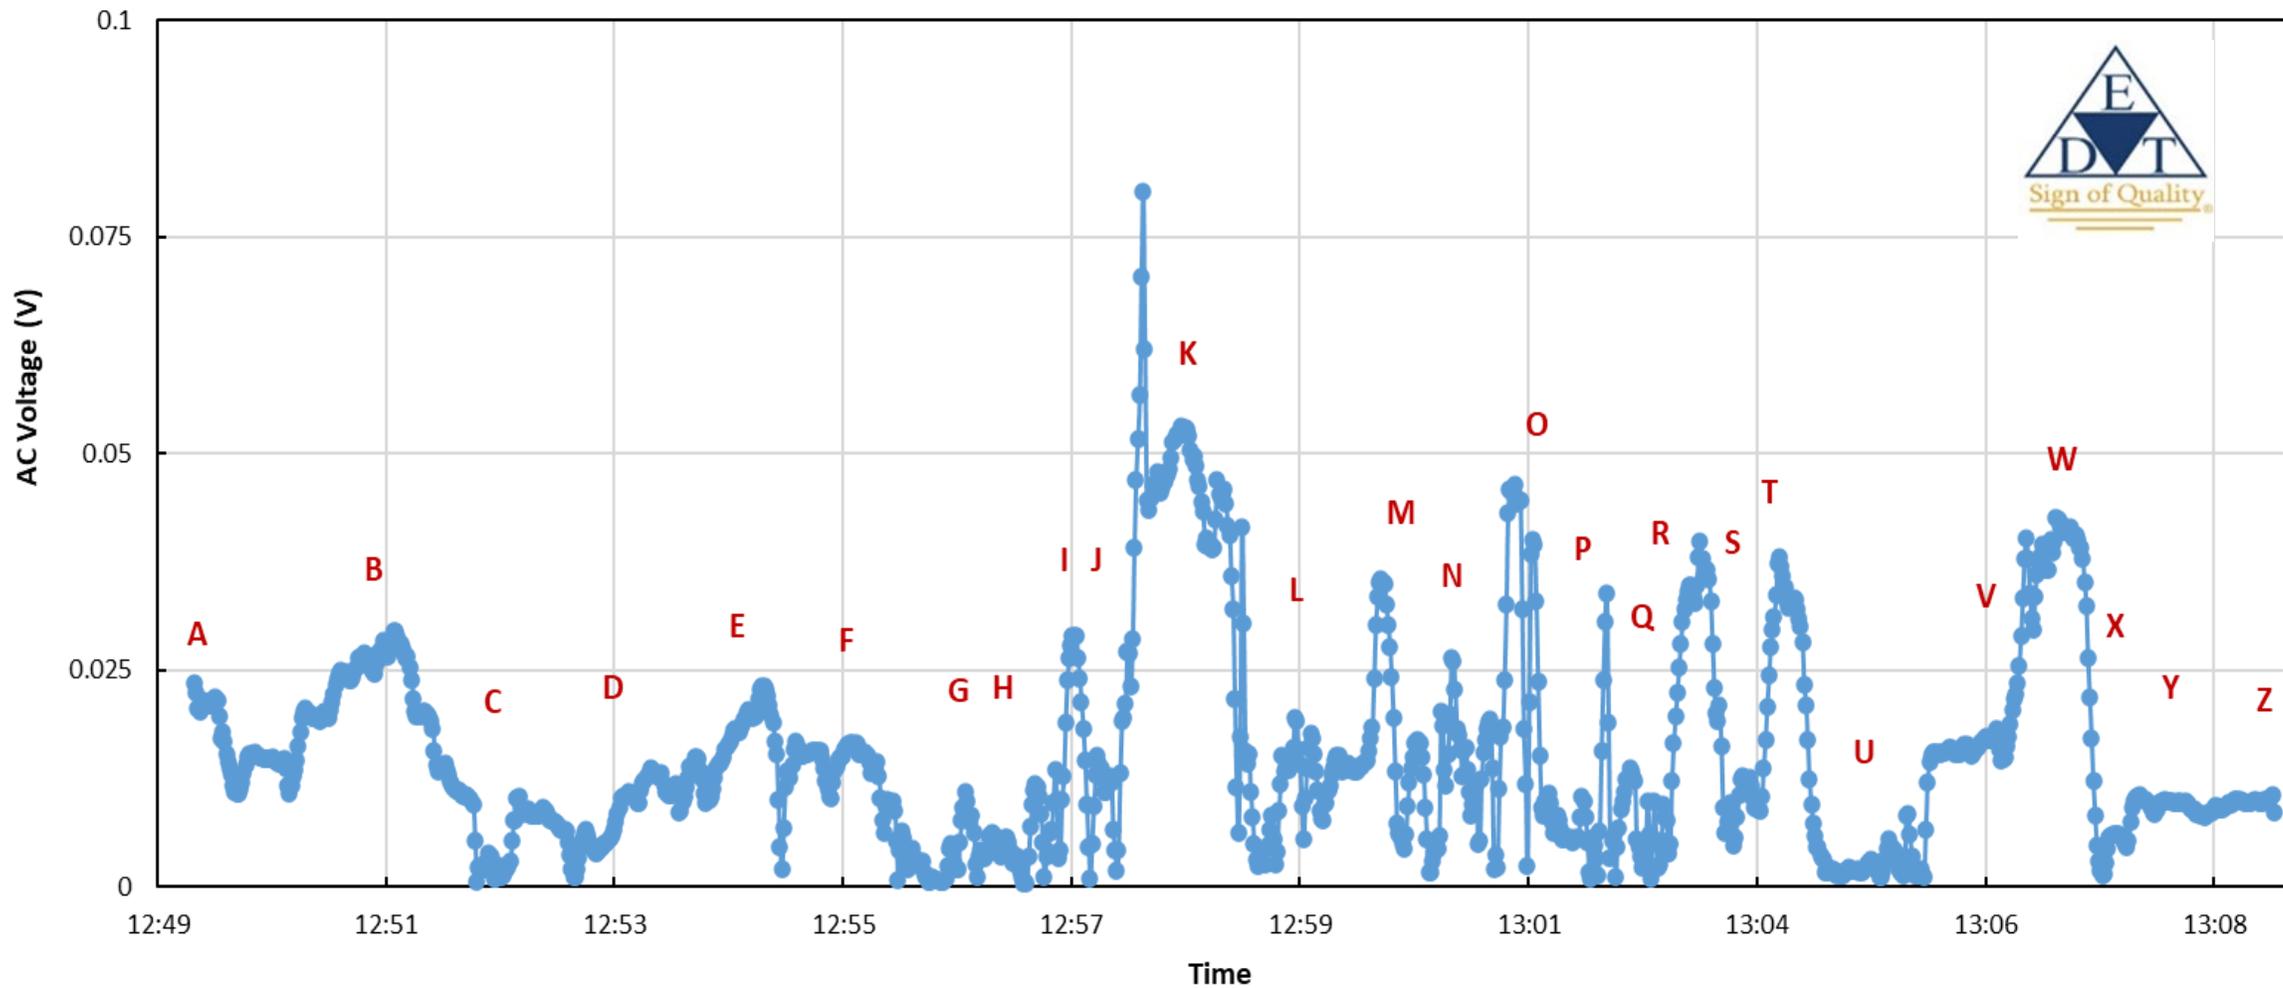
For both the first and second boat trips, the DC voltage values were generally between -5mV to +5mV with no distinguishable peak. Also, the majority of AC voltage values were between 0 to 50mV with the highest value of 80mV which was measured between locations J and K during the second trip at about 12:58pm. (See **Appendix B**).

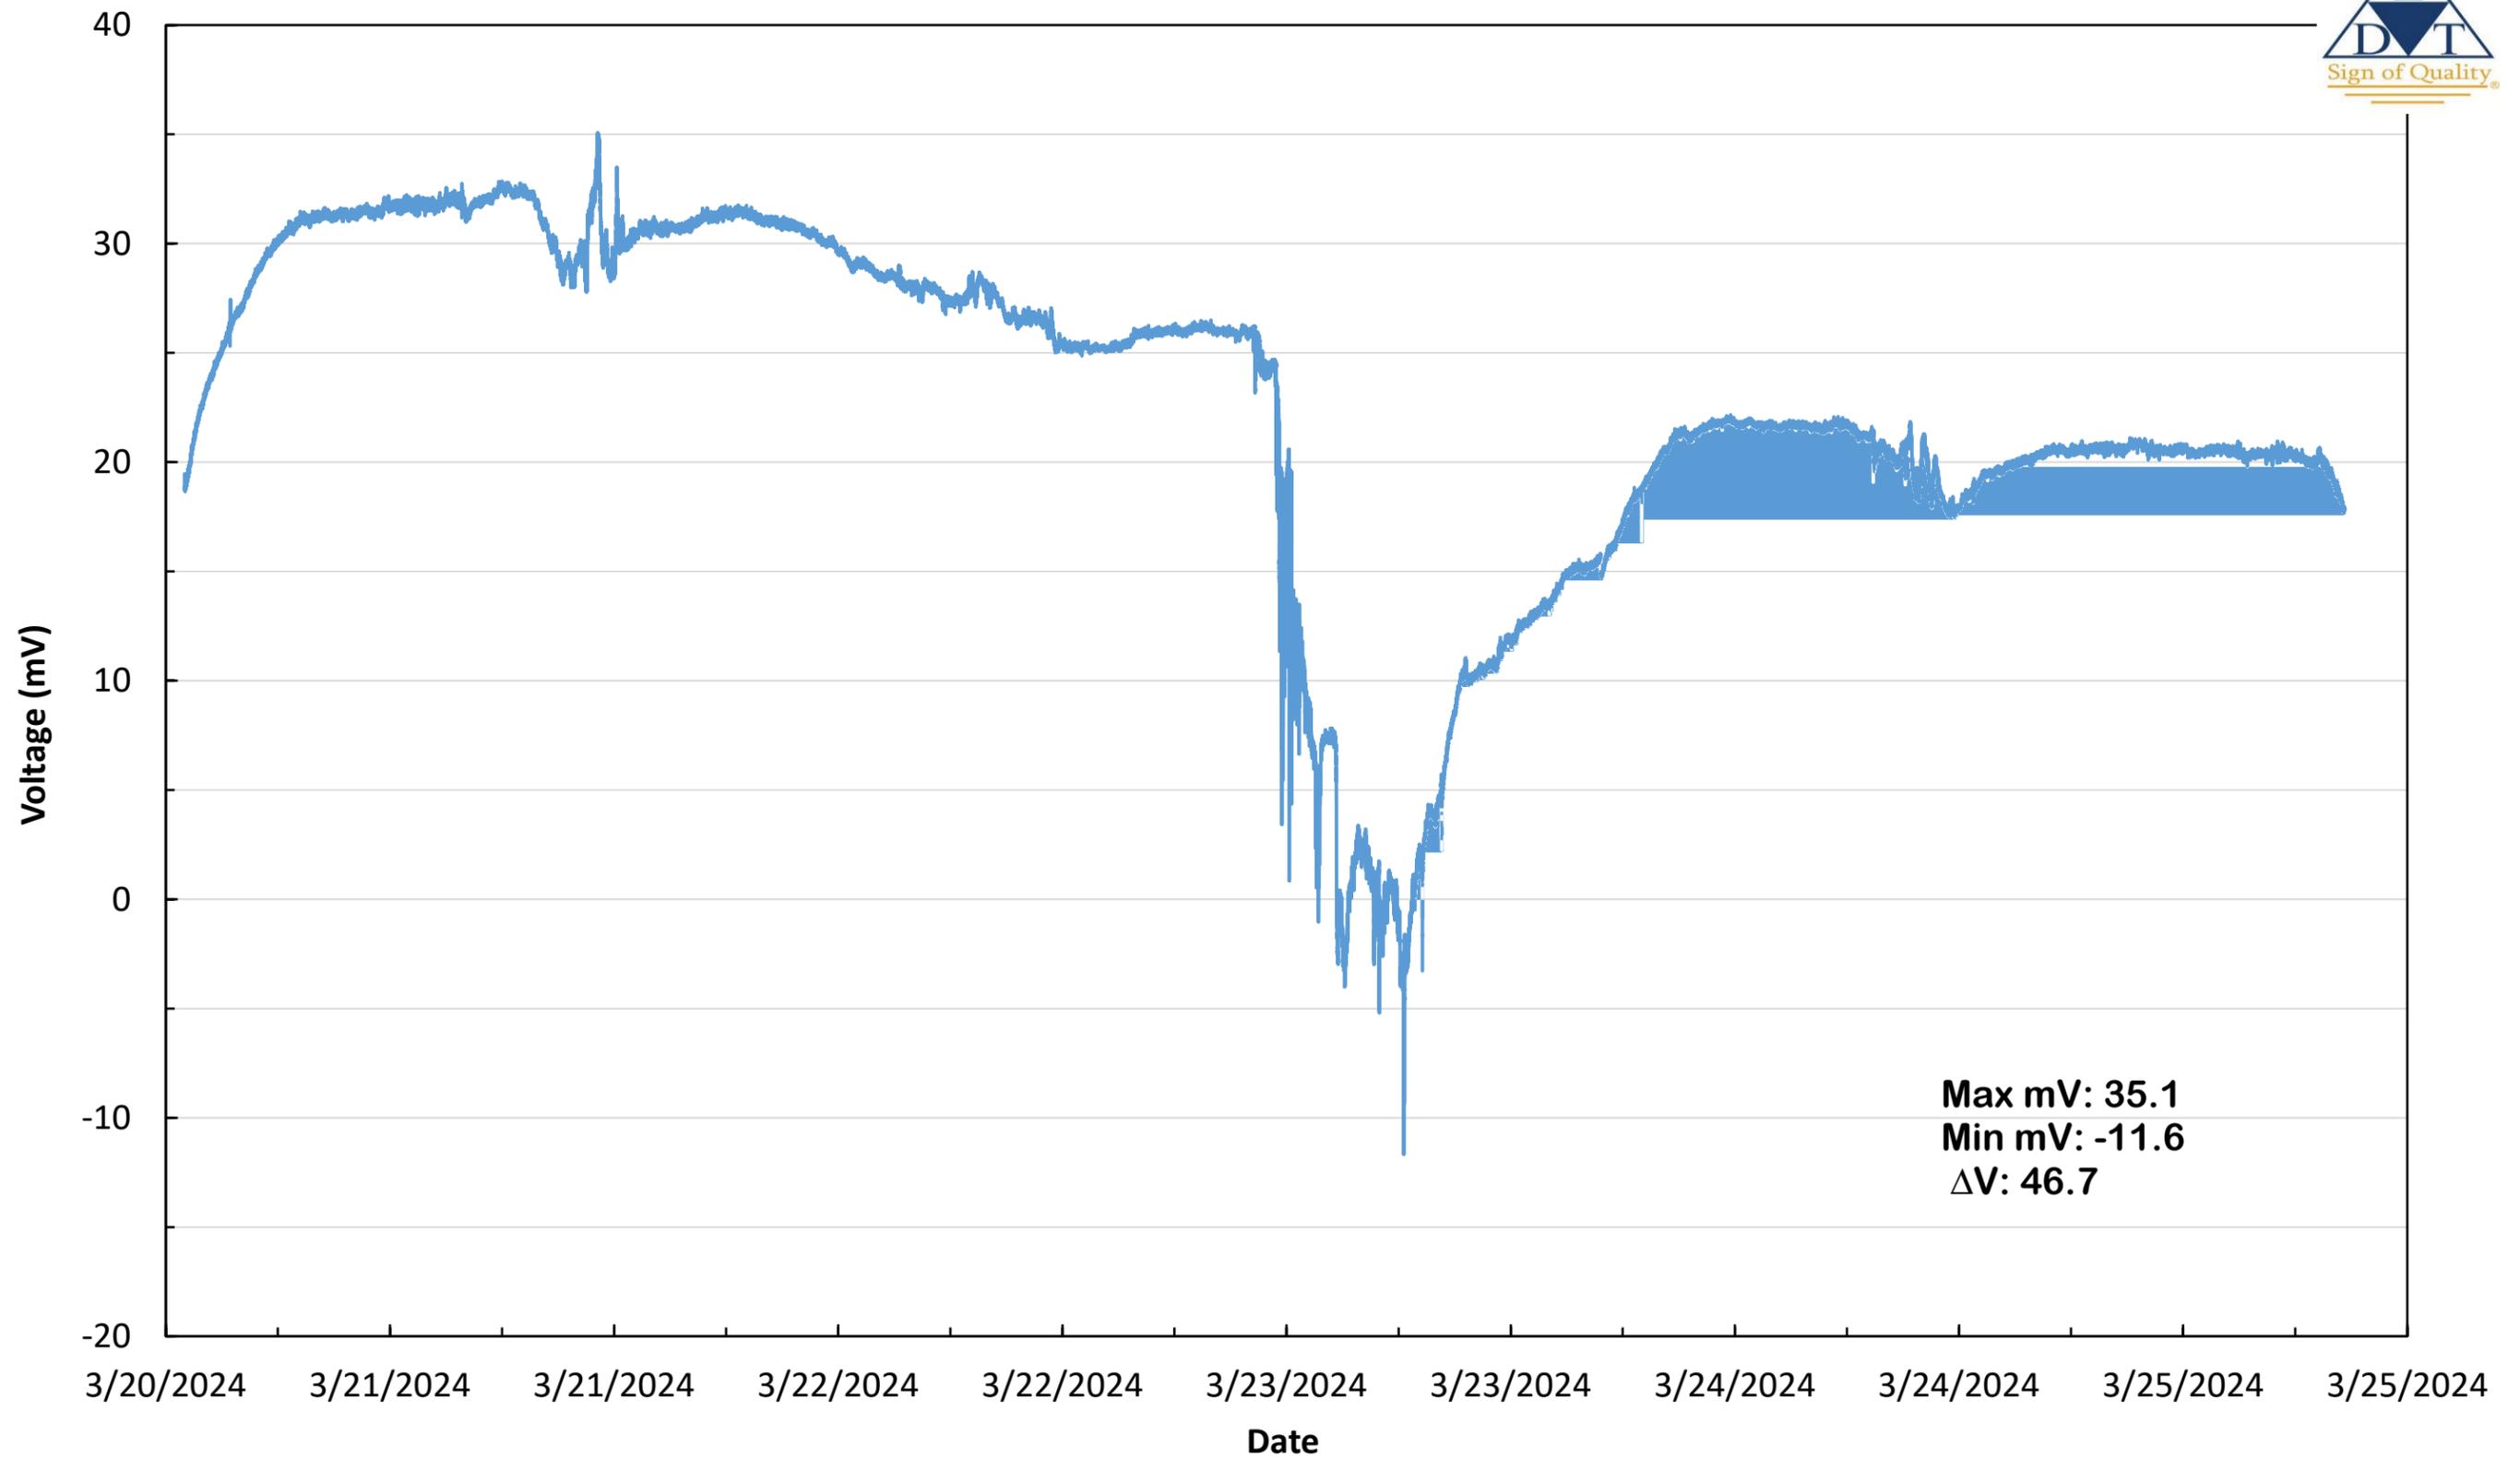
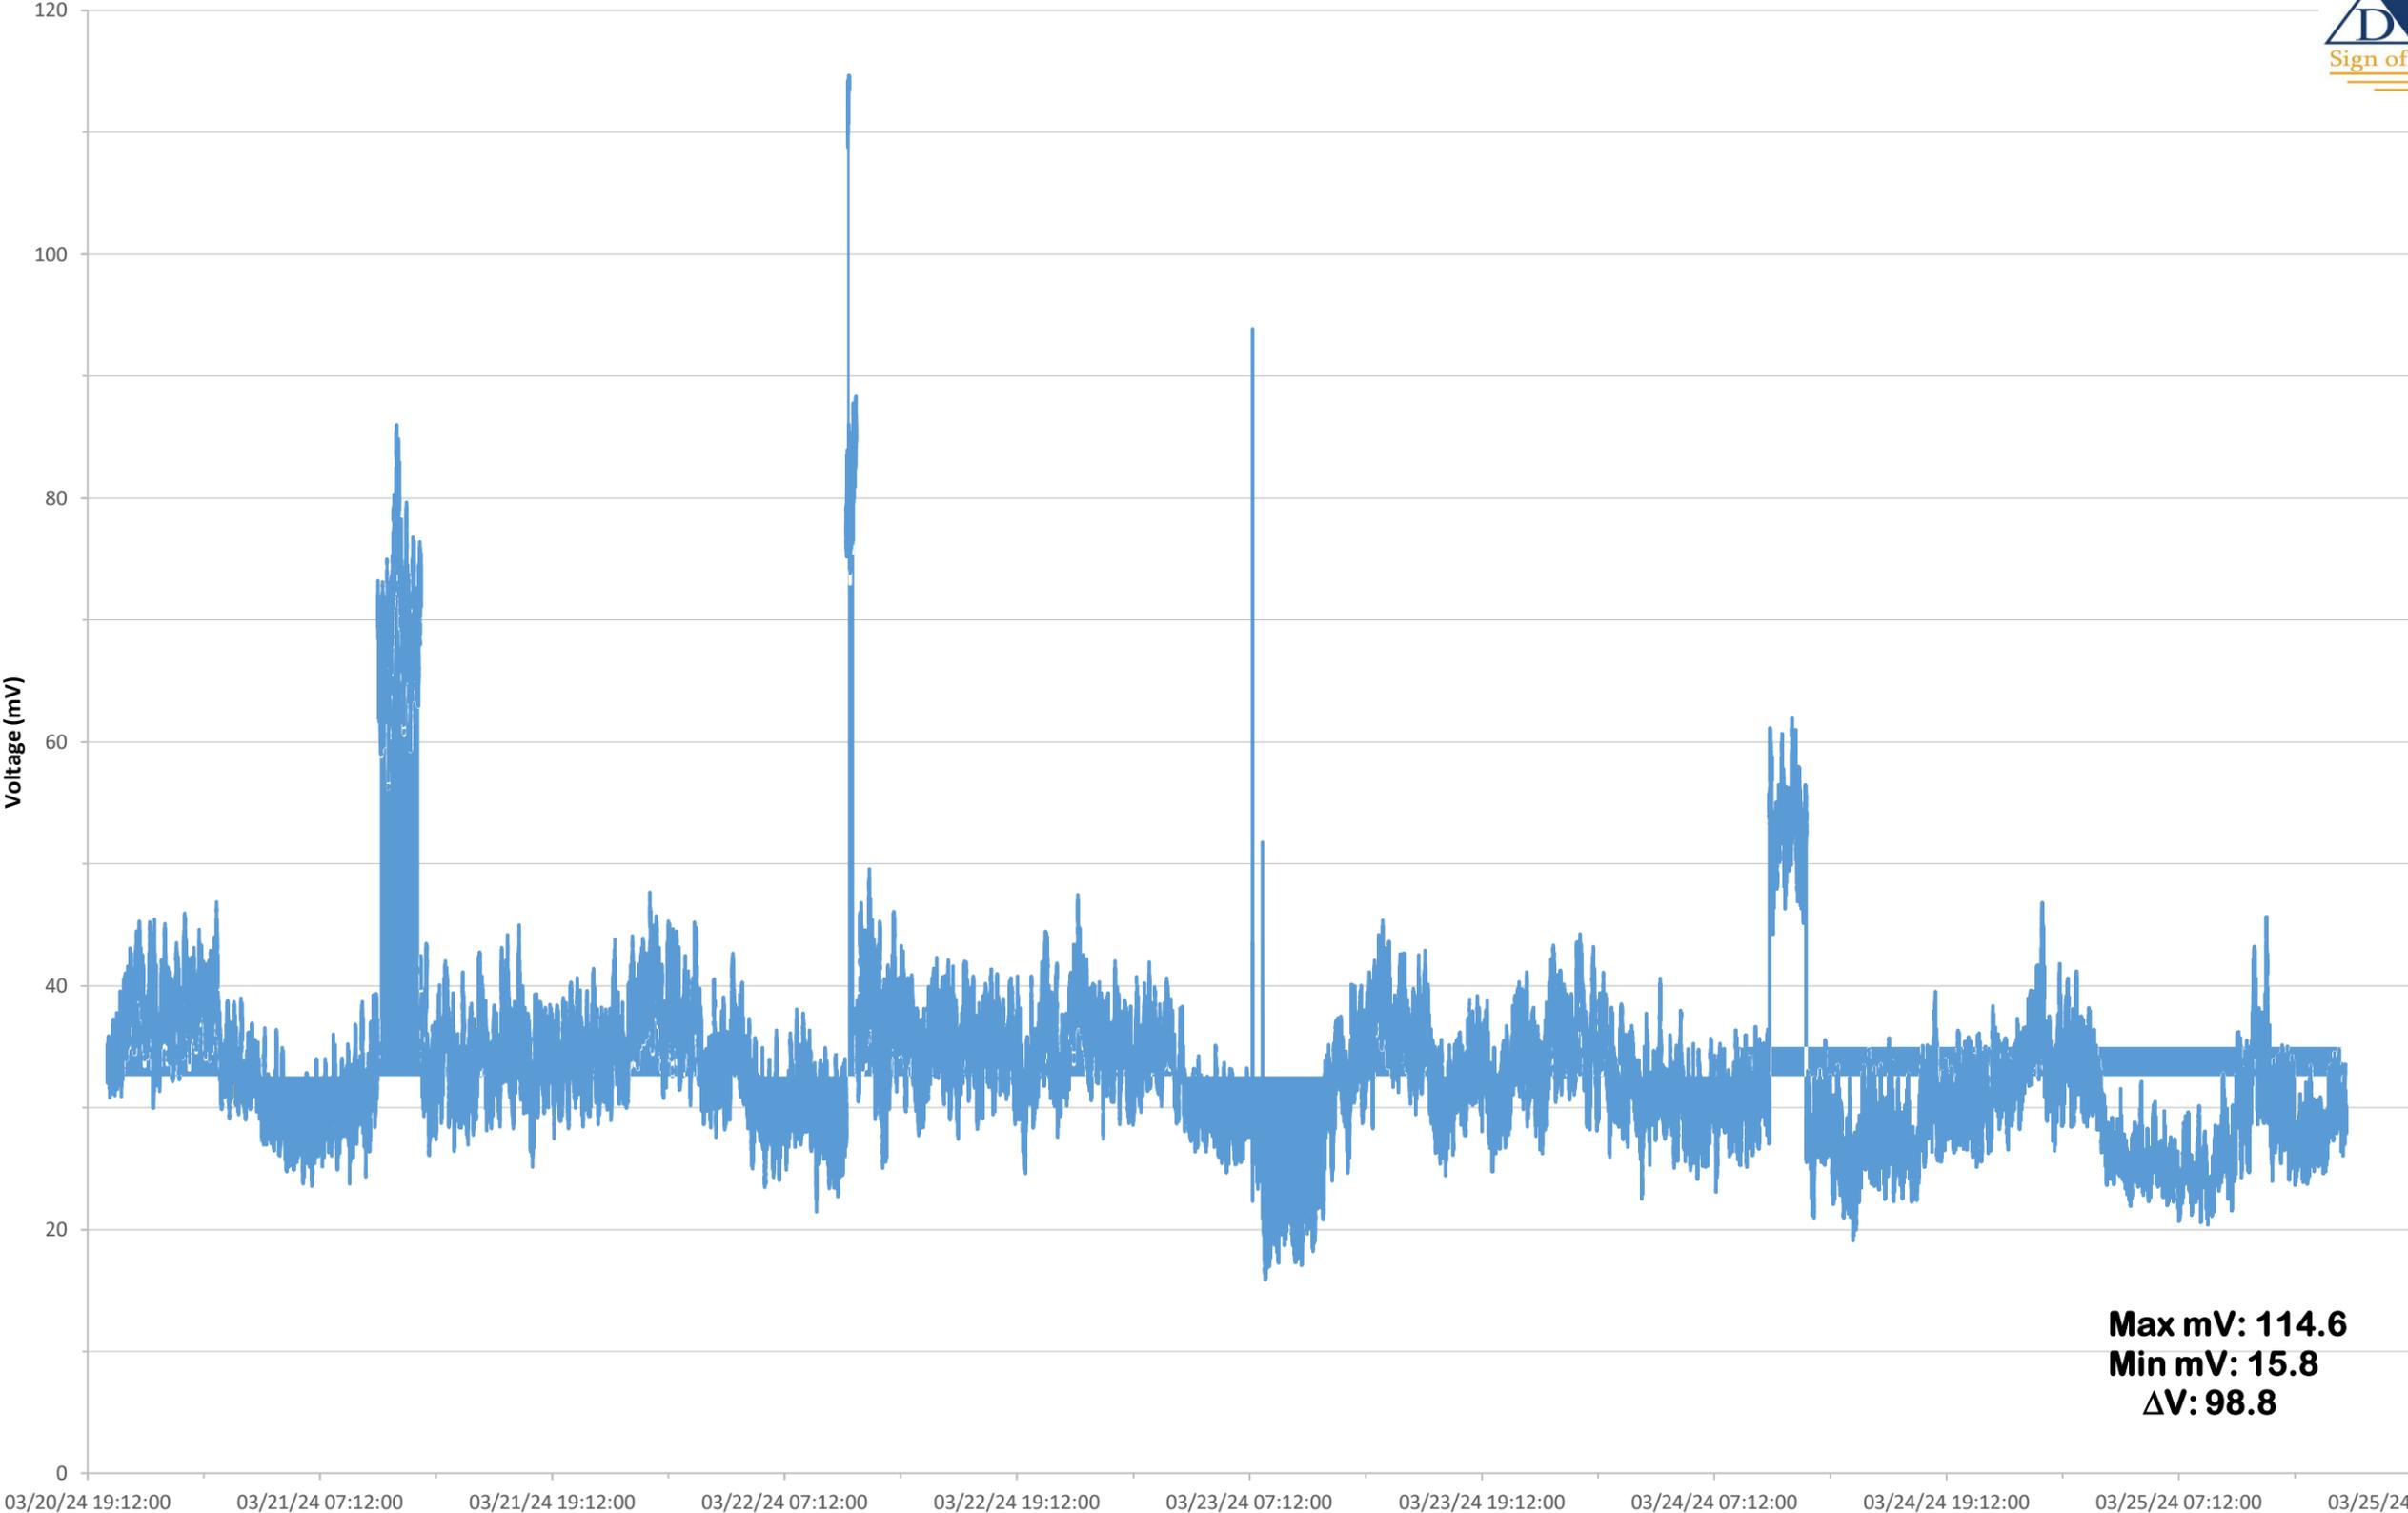
Most of the collected DC values are between 15 to 35mV except for the values that were recorded from March 23<sup>rd</sup> at 6:40 am through Marh 24<sup>th</sup> at about 4:00 am. The maximum and minimum values for the recorded DC voltages are 35.1 mV and -11.6 mV respectively. See **Appendix C** for the graphs. Note that steady-state (unvarying) DC voltages are not likely to be detected by humans.

Most of the recorded AC voltage values are between 20 mV to 50 mV with four distinguishable peaks exceeding 50 mV on Thursday March 21<sup>st</sup> around 10:12 am (duration ~2 hours), Friday March 22<sup>nd</sup> around 10:23 am (duration 20 minutes), Saturday March 23<sup>rd</sup> around 7:03 am (duration a few seconds), and Sunday March 24<sup>th</sup> around 10:03 am (duration ~2 hours). While the sources of these peaks are unknown, the onset and pattern of the peaks suggest that they are likely manmade. The maximum and minimum measured voltage values are 114.6 mV and 15.8 mV (See **Appendix C**).

The tests performed on land indicate a voltage change throughout the week. The daily periodicity of the peaks, which occur at different times and last for different durations, indicates a human-activated device was the cause but the source could not be identified. For example, regular peaks would be observed as a result of electric rail travel. Increases in the morning, at noontime, and in the evening would indicate that the source was residential power usage. Peaks in weekly working hours might indicate manufacturing facilities as the source.
