Annapolis City Dock

Cultural Landscape Report

Heritage Preservation Services
with Land and Community Associates

Prepared For
The City of Annapolis
Department of Planning and Zoning

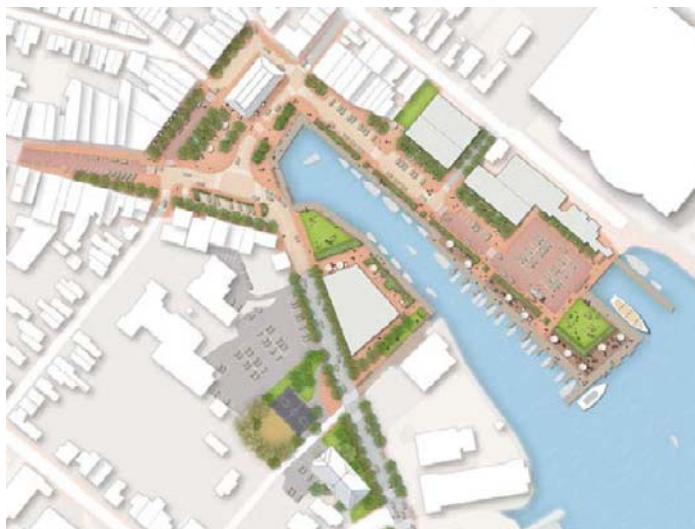
Plan / Drawing from the 2013 Annapolis City Dock Master Plan, By the Members of the Annapolis City Dock Advisory Committee. Graphics provided by Christopher N. Jakubiak, AICP; Jakubiak Town+ City Planning, Towson, MD, p. 8.

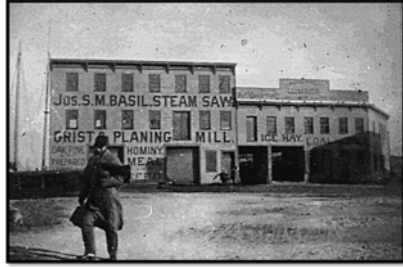
Archival Photo - Jos. Basil Steam Saw Grist and Planing Mill ca. 1895 at City Dock at foot of Main street. HA Scanned Image,

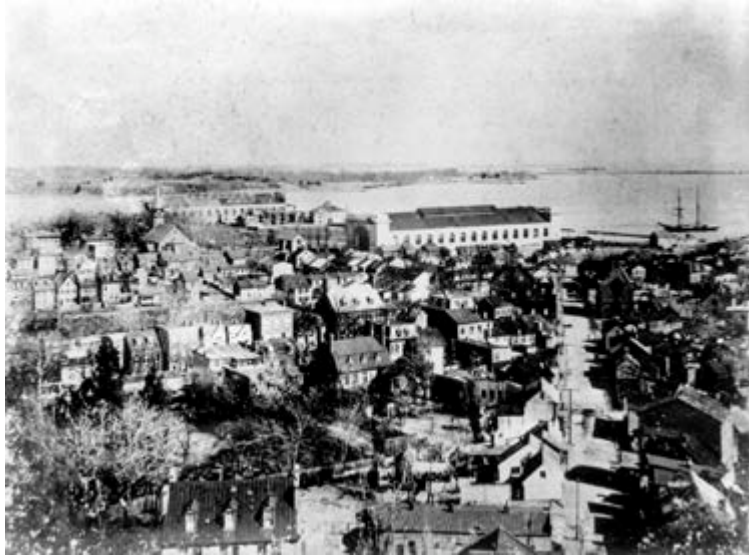
Maryland State Archives, 1902
View of City Dock. (Cd11)

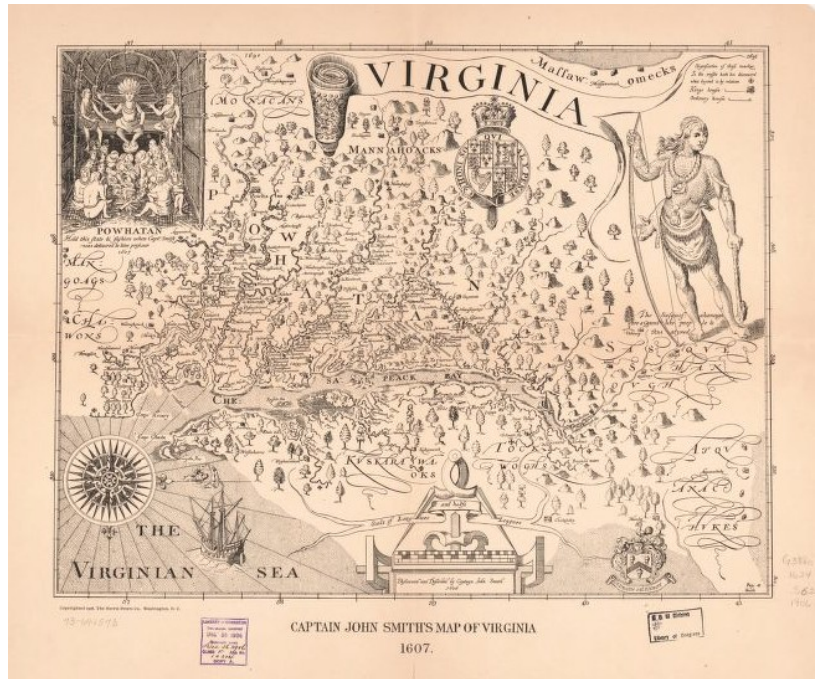
Detail of Capt. John Smith Map, 1612 Showing approximate location of what would develop as Annapolis, north of the "Roade" River.

The Captain John Smith Map of 1612, considered the most reliable image of the Chesapeake for most of the seventeenth century, provides visual documentation of the vicinity's water/land relationship in its pre-European development condition. Prior to European exploration and settlement, the water/land relationship was undisturbed by development but subject to storms and other natural forces and processes. Shorelines would have been vegetated with natural vegetation that provided wildlife habitat. While no European settlements like "Annapolis" are named on Captain John Smith's map, the area where Annapolis would later develop is generally shown.

There were no intentional sightlines in this era. While the types of sailing vessels changed over time, there are still the inherent navigational views. The original views were of natural land and water unobstructed by buildings and structures both from and to the water. Foreground and middle ground views of the water from land survive; background views from the City Dock location have changed significantly with development of the opposite shore. Views to the City Dock location and Annapolis have no seventeenth-century precedent.

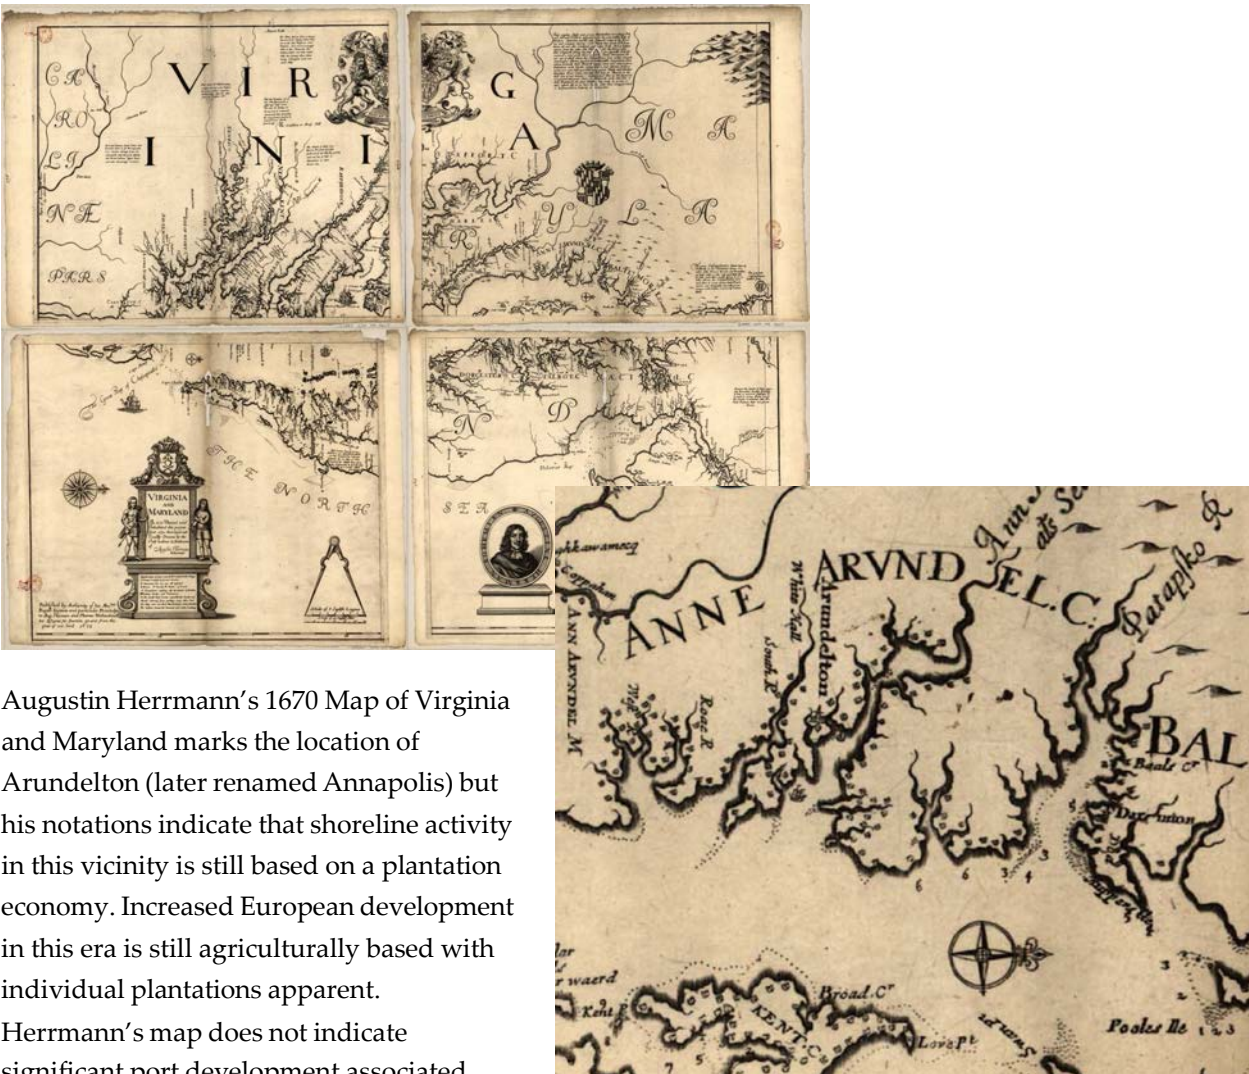
Augustin Herrmann's Map of Virginia and Maryland, 1670

Augustin Herrmann's 1670 Map of Virginia and Maryland marks the location of Arundelton (later renamed Annapolis) but his notations indicate that shoreline activity in this vicinity is still based on a plantation economy. Increased European development in this era is still agriculturally based with individual plantations apparent. Herrmann's map does not indicate significant port development associated with the area that develops into Annapolis.

Detail of Augustin Herrmann's 1670 Map highlighting "Arundelton."

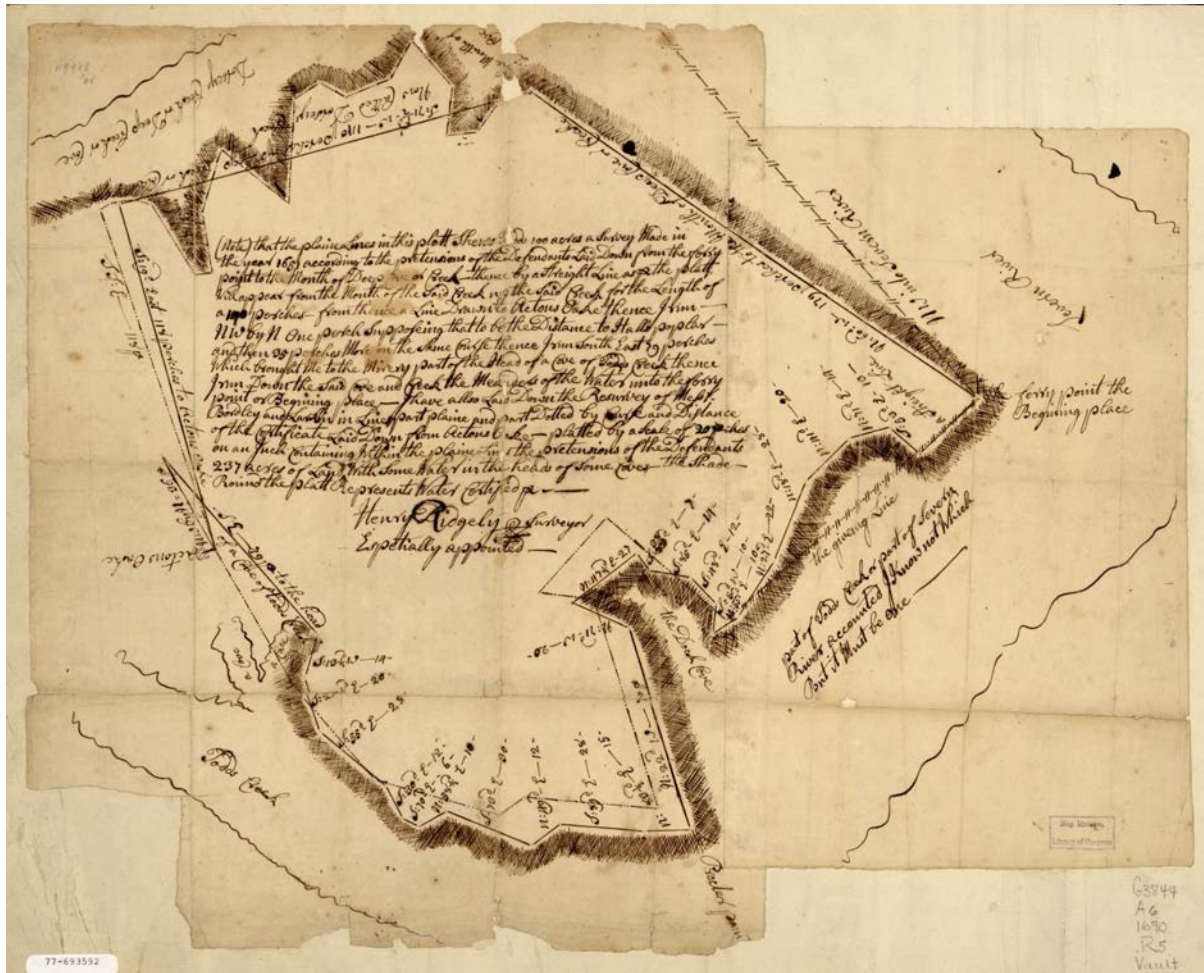
Henry Ridgely, in his 1690 "Survey of Annapolis," identifies the present City Dock location as "The Dock Cove," the first known use of the term "dock" for the sheltered cove.

Survey of Annapolis, 1690, Library of Congress The Cove is delineated and labeled "Dock Cove."

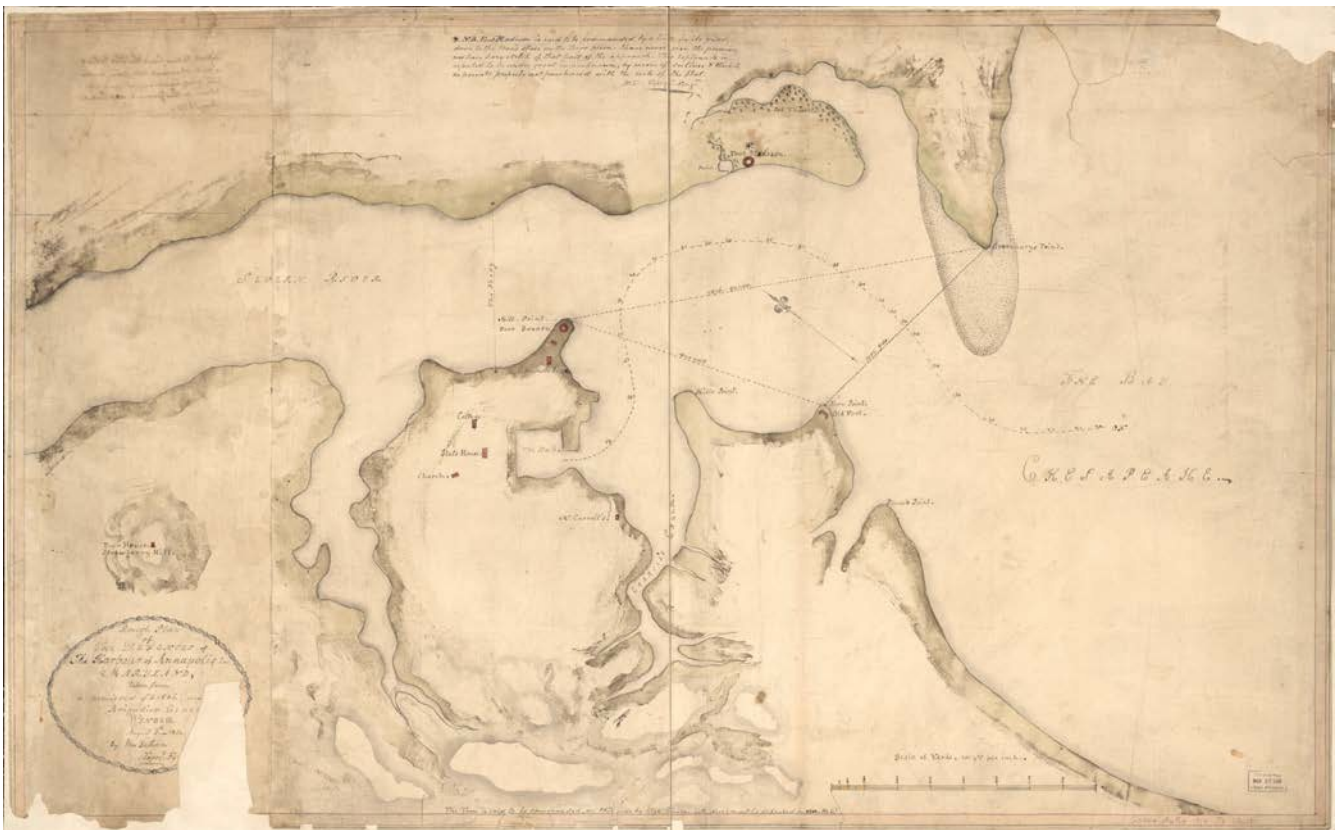
“Rough Plan of the Defences of the Harbour of Annapolis,” Tatham, 1814

This plan gives the depth of the channel to the dock and actually shows the cove/basin configuration as more rectilinear than in the past which supports the belief that fill had begun to even out the banks. The plan also uses the identifier of “The Dock.” The line shows a channel with depth of 18 feet off Mill Point dropping to 12 feet as it approaches the dock. This plan shows the College, Statehouse, Church, the Carroll House and their interrelationship. A ferry is shown on what is the Naval Academy property today. No land use, vegetation or streets are shown. There is no indication of major features or additions that would have blocked or obstructed direct visual access.

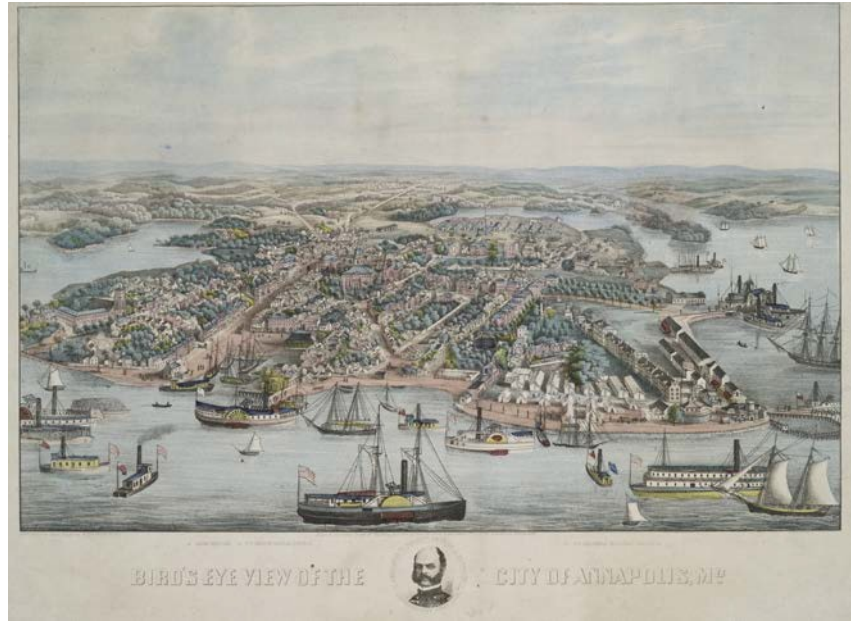
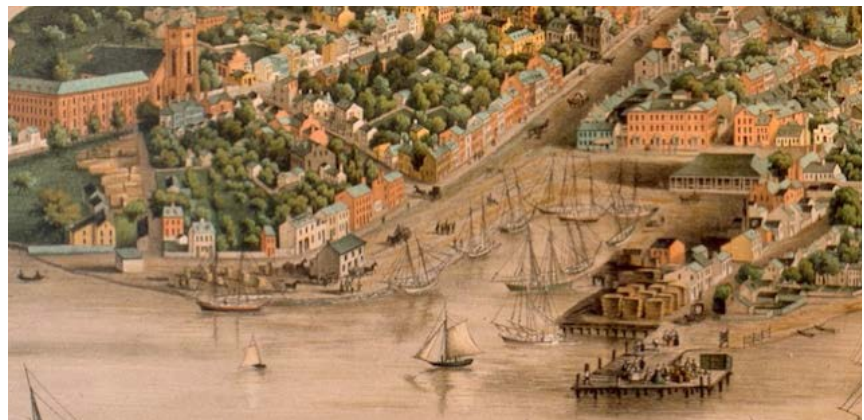
Sachse Birdseye, 1858

Despite its inherent artistic license, the 1858 Sachse Birdseye provides our best first historical development view of City Dock as well as depictions of the types of maritime vessels in and adjacent to the dock, including steam boats, a paddle boat, and there are also a variety of sail boats both in the dock as well as approaching or departing the city via Spa Creek and the Severn River. The addition of groups of human figures as well as horses and horse-drawn vehicles give some indications of the City Dock area as the focus of much of the activity associated with this important place of maritime dependent commerce and industry.

Detail of Sachse's Birdseye, 1858, highlighting dock area

The intention of the vision of the Nicholson Plan is quite evident with the hierarchical views and sight-lines to and from the river and dock to the city's landmarks and higher elevations. Market Space and Compromise Streets appear as rough-surfaced roads composed of compressed earth, rubble, and oyster shell. The birdseye also provides the visual contrast between the almost entirely vegetation-less dock vicinity landscape and that in other areas of the city portrayed with leafy tree-lined streets and yards.

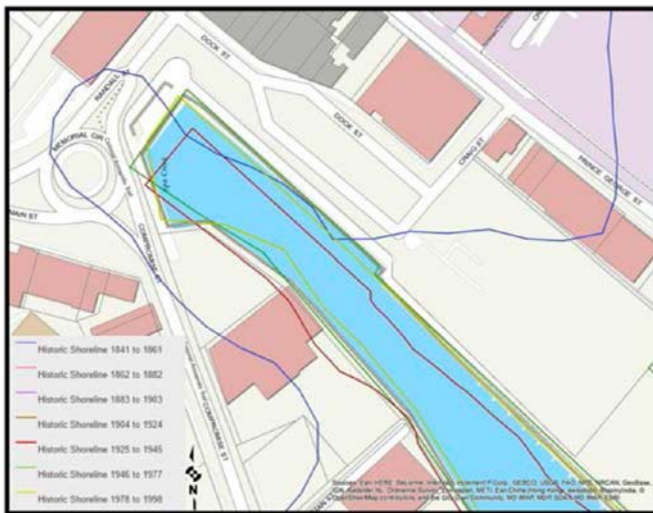
Changing shoreline as determined by Kerns CRM, Archaeological Monitoring for the Annapolis City Dock Bulkhead Repair Project, March 1-25, 2016

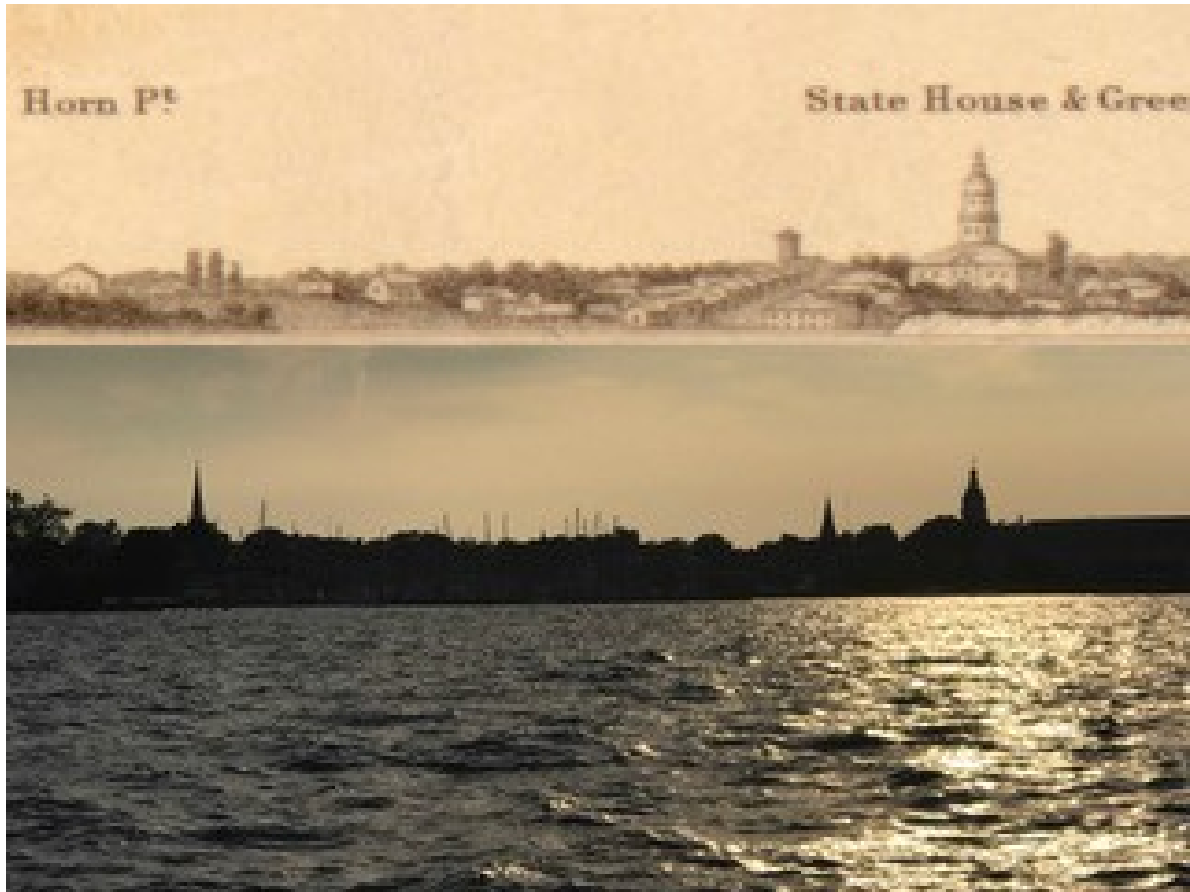
Elevation comparison of water view from outside Annapolis Harbor towards City Dock in 1846 and 2018. Bache, 1846, HPS, 2018.

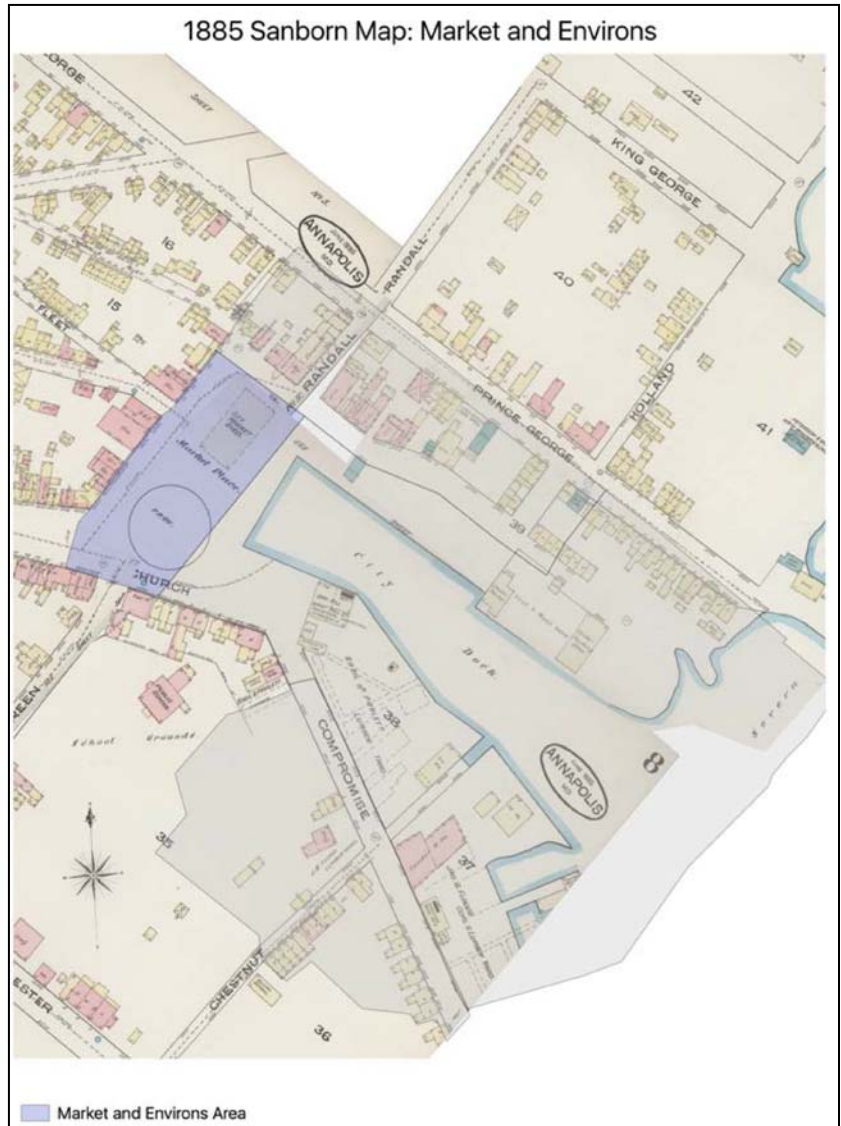
Sanborn Fire Insurance Map, 1891

The 1891 Sanborn map documents the first appearance of a long wooden structure labeled “Market” at the water’s edge of the dock east of the 1857-1858 market. It appears to have been completely built out over the water and has no discernible interior divisions. Dashed lines indicate that it may have been open to the dock but enclosed on its other three sides. Sanborn shows the market as the “City Market Shed” which appears to be open with an enclosed area for its “coffee house” and brick structures inside for scales and tools. Sanborn applies the name “Market Space” to the street in this area for first time on its maps; and the maps shows the area between the market and the park is called “Market Place.” The map identifies the circle simply as “Park.” The developed urban blocks that surround the market have a variety of uses, including groceries, residential “tenements,”

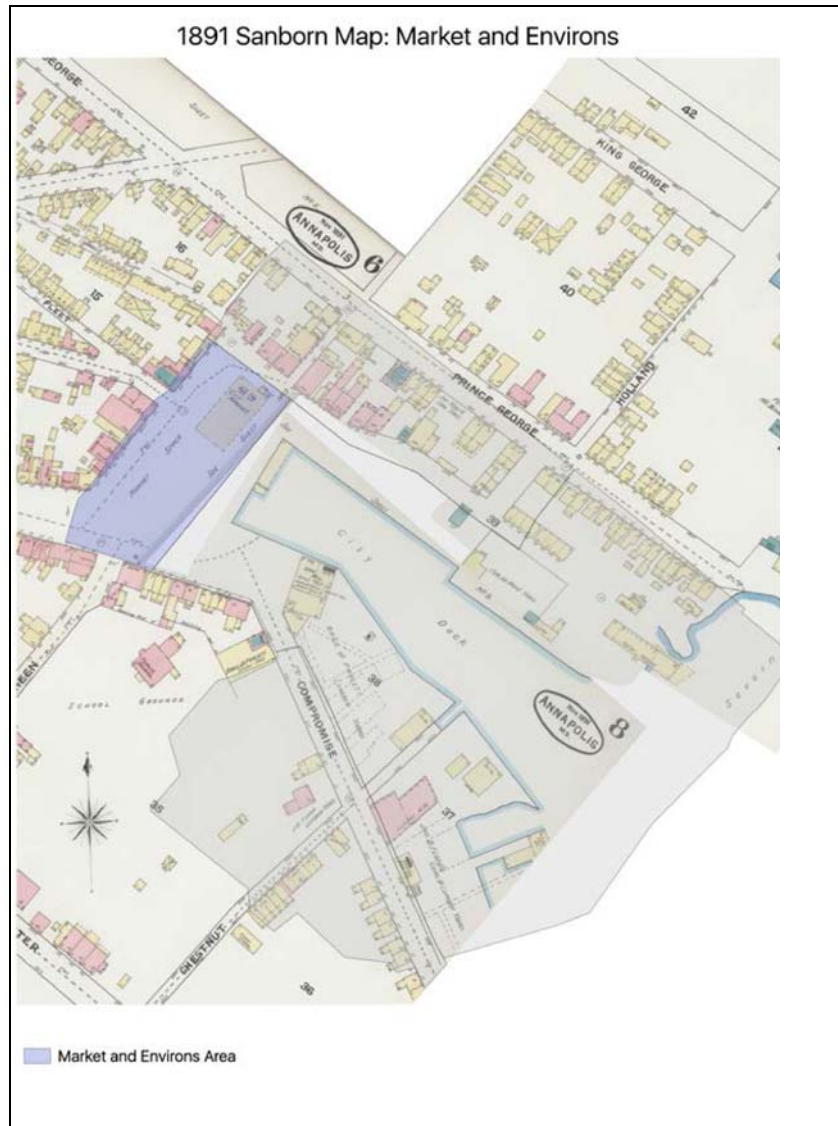
Sanborn Fire Insurance Map, 1897

Two names apply to the public space adjacent to the market in 1897; the street alignment from Church Street past the market is identified as Market Space, while the area between the dock is called "Market Place." The market's small, covered entry is shown as oriented to Market Space; its two brick interior structures are described: one for "tools" and the other for "scales." The market appears to be open.

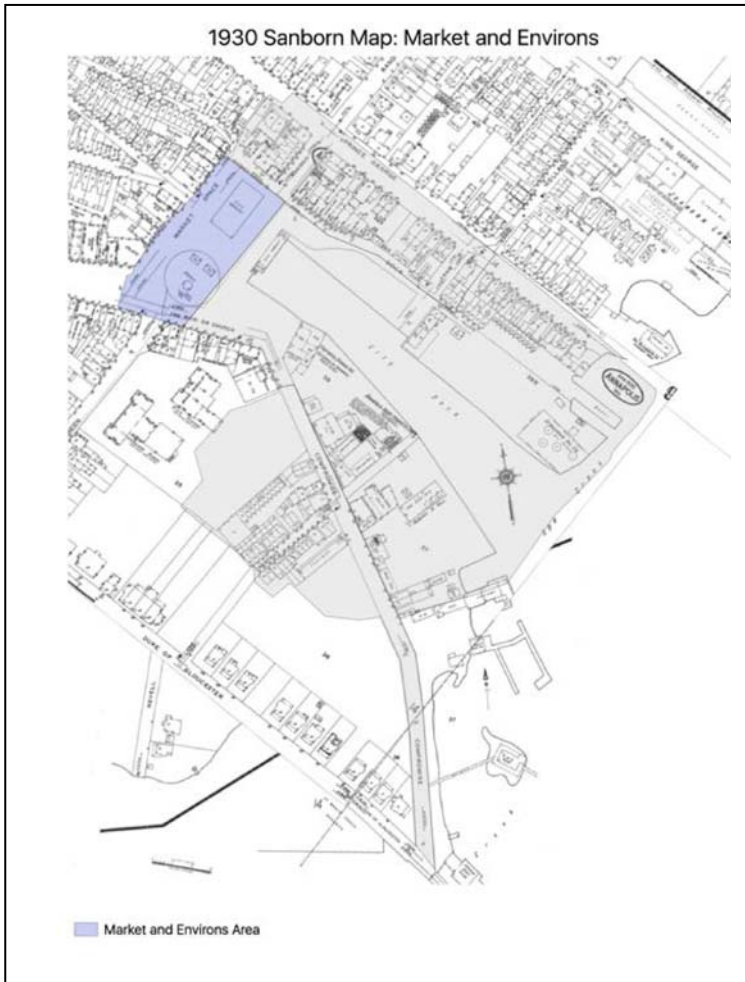
Sanborn Fire Insurance Map, 1930

For the first time in decades there has been construction in the middle of Market Space. While historically, the only known structure was a small coal office built of wood, by 1930 a gasoline filling station in this very visible location certainly symbolizes the transition to the automotive age and the City Dock area's accommodation to it. The station with its two detached restroom structures provided an architectural focal point and traffic routings through Market Space.

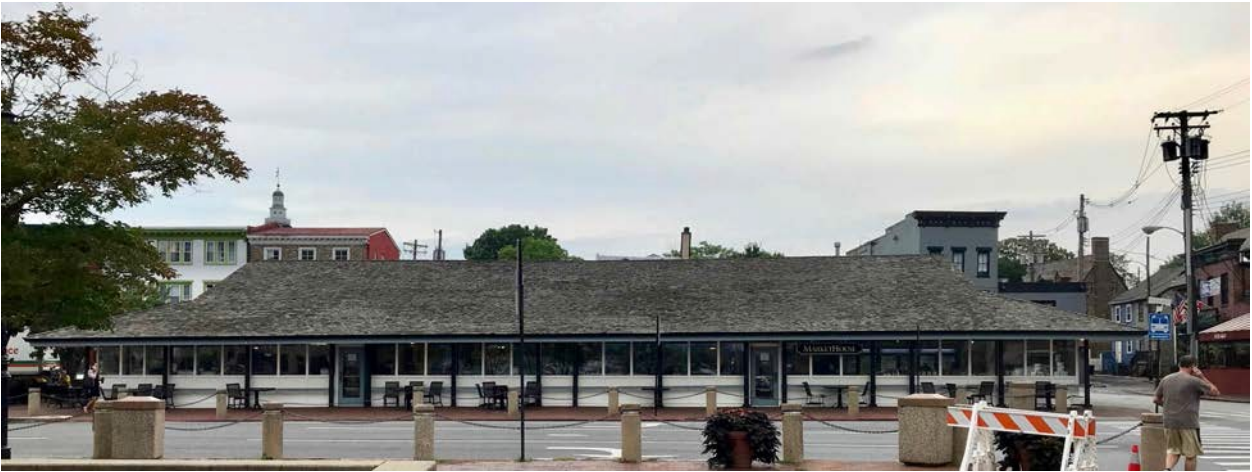
Existing Condition Photo of Market House at Market Space and Randall Street, Annapolis, MD. Detail view of overall Randall Street (East) facade of building, looking North toward Prince George Street. Taken July 30, 2018. HPS/LCA photo.

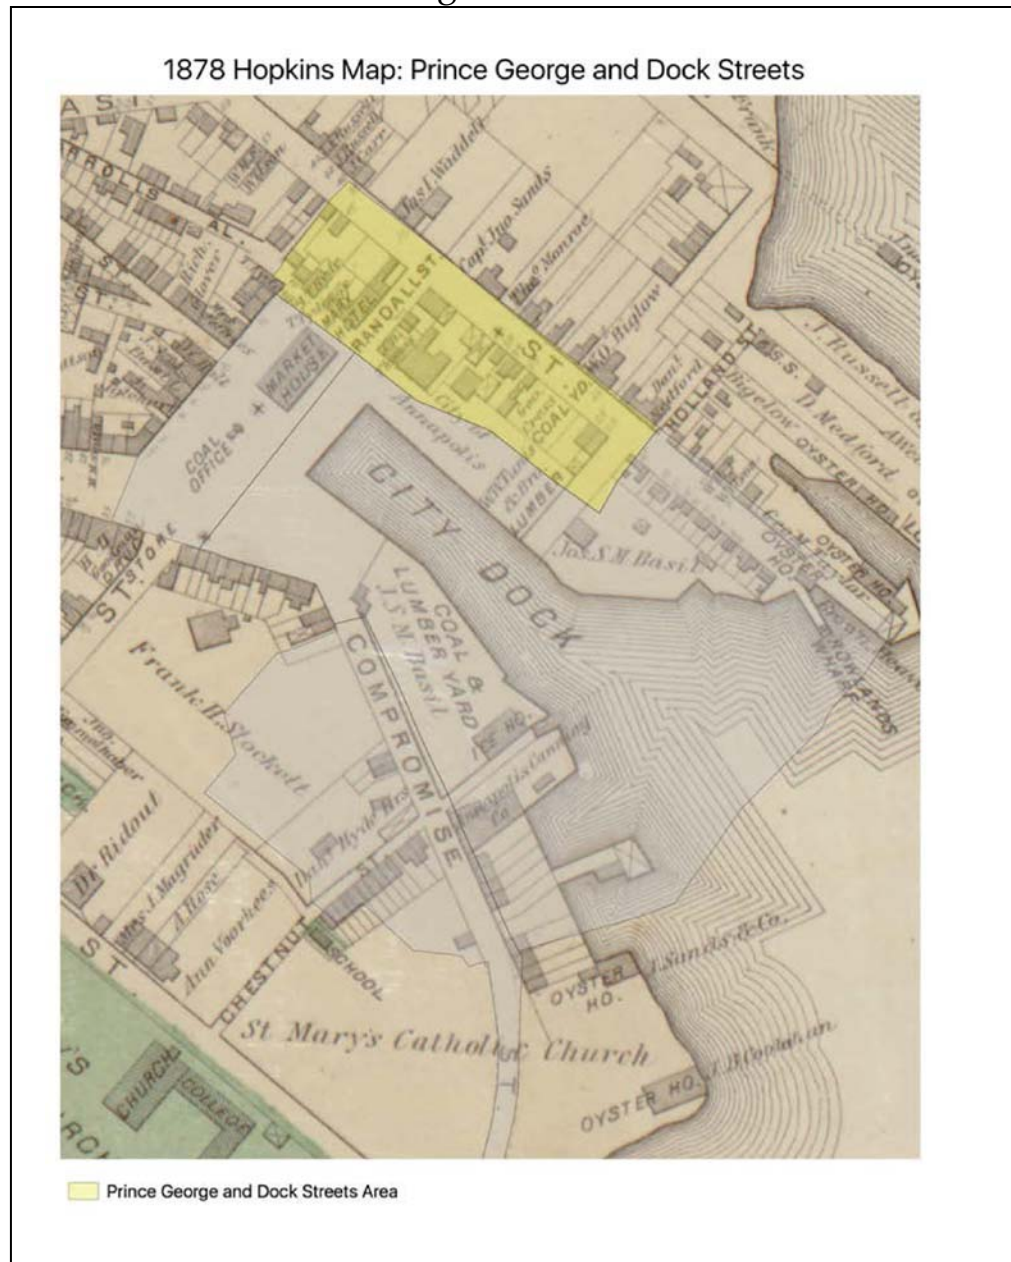
Hopkins Map of 1878 "Atlas of fifteen miles around Baltimore including Anne Arundel County, Maryland"

The Hopkins map provides considerable information about the Prince George/Dock Street area, presenting the first detailed and holistic, physical information about street alignments as well as relative building size and material. Some of the city's largest and most substantial commercial and residential buildings such as the former Middleton Tavern occur within and adjacent to this area. The largest buildings do not exceed three or three-and-a-half stories in height, and the blocks making up City Dock and its most immediate environs generally are arranged in linear rows and blocks with an individual principal building range of two, two-and-a-half-, three- and three-and-a-half story buildings. Rear additions, sheds, and other auxiliary structures are almost always one or one-and-a-half-stories in height. These are the largest commercial, residential, and mixed-use type buildings in this-area. While some are exclusively residential, most appear to have commercial/retail ground floor, front façade uses and residential uses on the second and third floors.

Hopkins shows an irregular row of buildings facing the Dock that perhaps reflect the traditional high tide, build-to line that guided permanent development in this area that is subject to episodic flooding even historically. Their arrangement also hints at the origins of the dogleg in the future Dock Street building line and alignment. Prince George Street is primarily a residential street, and a clearly defined streetscape in 1878, albeit with some gaps and utilitarian uses. A mix of large and small wood frame buildings occur in a linear but not continuous arrangement along the south side of Prince George Street. On Prince George east of Randall Street, there are four stables or sheds fronting on the Prince George and one larger stone or brick stable. The George Cress Coal Yard occupies a large lot on Prince George Street east of the stables with two wood frame dwellings between the coal yard and Craig Street, and there is an ell-shaped house on the east side of Craig Street. The Craig Street alignment appears on the Hopkins Map with just one house. Since there are residential yards associated with a few houses, there may have been vegetation, walks, and paths.

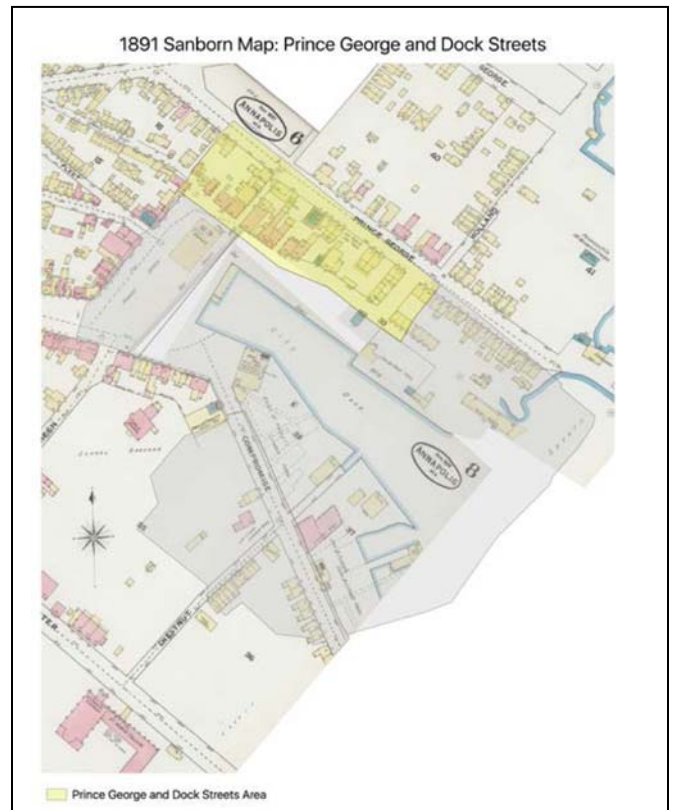
Sanborn Fire Insurance Map, 1897

This area has a combination of ground-floor uses that range from industrial to residential and include a variety of goods and services. Second and third floors are primarily used as residences and for storage. The historic Middleton Tavern has converted one side for a restaurant-type use described as "meal," and the former hallway between two saloons appears to be a dwelling. The tin shop at the southeast corner of Randall and Prince George Streets occupies a former dwelling that has undergone a fire resistant rehabilitation. The coal yard is no longer in this area, but the blacksmith remains. There is a confectionary in part of a dwelling at the southwest corner of Prince George and Craig Streets. The one vacant lot one lot east of the southeast corner of Randall Street has been in-filled with a new two-story brick stable. Dock Street is filling in with more brick buildings, but there are fewer exclusively residential uses. The general store at the intersection of Dock and Randall streets has been enlarged to the east. Other uses on Dock

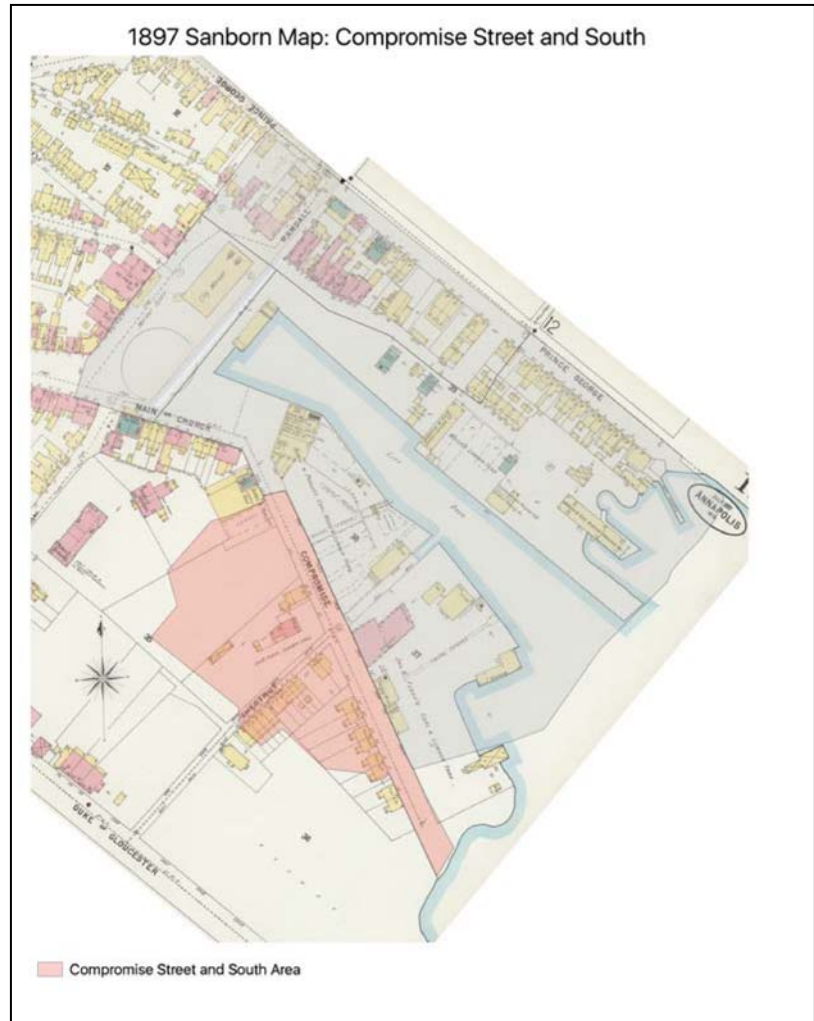
Sanborn Fire Insurance Map, 1903

By 1903, the Flood Lumber property has developed with a row of eight wooden, attached houses on the west side of Chestnut Street opposite the tenements that have existed for several years; there are an additional two houses on Compromise Street. A wagon shed has been built in the location of a former lumber company shed. The large brick house associated with the lumberyard is not identified, but a similar building occurs in 1908 so perhaps this is a map error. Each of the new dwellings has a back porch and detached shed. None of the houses are identified as tenements, and no race is identified. The lumber operation is now named Parlett and Parlett in the same location, and a large open land area still remains between it and the Compromise Street houses. The former Negro school location is described with a two-story dwelling that could represent an adapted use of the former school building. There is a one-story wooden building used as a “restaurant” near the water at the end of the Compromise Street houses sometimes identified as tenements.
