# Final Report

## Back Creek Watershed Action Plan

Developed for:  
Back Creek Conservancy  
Annapolis, MD  
[www.backcreekconservancy.org](http://www.backcreekconservancy.org)

Developed by:  
Center for Watershed Protection, Inc.  
3290 North Ridge Road, Suite 290  
Ellicott City, MD 21043  
[www.cwp.org](http://www.cwp.org)

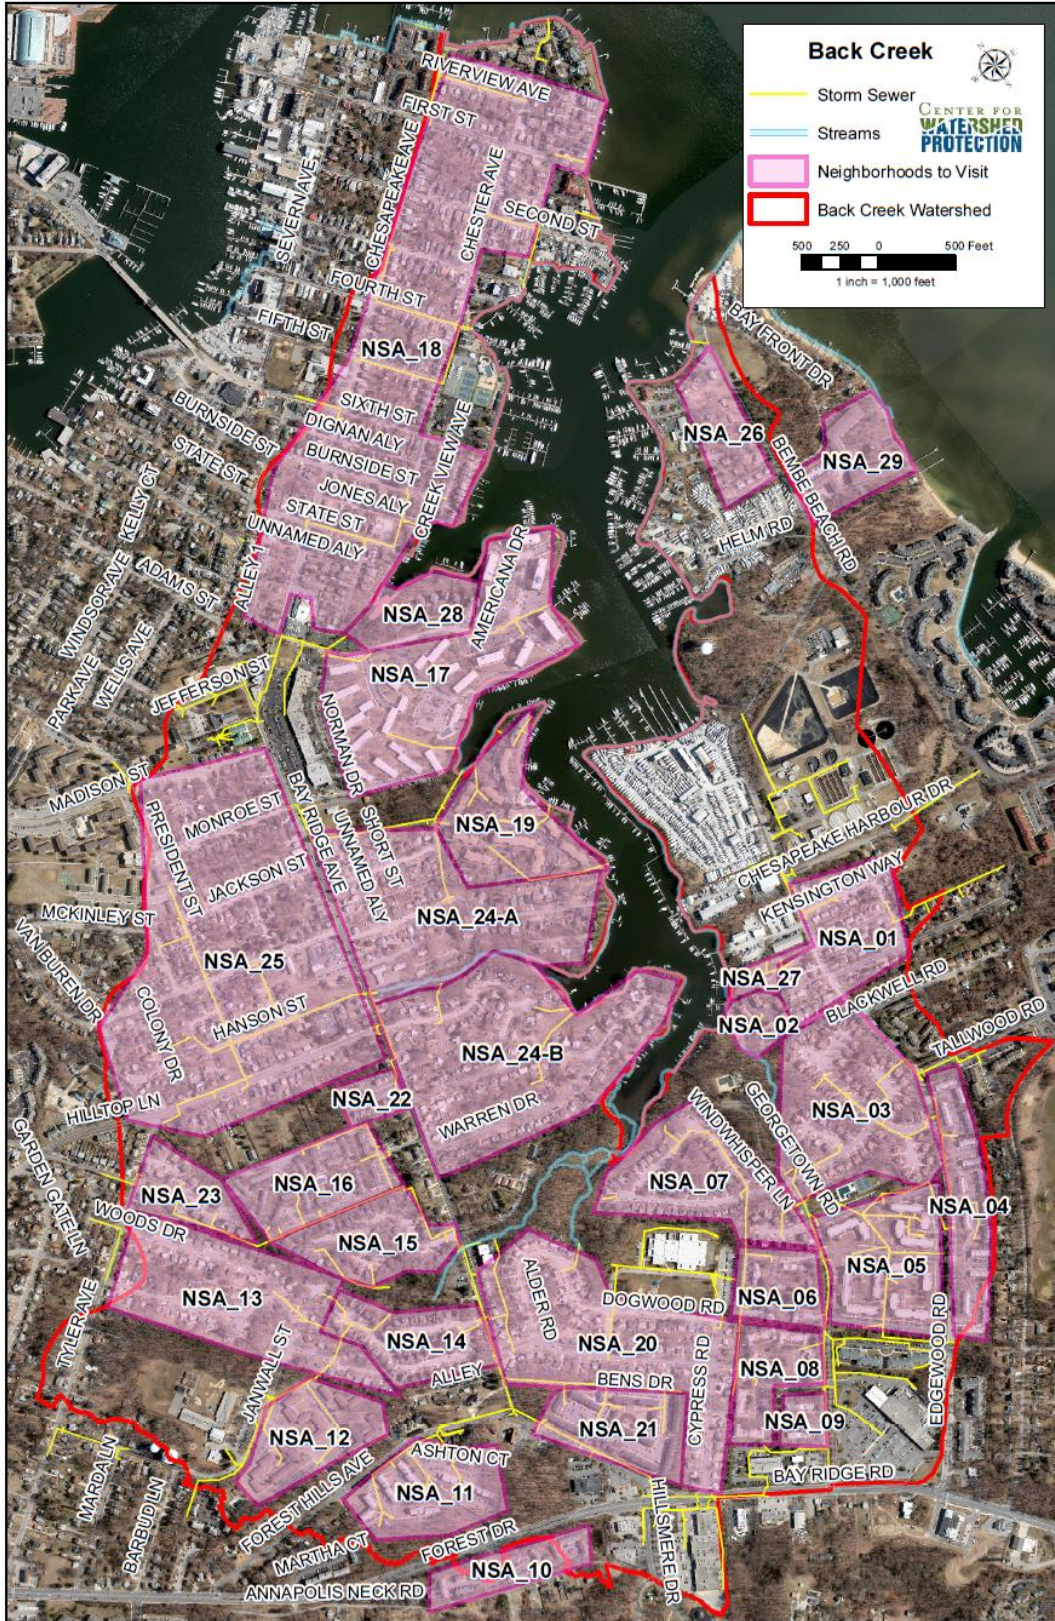
Figure 5. Neighborhoods Visited

A total of 29 neighborhoods were visited by the field crews as shown in Figure 5. A majority of the watershed is residential, and most homes are single-family, with some multi-family apartments and condos. Almost all neighborhoods had no visible stormwater management practices. There are only two stormwater ponds in the entire watershed. Maps of the neighborhoods corresponding to the NSA labels of Figure 5 are shown in Figure 6, Figure 7, and Figure 8.

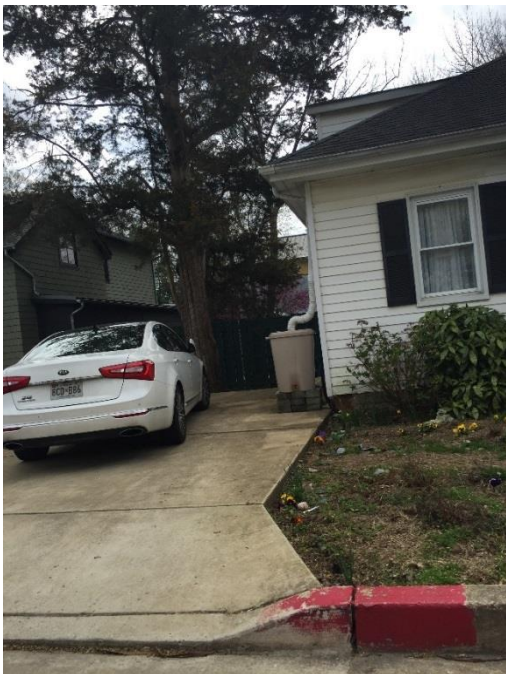
Figure 9. Rain Barrel in NSA\_25

A few homes had rain barrels, such as the one in Figure 9, located in NSA\_25. An additional opportunity for reducing soil erosion and runoff could occur in the backyards of a few single family homes in NSA\_20. These backyards direct stormwater runoff into the headwaters of a stream near Georgetown Elementary. See Figure 10.

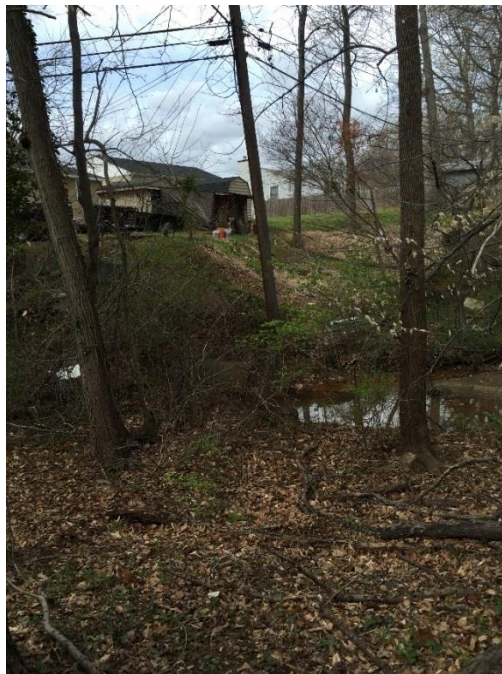
Figure 10. Backyard in NSA\_20 near the school

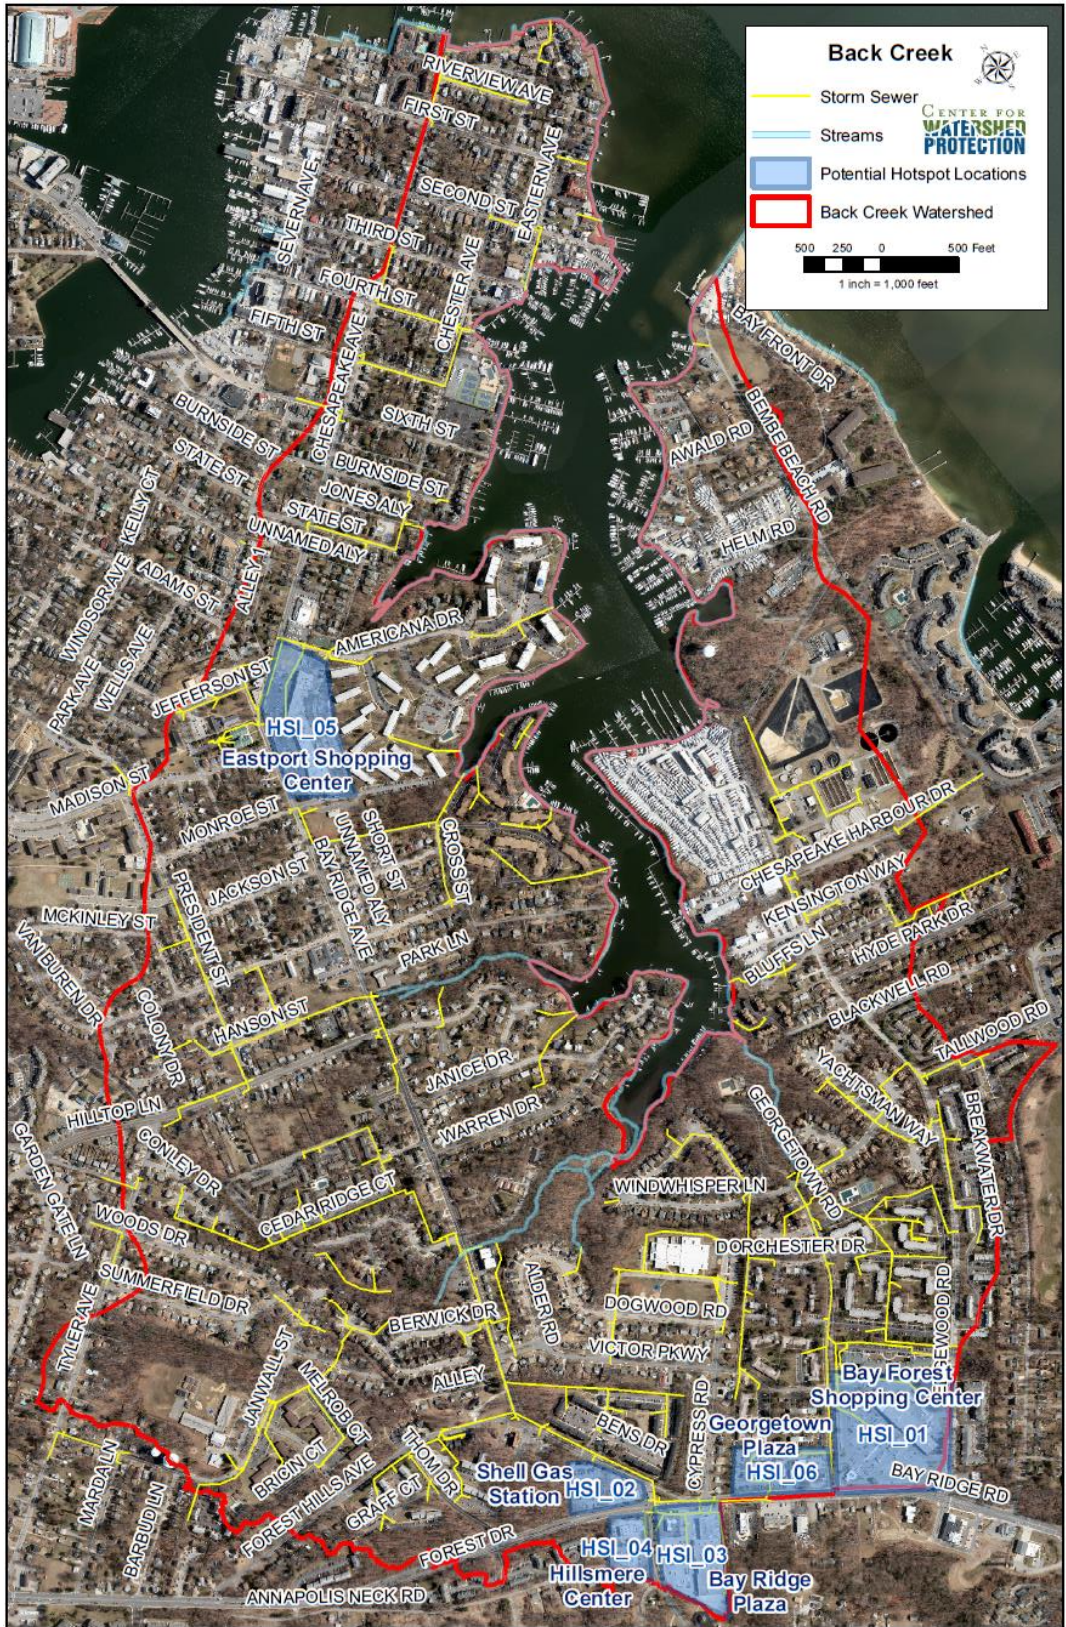
Figure 11. Potential Hotspot Locations

All the non-marina commercial sites were assessed for potential hotspots and are shown in Figure 11. Two of those locations were confirmed as hotspots as pollution producing behaviors were witnessed, as described in Table 12. Figures 12, 13, 14, and 15 show photos taken during the field assessment of the confirmed hotspots.

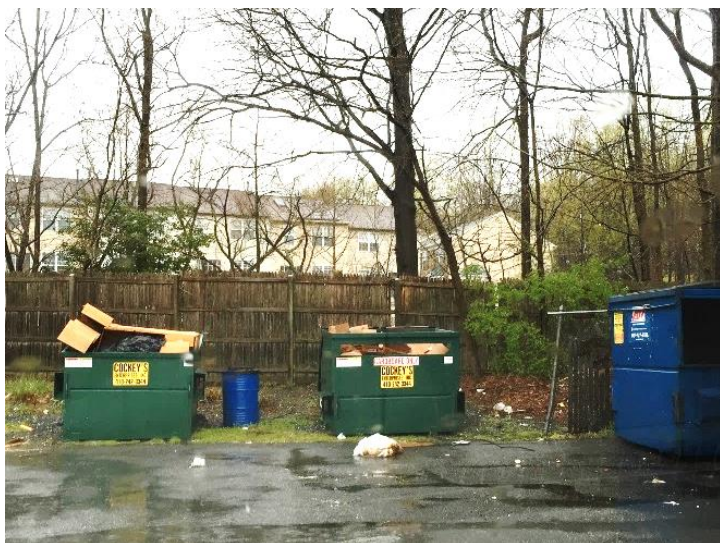
Figure 12. HSI-04

<b>Table 12. Confirmed Hotspot Sites</b>				
<b>Site ID</b>	<b>Location</b>	<b>Type of Hotspot</b>	<b>Description</b>	<b>Recommended Actions</b>
HSI-04	Hillsmere Center (110 Hillsmere Dr)	Dumpster Management	Overflowing dumpster, nearby trash, cover open	Outreach materials to target business groups
HSI-06a	Georgetown Plaza (914 Bay Ridge Road)	Outdoor Material Storage	Restaurant - grease storage	Outreach materials to target business groups, containment pallet
HSI-06b	Georgetown Plaza (914 Bay Ridge Road)	Storm drain Inlet Dumping	Catering company - washing carts and wash water draining to catch basin	Outreach materials to target business groups, containment mat and pump

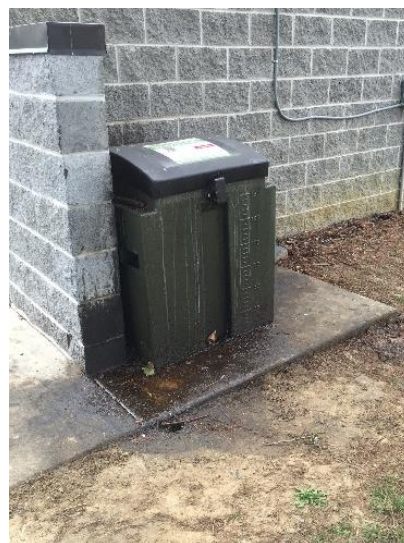
Figure 13. HSI-06a - Grease Storage

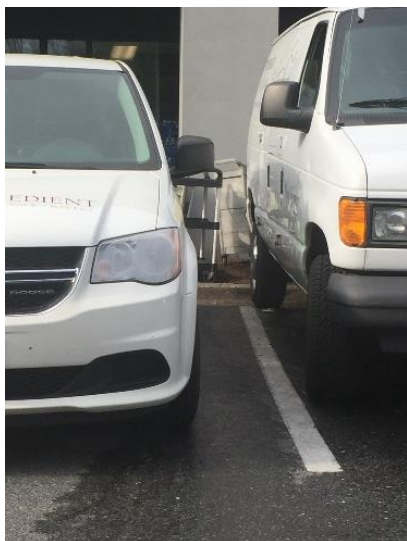
Figure 14. HSI-06b - Wash Water

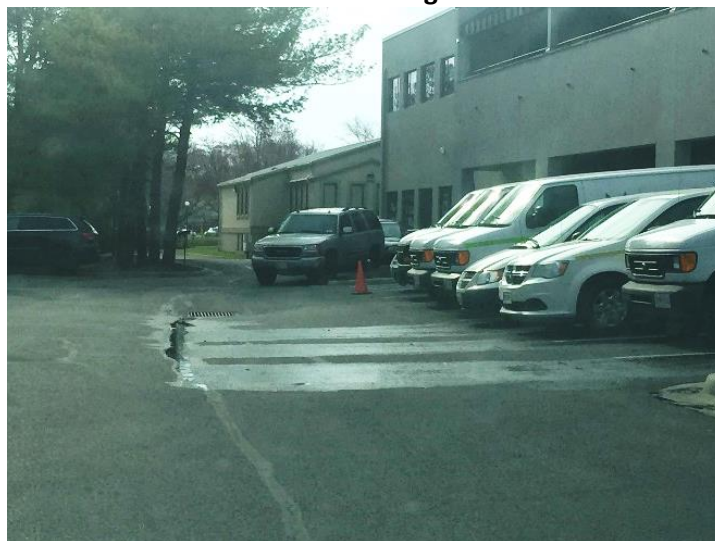
Figure 15. HSI-06b - Wash Water

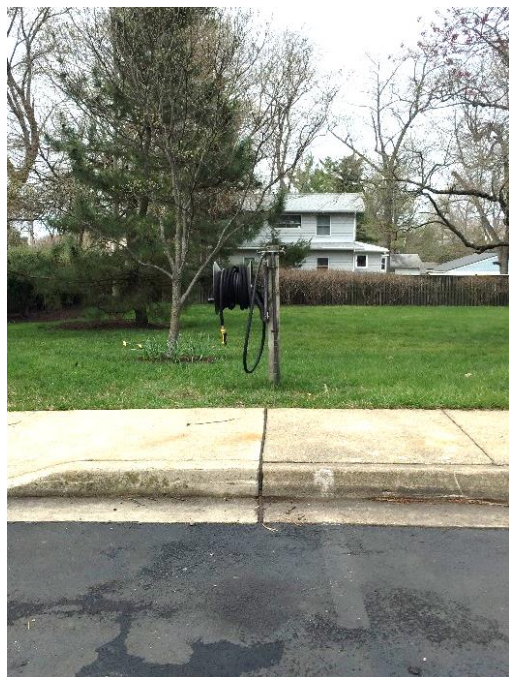
Figure 16. HSI-NSA\_19

When assessing the neighborhoods, a potential hotspot was observed in the Severn House neighborhood in the form of a hose available for washing vehicles. This is described in Table 13 and shown in Figure 16.

Table 13. Potential Hotspot Site				
Site ID	Location	Type of Hotspot	Description	Recommended Actions
HSI-NSA_19	Severn House	Vehicle Operations	Outdoor car wash that conveys wash water to the parking lot storm drain	Divert water from storm drain using containment mat and provide education

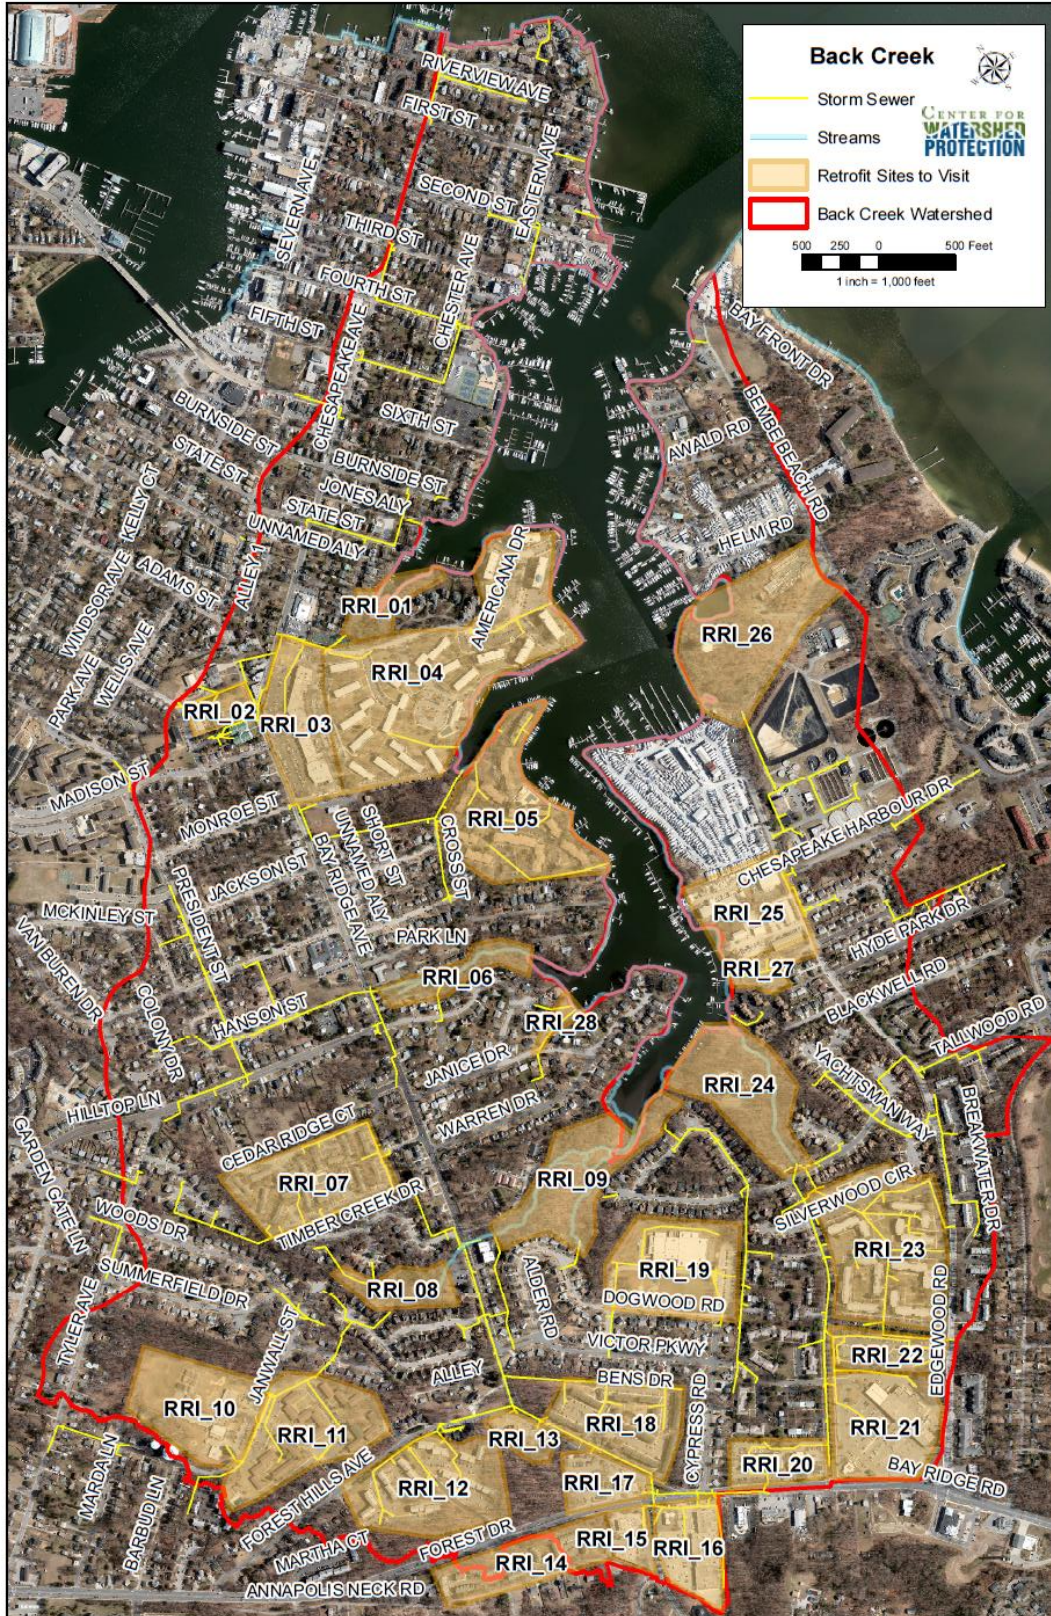
Figure 17. Potential Retrofit Locations Visited During Field Assessment

Overall, the Center identified 28 locations to visit to look for potential retrofits (see Figure 17).

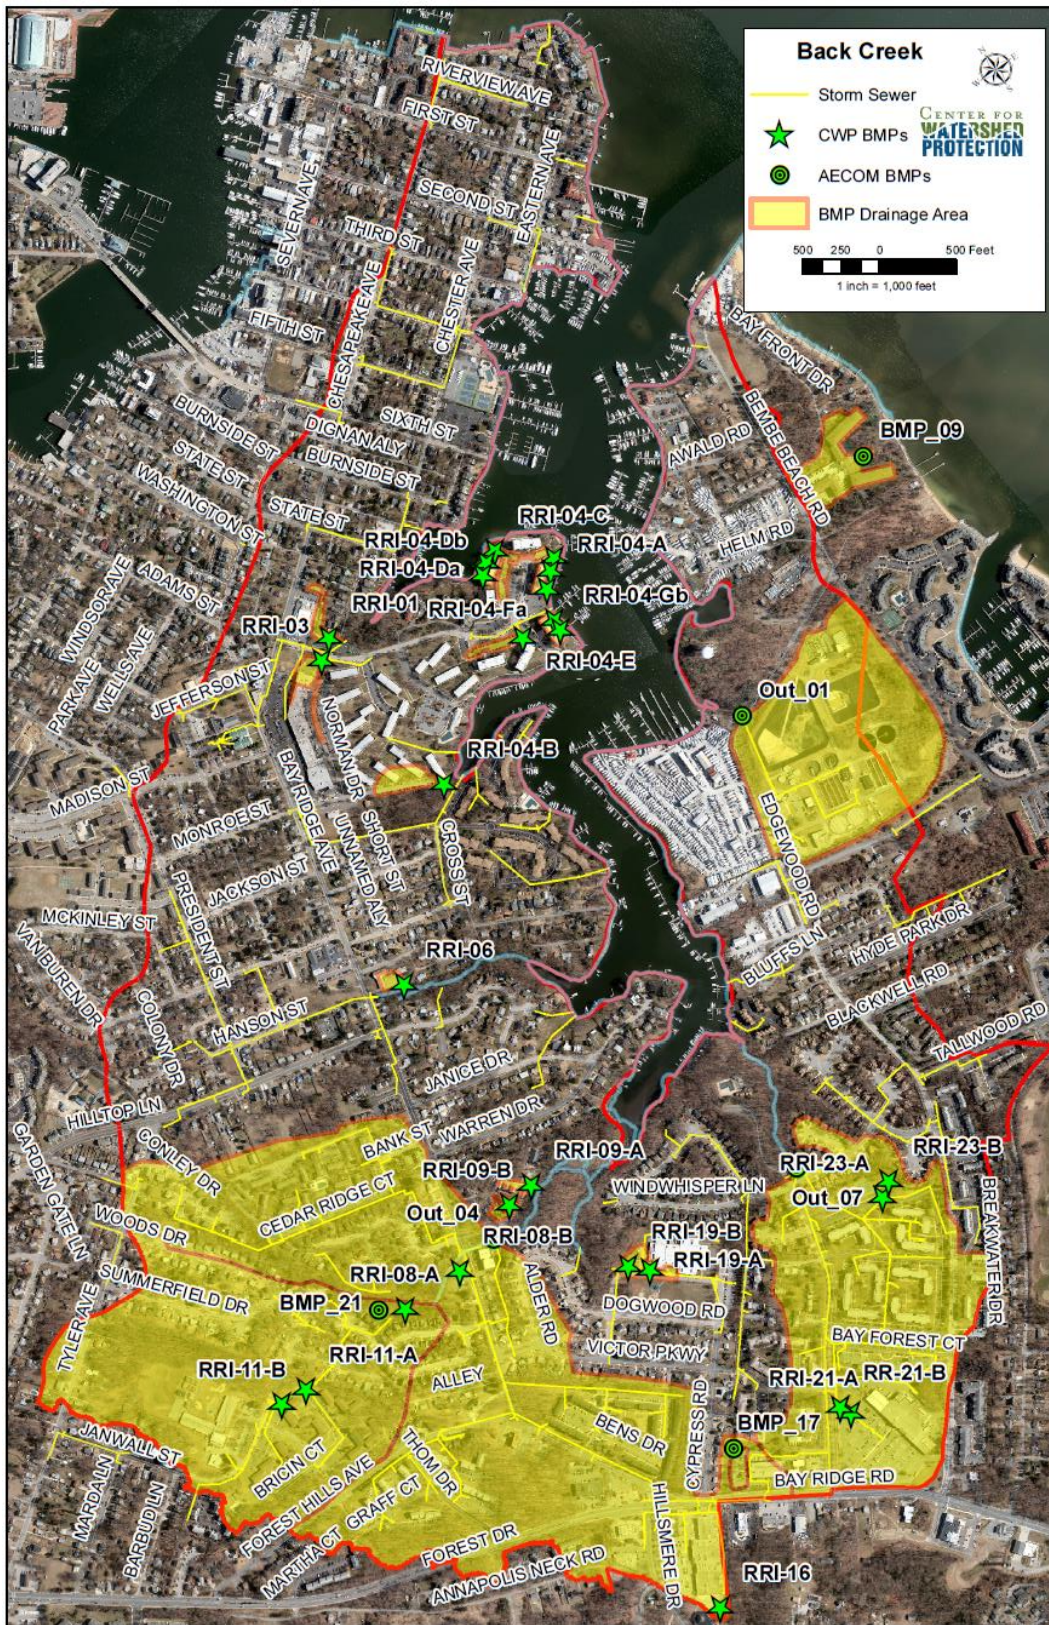
Figure 18. Retrofit Opportunities and their Contributing Drainage Areas (CDAs)

If a regenerative stormwater conveyance is constructed at this outfall, approximately 26,600 lbs of sediment would be captured each year. The BMP with the second highest rate of removal is RRI-08-A, the stormwater pond in the Ambridge neighborhood, just upstream of Out\_04. If this pond is converted from a dry pond to a wet pond, approximately 10,570 lbs of sediment would be captured each year. The City of Annapolis plans to modify the Ambridge pond so both of these retrofit locations would need to be evaluated again after the City work is complete to see if further restoration at Out\_04 is needed.

Also, because RRI-11-A, RRI-11-B, and BMP\_17 are within the drainage area of RRI-08-A, if the pond is retrofitted, RRI-11-A, RRI-11-B and BMP\_17 may become a lower priority, as any runoff from those sites would be treated by the downstream pond retrofit at RRI-08-A. The same caveat is true for RRI-21-A, RRI-22-B, RRI-23-A, and RRI-23-B, which fall within the drainage area of Out\_07, and RRI-08-B, which falls within the drainage area of Out-04. While these “upstream” retrofits may become lower priority due to the effect of downstream retrofits, they should not be considered redundant or eliminated from consideration. Constructing retrofits in series, or a “treatment train,” can increase the overall volume treatment, pollutant removal, and resiliency of the system.

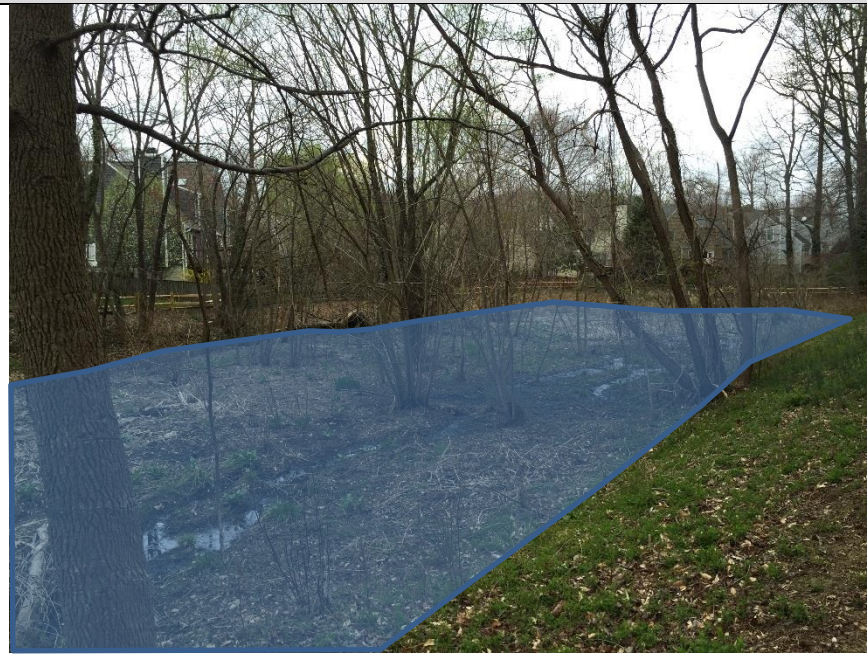
Table 14. Center Identified Retrofit Locations	
Retrofit	Photo Location
<p><b>RRI-08-A – Ambridge Neighborhood Pond</b> Approximately 70 acres of the Back Creek watershed drains to this stormwater pond in the <b>Ambridge</b> neighborhood. The Center proposes to convert this existing dry pond to a wet pond by digging the pond deeper and modifying the outlet.</p>

<p><b>Dry Pond to Wet Pond Conversion</b> (photo taken facing northwest)</p>
<p><b>RRI-08-B – Overflow parking for 1819 Bay Ridge Ave</b> The Center proposes removing a portion of the underutilized parking lot.</p>

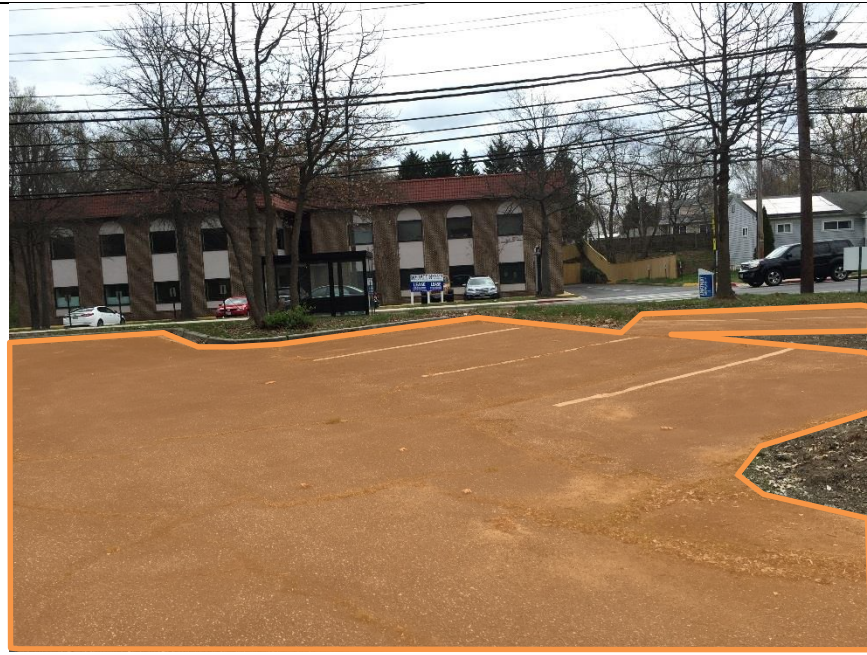
<p><b>Impervious Cover Removal</b> (photo taken facing southeast)</p>

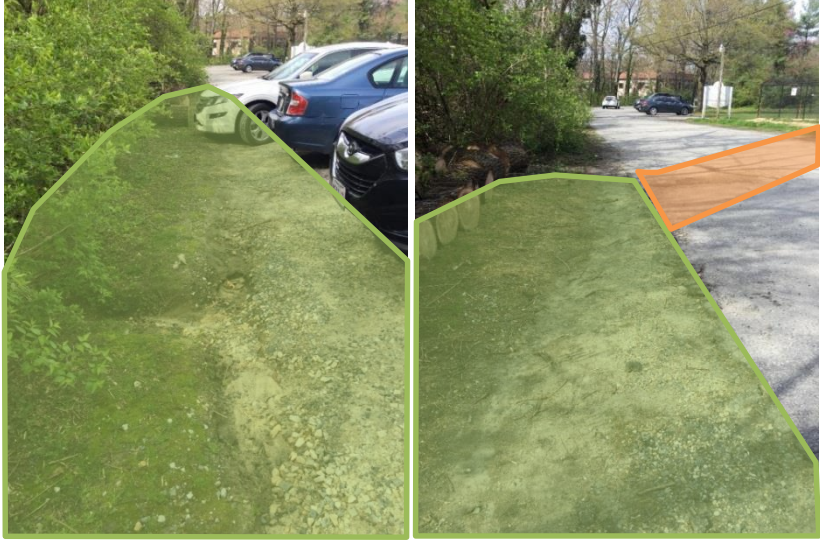
Table 14. Center Identified Retrofit Locations	
Retrofit	Photo Location
<p><b>RRI-09-A – SPCA parking lot</b> Stormwater runoff from the <b>SPCA</b> gravel parking lot is eroding the slope next to the parking area and creating a channel to the nearby stream. The Center proposes to construct a bioretention at the edge of the parking lot to reduce or eliminate the erosion to the stream. The bioretention could also capture water that currently ponds near the kennel if a valley gutter is constructed across the parking lot driveway.</p>

<p><b>Bioretention with valley gutter</b> (photos taken facing west)</p>
<p><b>RRI-09-B – Yard inlet at SPCA</b> The Center proposes constructing a bioretention next to the yard inlet at the <b>SPCA</b>. The yard inlet would serve as the overflow and where the underdrain would connect.</p>

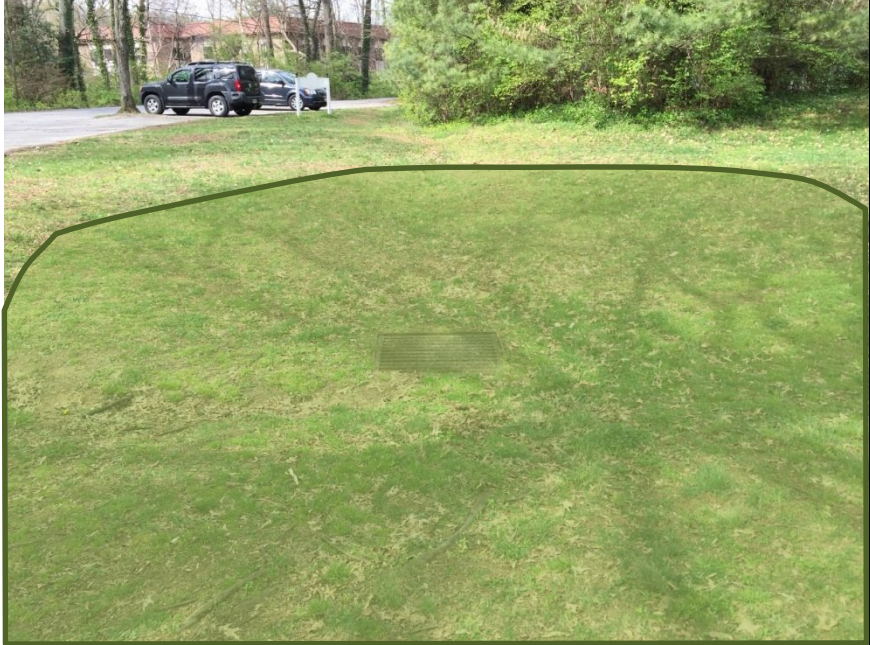
<p><b>Bioretention</b> (photo taken facing southwest)</p>

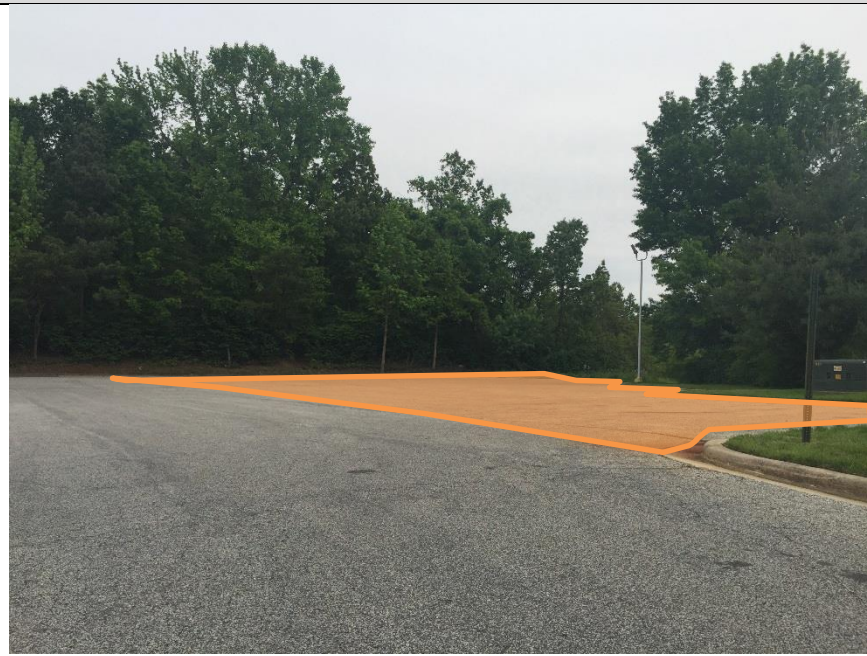
Table 14. Center Identified Retrofit Locations	
Retrofit	Photo Location
<p><b>RRI-16 – Bay Ridge Plaza, 123 Hillsmere Drive</b> The Center proposes removing the south end of the underutilized parking lot at <b>Bay Ridge Plaza</b>.</p>

<p><b>Impervious cover removal</b> (photo taken facing southeast)</p>
<p><b>RRI-19-A – Georgetown East Elementary School</b> The Center proposes a bioretention in front of <b>Georgetown East Elementary School</b>. A curb cut and trench drain through the sidewalk would be needed to channel the water from the drive to the bioretention. The underdrain would directly connect to the nearby storm sewer.</p>	  <p><b>Bioretention</b> (photo taken facing east)</p>

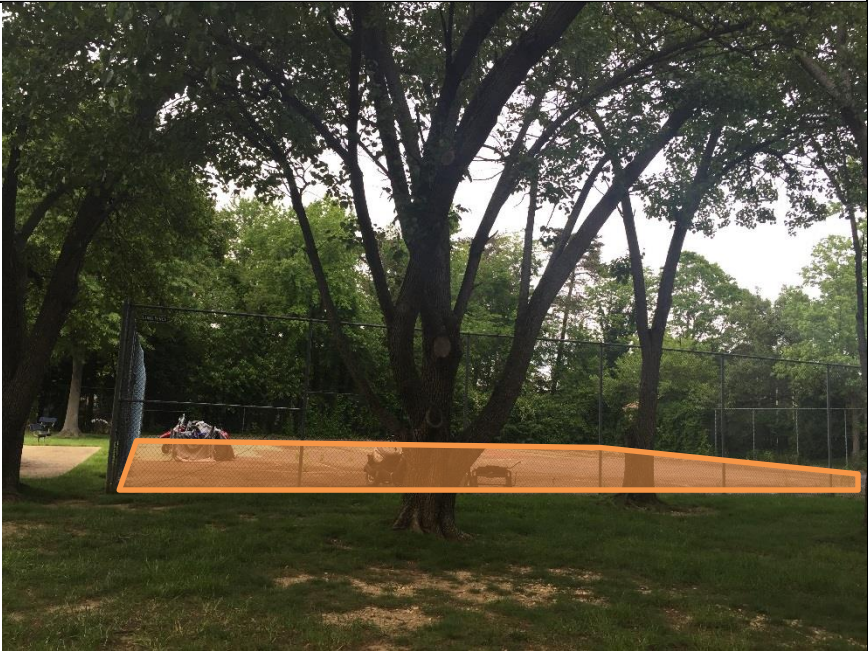
Table 14. Center Identified Retrofit Locations	
Retrofit	Photo Location
<p><b>RRI-23-B – Fairwinds of Annapolis – East, Silverwood Circle, near the tennis courts</b> The Center proposes removing the old, unused tennis courts at <i>Fairwinds of Annapolis – East</i>.</p>

<p><b>Impervious cover removal</b> (photo taken facing northeast)</p>

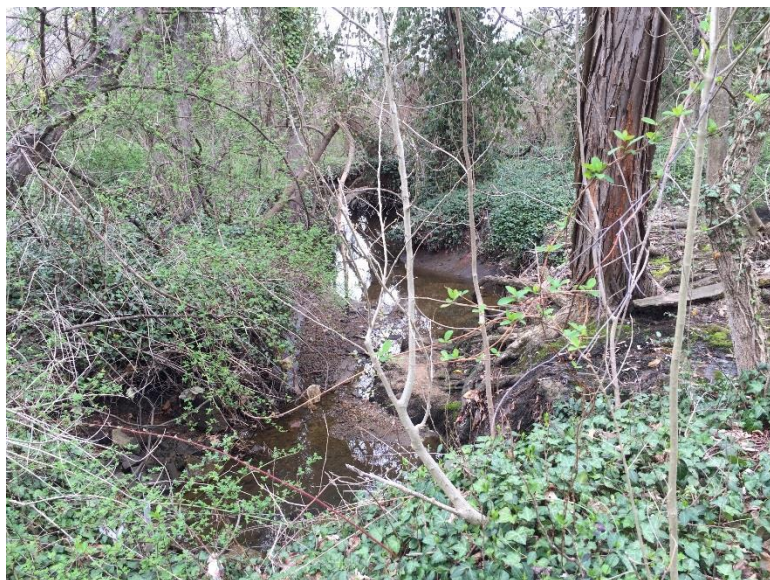
**Figure 20. Joan's Cove**

The field assessment included a visit to Joan's Cove. While a stormwater retrofit is not proposed for this outfall location, the cove could benefit from invasive plant removal, slope stabilization, and wetland restoration. See Figure 20.
