# TRUXTUN PARK STRAY VOLTAGE STUDY

Engineering Design Technologies, Inc.

# SUMMARY

No hazardous\* amounts of stray voltages were detected during this study.

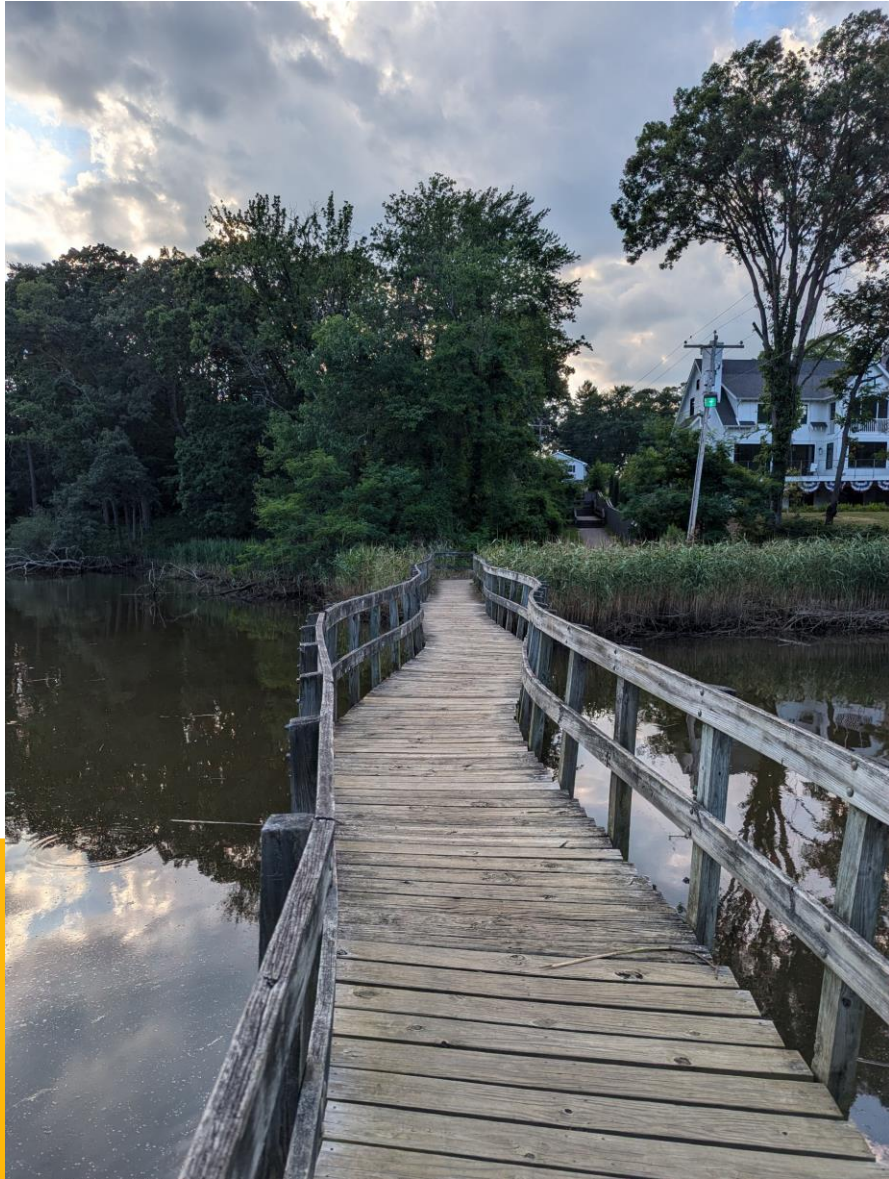
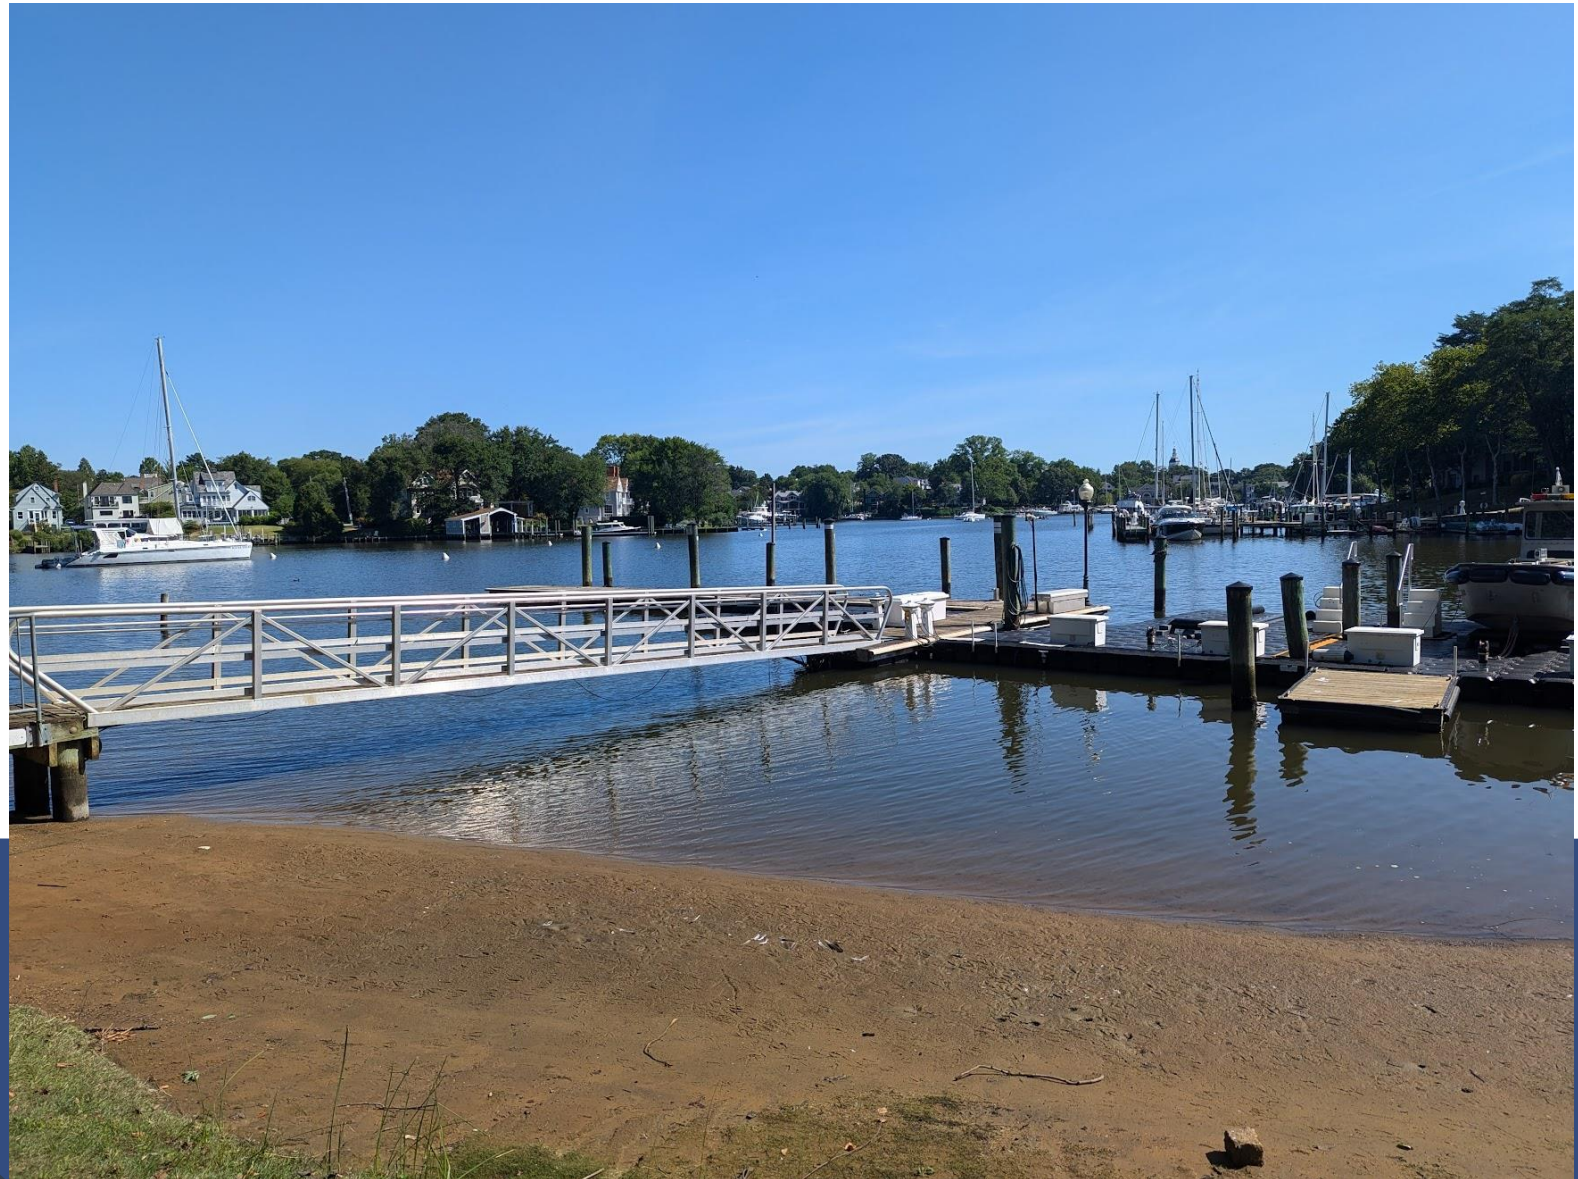
# TEST LOCATIONS- “RICKETY” FOOT BRIDGE AND MAIN DOCK

**INSTANTANEOUS TESTING ON LAND WAS PERFORMED ON THE SOIL  
AND BEACH IN THIS GENERAL AREA.**

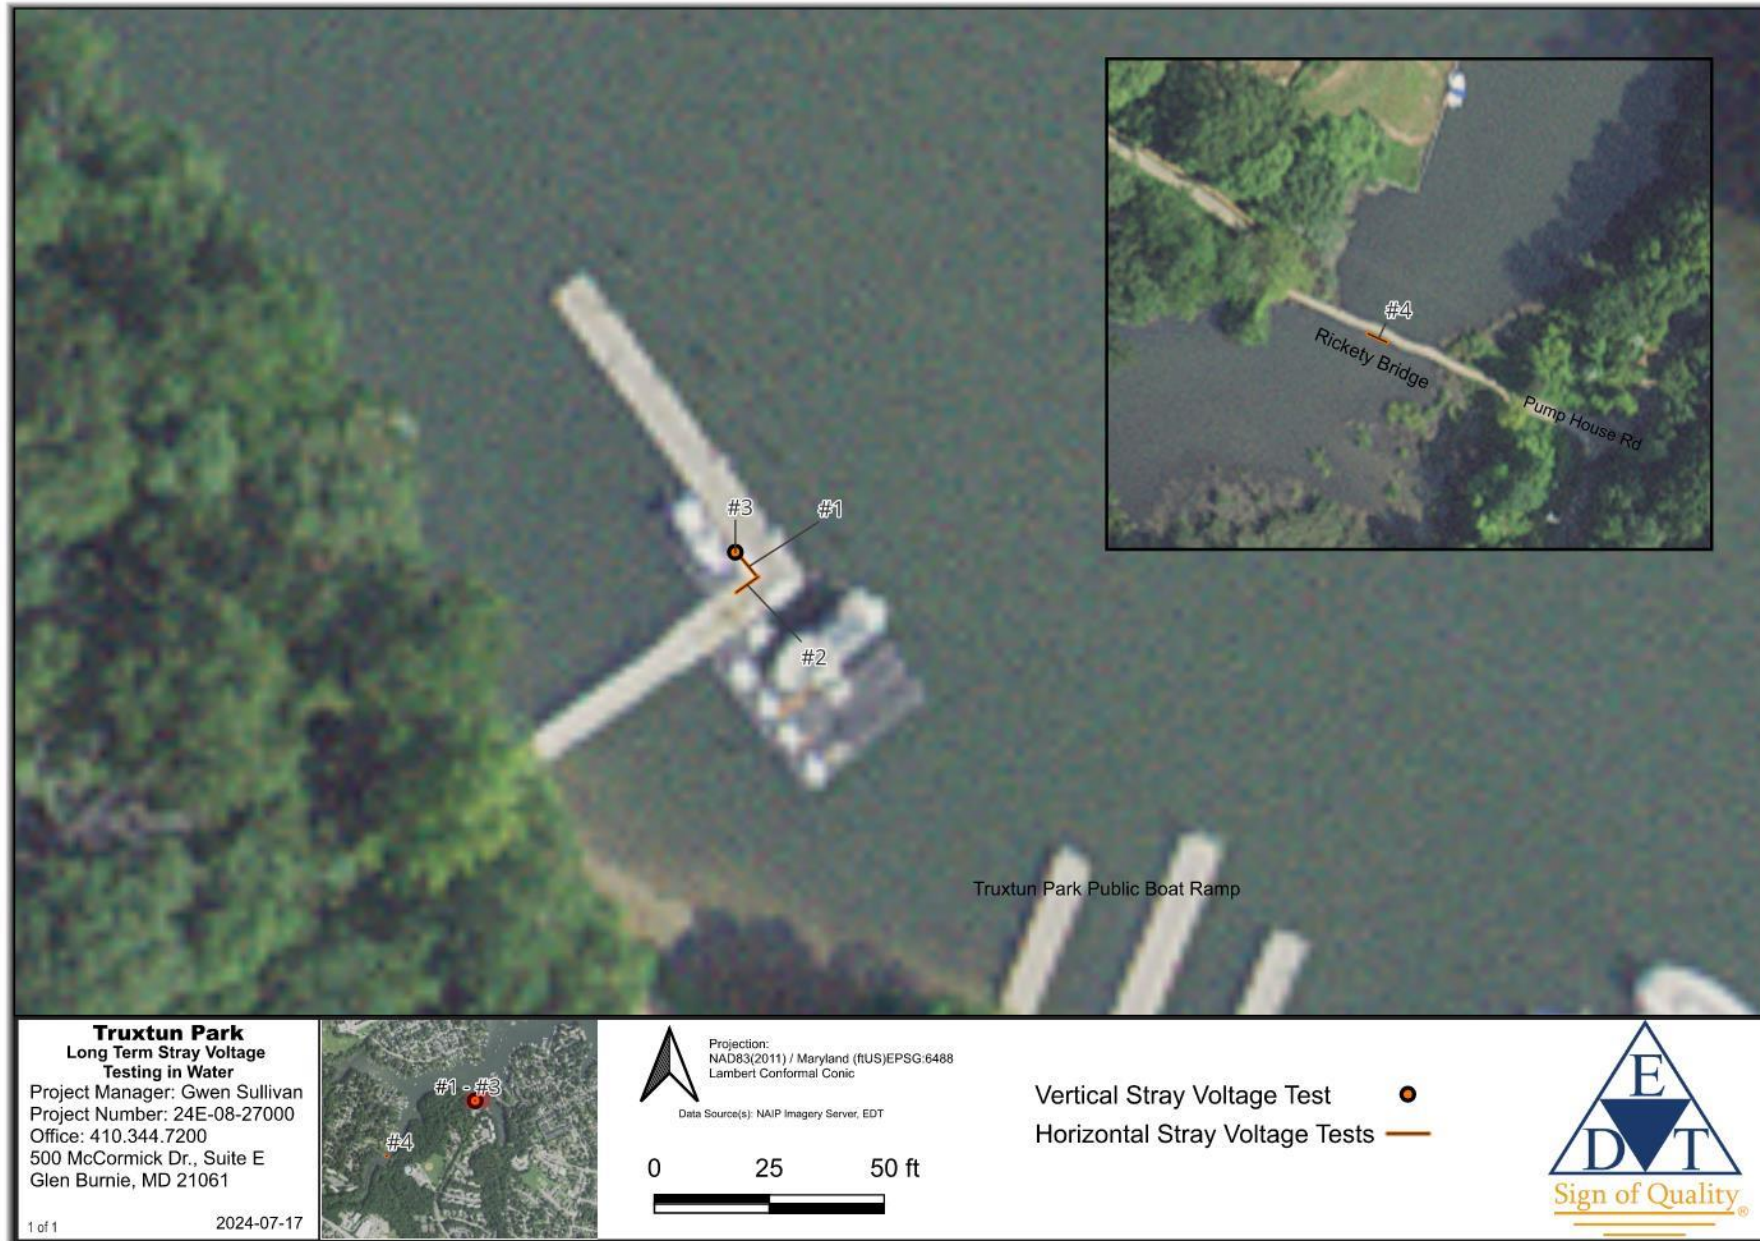
# MAPS OF THE TEST LOCATIONS FIXED LOGGING IN WATER

- Data logging measurements once a second for days
  - There were three locations where these tests were conducted
    - On land: to the south of the dock
    - In water: Adjacent to the dock (to determine if findings on the land were also visible in the water)
    - In water: Adjacent to the "Rickety" bridge
- Instantaneous
  - There are two locations tested
    - Between the grounding system for the dock's circuit breaker box and an earth probe
    - Electrical current flowing on the dock's circuit breaker panel grounds

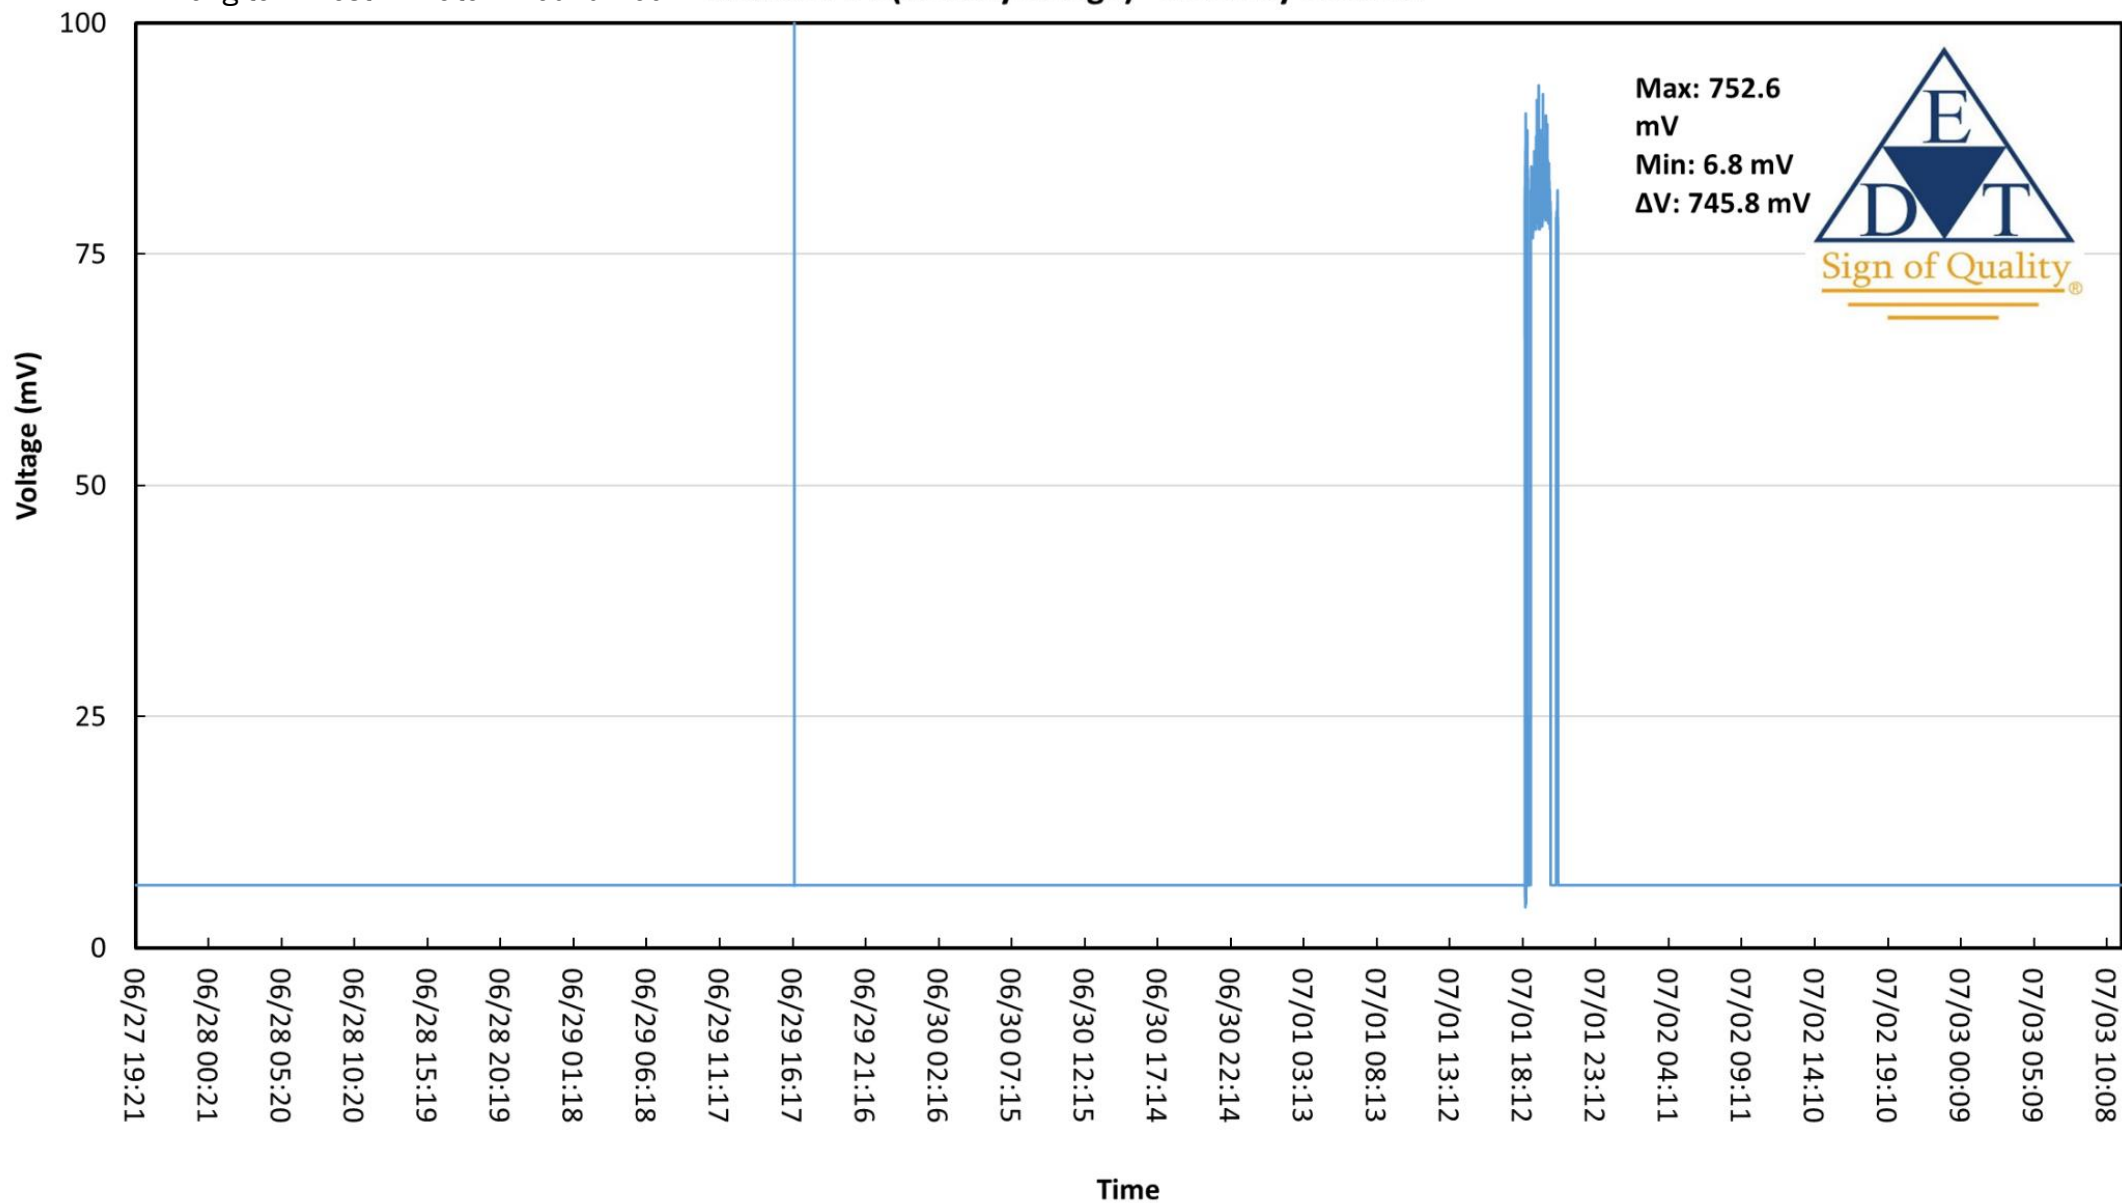
Long-term Test in Water: Around Dock Location #4 (Rickety Bridge) - AC Stray Current

Stray voltages which were recorded were below the sensible threshold (except for seven seconds at the “Rickety” foot bridge) on both water and on land.

| Test | AC Max (mV) | AC Min (mV) | DC Maxv (mV) | DC Min (mV) | Comments |
|---|---|---|---|---|---|
| Location #4 (Rickety Foot Bridge) | 752.6 | 6.8 | 63.8 | -87 | Peak happened during thunderstorm |
