City of Annapolis Stormwater Management Inventory and Watershed Improvement Plan

October 2016

Stormwater Management Inventory and Watershed Improvement Plan

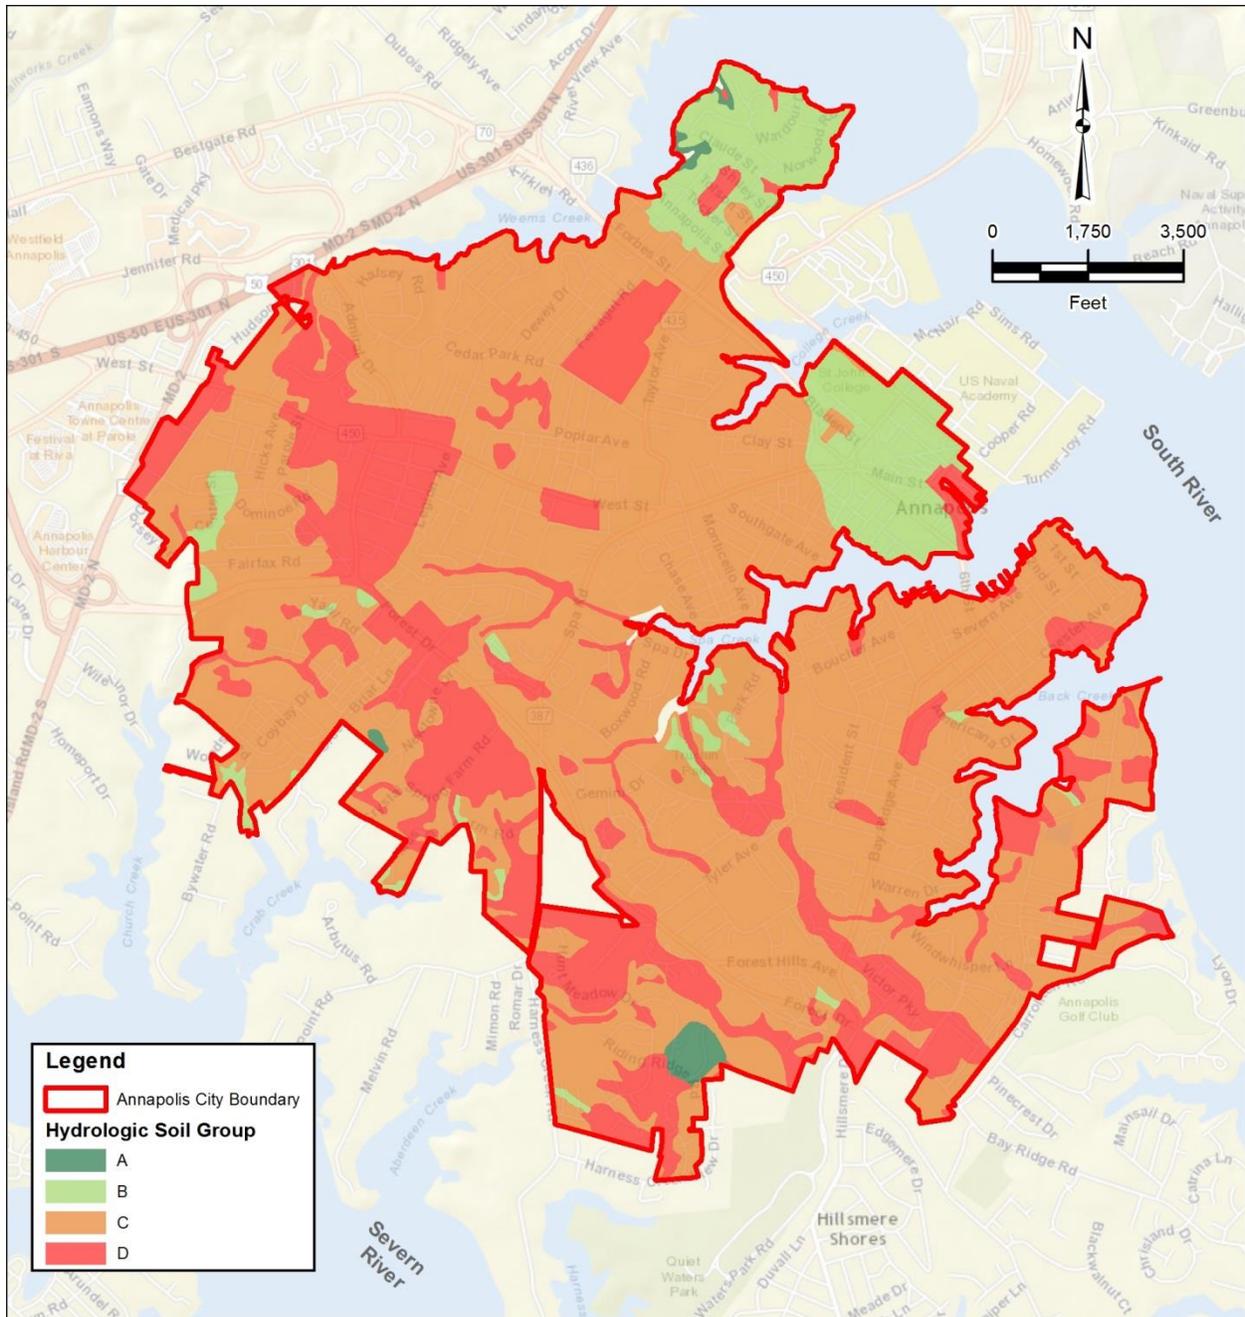
Figure 3-3: Hydrologic Soil Group Distribution in the City of Annapolis

The majority of the soils in the City of Annapolis are hydrologic group C (68 percent) or group D (23 percent), which have low infiltration rates, and therefore are not typically suitable for infiltration practices (Figure 3-2). Figure 3-3 shows the distribution of soil groups in the City.

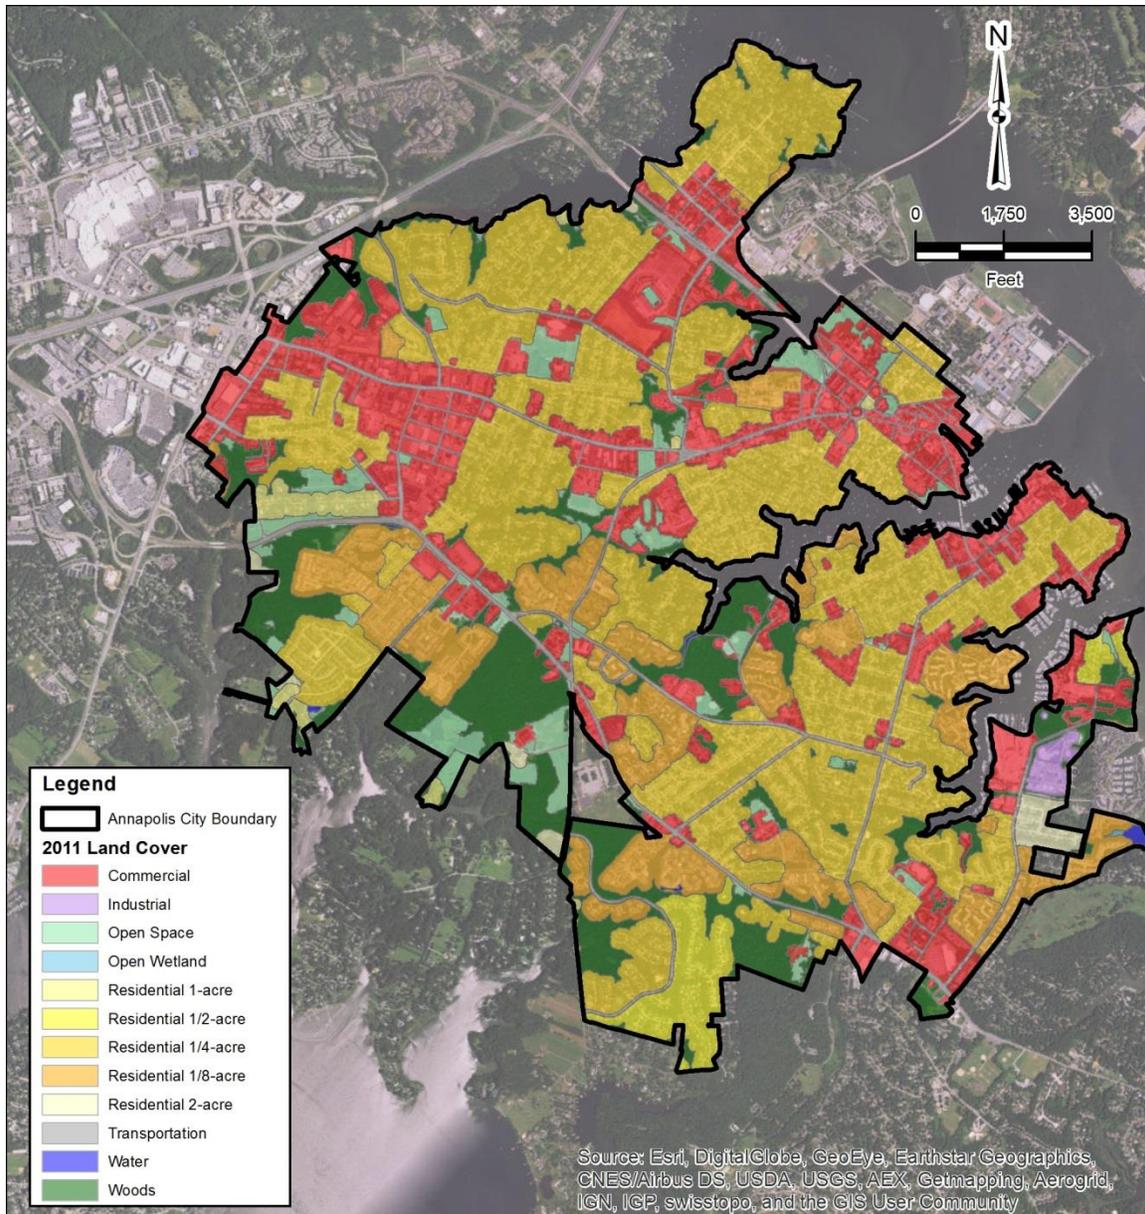
Figure 3-4: City of Annapolis 2011 Land Cover (Source: 2011 Anne Arundel County Land Cover Study)

Anne Arundel County updated their land cover GIS dataset in 2011 using aerial imagery collected in Spring 2011 by the state of Maryland. This dataset includes the City and is used for the pollutant modeling performed as part of this plan. The land cover in the City is primarily residential (57 percent), with large commercial (22 percent) and forested areas (12 percent). Figure 3-4 shows the land cover for the City.

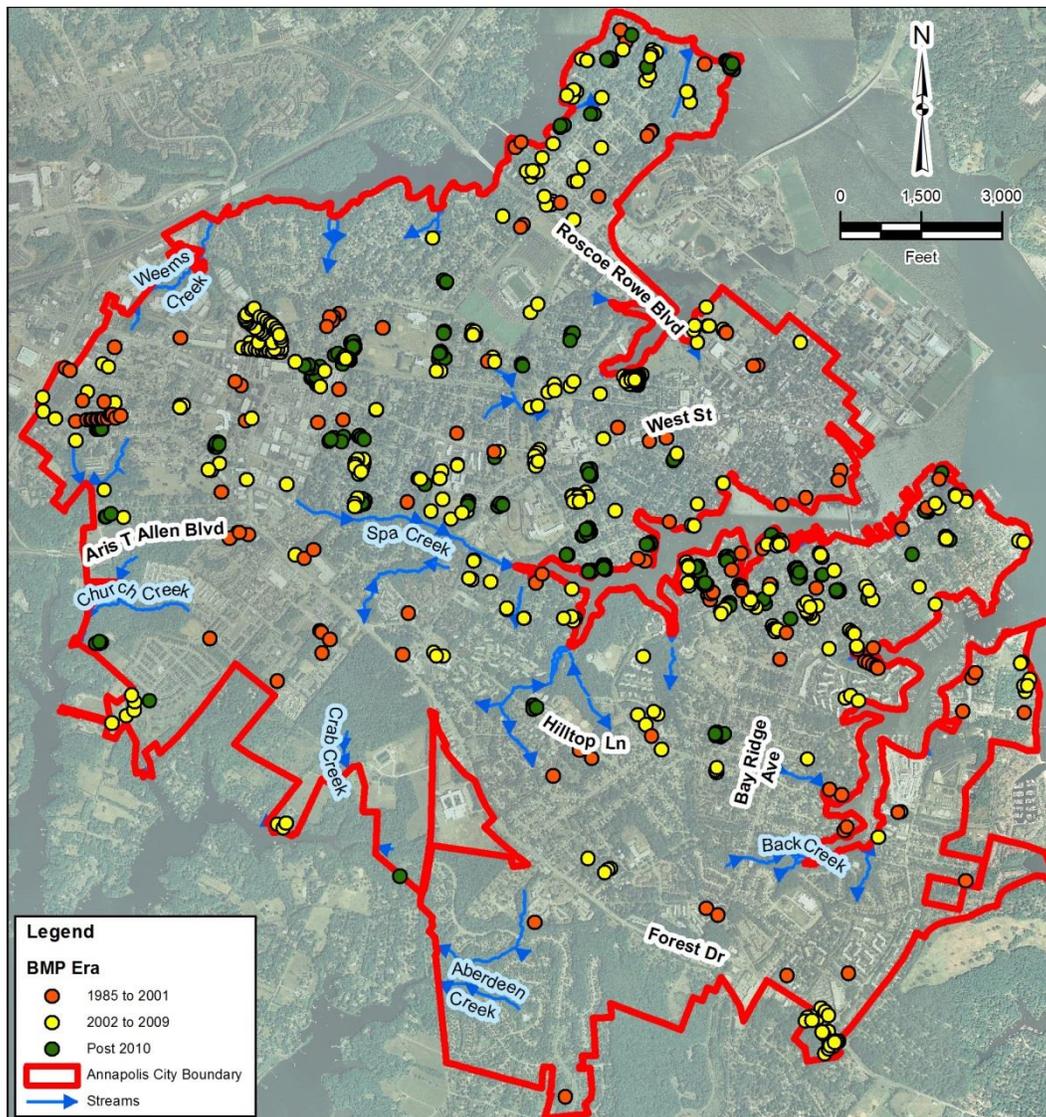
Figure 4-1: City of Annapolis Stormwater Management Inventory by Era

Of the documented BMPs, approximately 50 percent were implemented between 2002 and 2009, and approximately 35 percent were implemented between 2010 and 2015 (Table 4-2). The remaining BMPs were implemented between 1985 and 2001. According to MDE, areas developed prior to 1985 often do not have stormwater management, as they were constructed before the adoption of the stormwater management regulations by the State of Maryland. Until 2002, stormwater management in the City, like most of the jurisdictions in the State of Maryland, focused on managing stormwater quantity rather than quality. Most of the quantity control stormwater management practices were designed to collect stormwater runoff from its drainage area and release it at a controlled rate, providing limited water quality management.

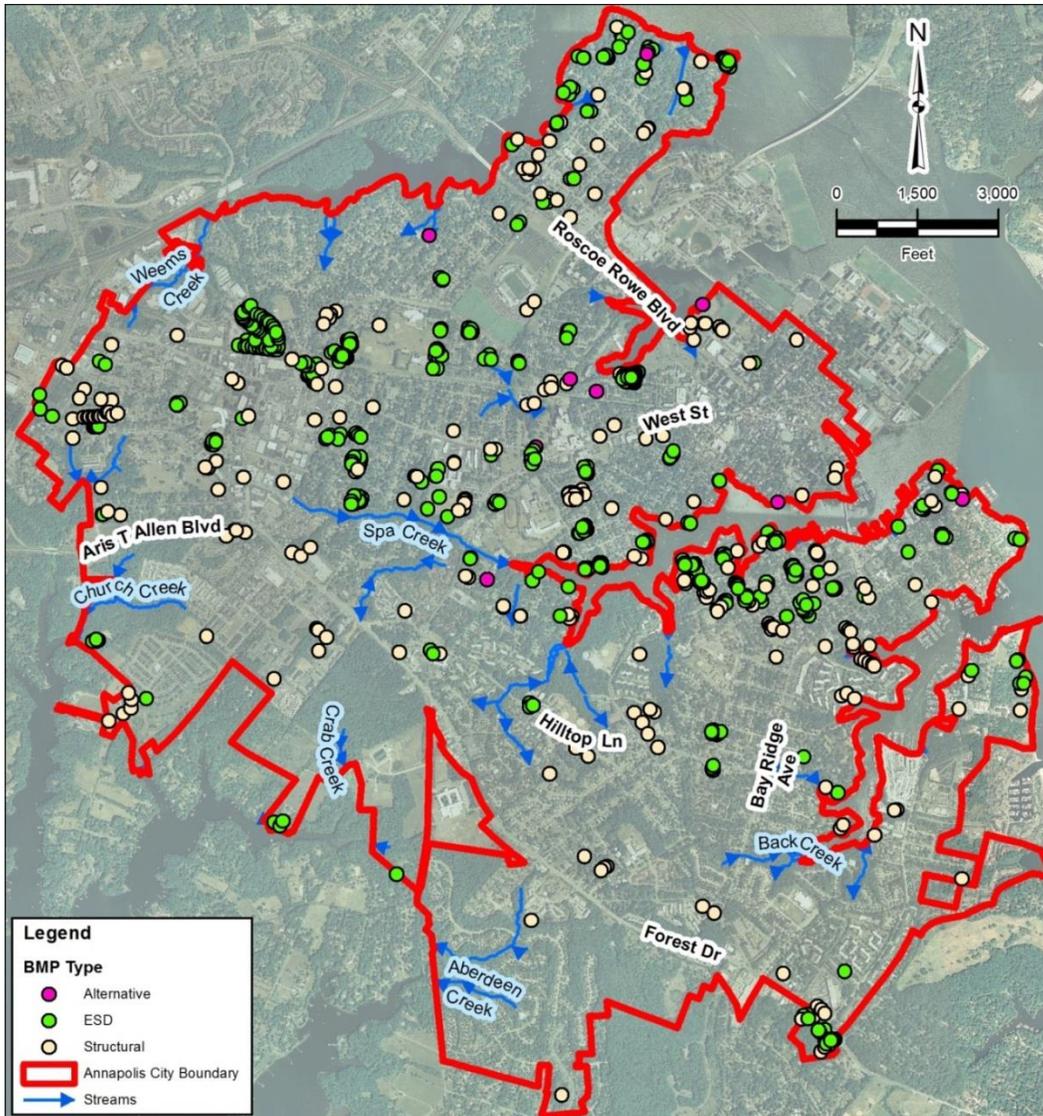
Figure 4-2: City of Annapolis Stormwater Management Inventory by BMP Type

Based on the data inventory of existing plans, there are 741 documented BMPs in the City of Annapolis. MDE assigns a unique three- to four-letter identifier for each BMP type that receives credit for treating runoff (e.g., bioretention facilities are represented as FBIO, and dry wells are represented as MIDW). There are 32 unique BMP types in the City database. The most common BMPs in the inventory were infiltration trenches, followed by dry wells, rain gardens, rooftop disconnections, and bioretention facilities. Appendix A provides a list of MDE-approved BMPs with their four letter BMP codes. Approximately half of these BMPs were implemented as part of new development projects, and the other half were implemented as part of redevelopment projects (less than 1 percent were implemented as part of restoration projects).

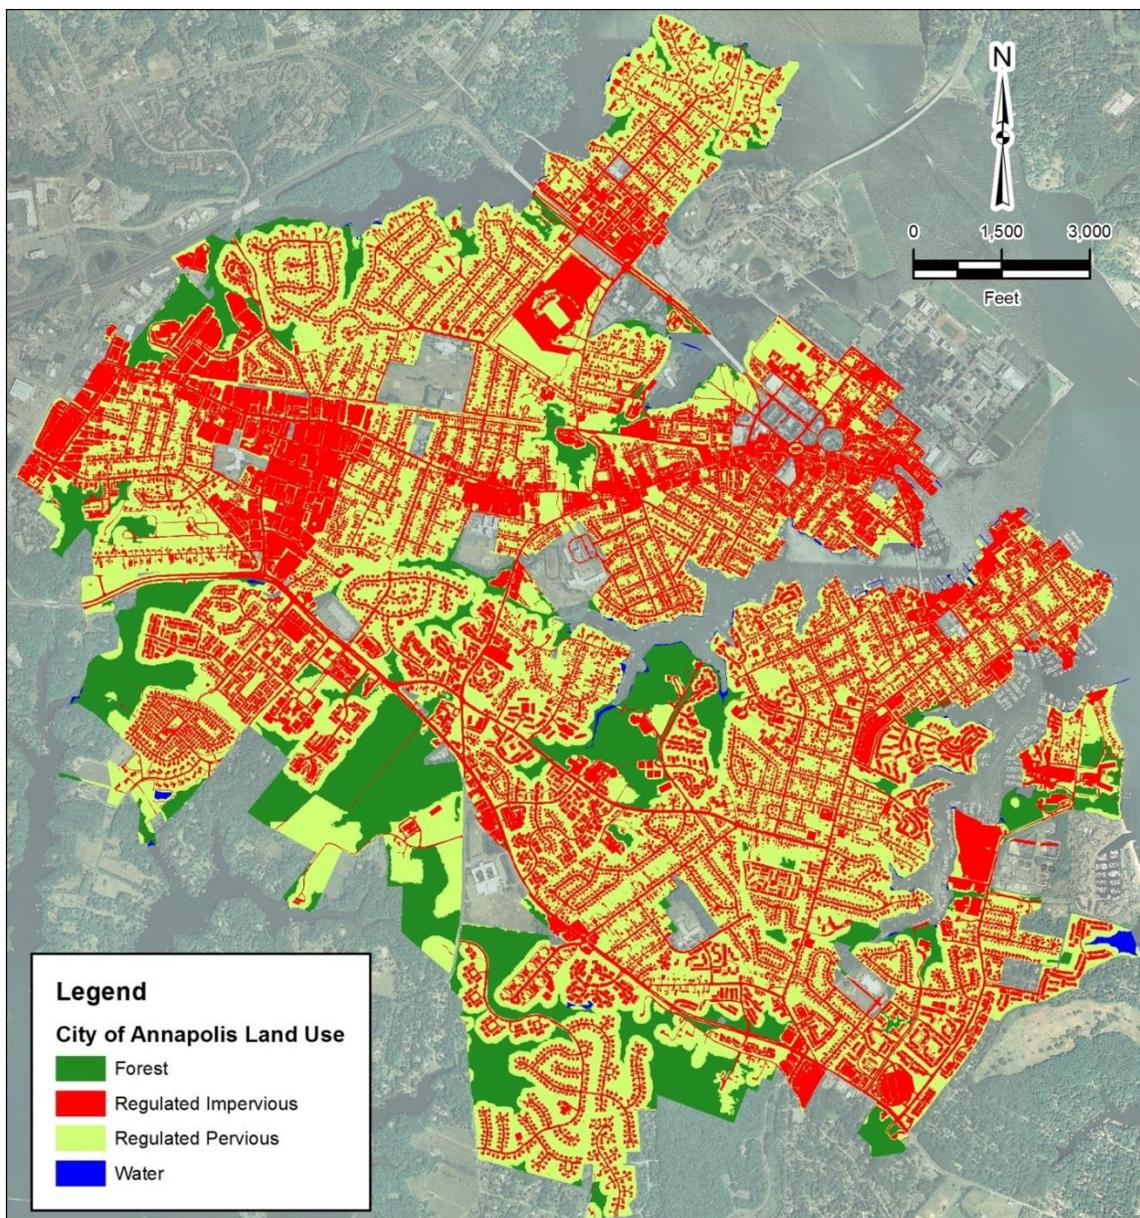
Figure 5-2: Land Use for City of Annapolis MS4 Area Required for BayFAST

Urban Land Use	Area, acres
Regulated Impervious	1,660
Regulated Pervious	2,130
Forest	490
Water	10
Total	4,290

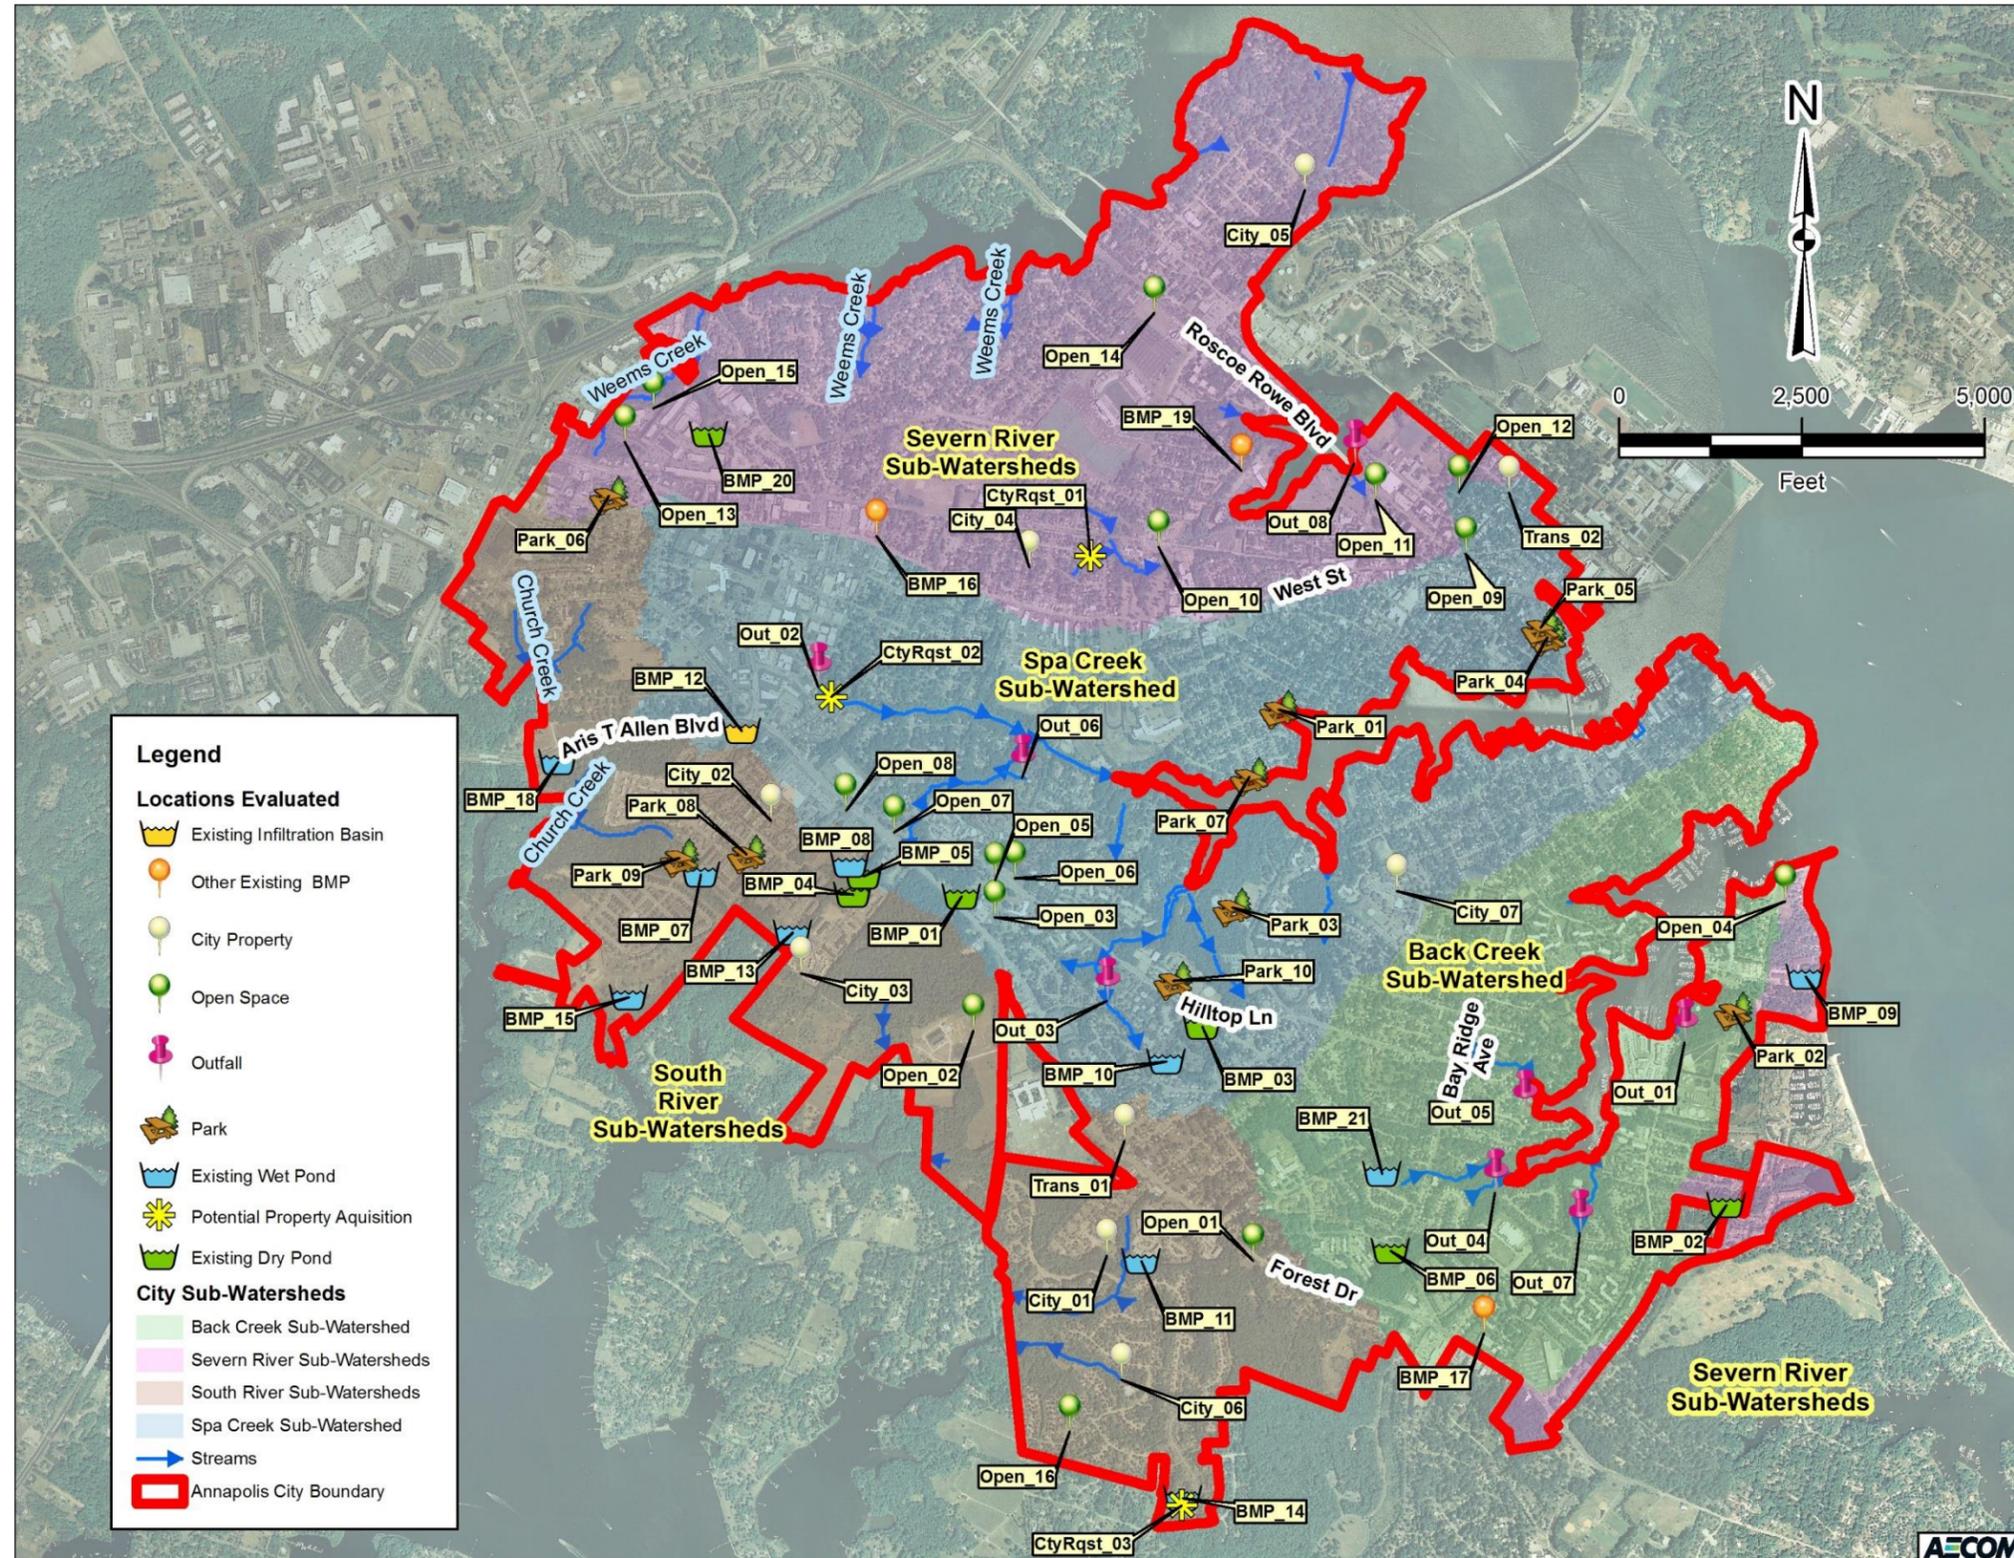
Figure 6-1: City of Annapolis Locations Evaluated during the Fall 2015 Field Investigation

Appendix C provides a table summarizing the data from the site assessments. Based on the field investigation, 46 sites were considered to have potential for stormwater management improvements. The remaining 17 sites were not considered appropriate for potential improvements because of significant site constraints (e.g., utilities, major accessibility concerns, small drainage areas). Reforestation or stream restoration is recommended for some sites as an alternative to stormwater management projects. Multiple facilities were proposed at four sites, resulting in 53 potential stormwater improvement opportunities.

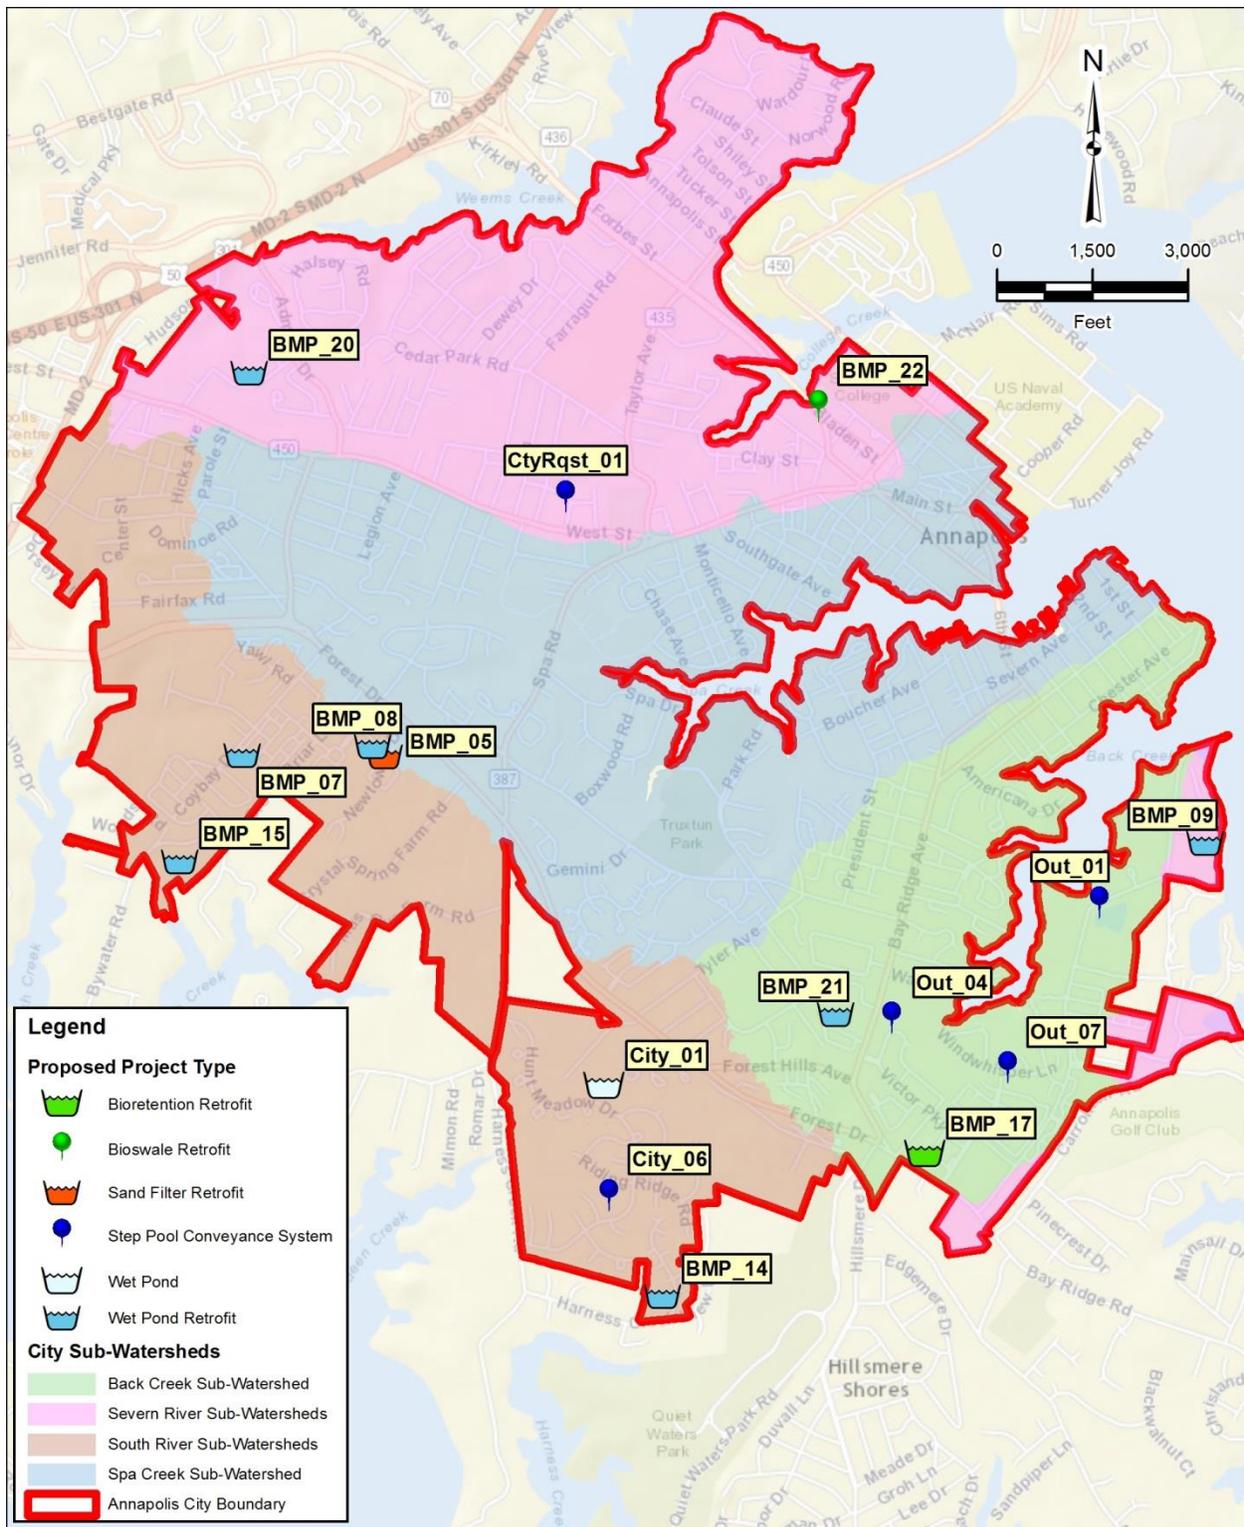
Figure 7-1: Locations of High Priority Sites Selected by the City of Annapolis

The high priority structural practices include retrofits and new BMPs designed to current MDE standards to collect and treat stormwater runoff to remove pollutants through processes such as filtration and infiltration.

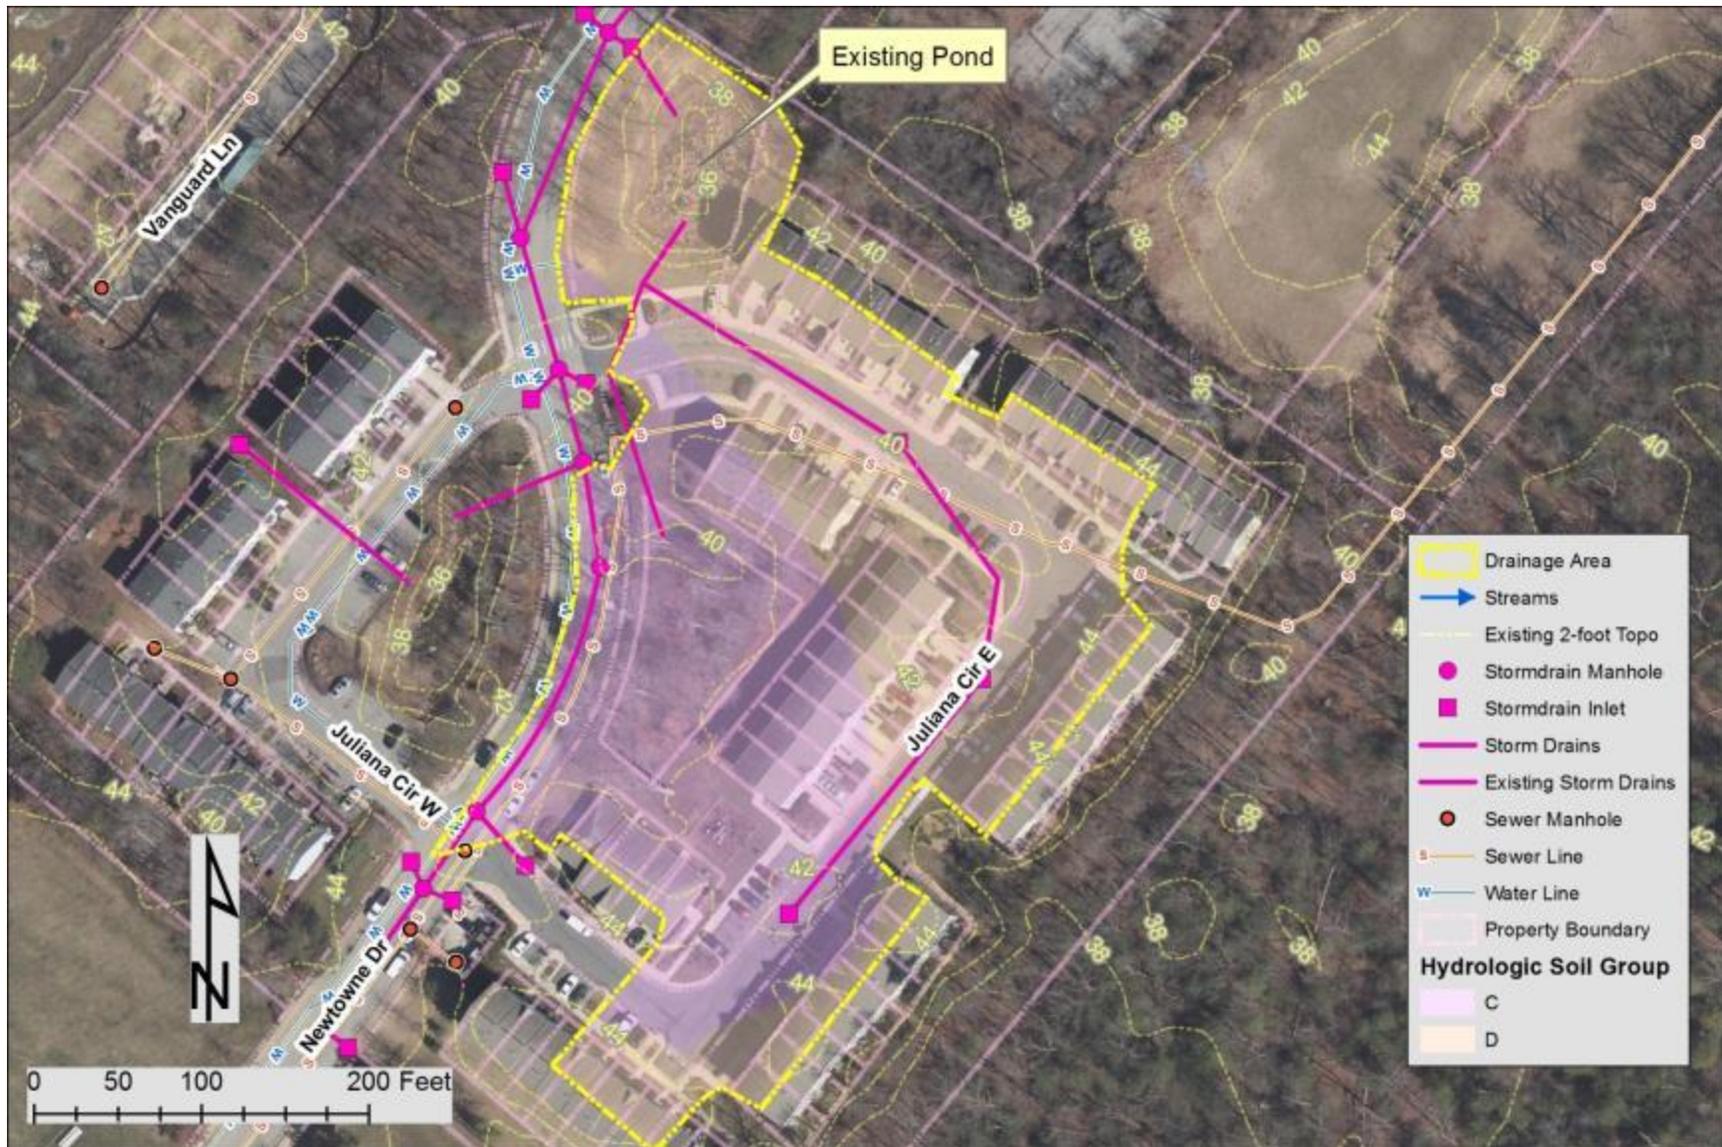
Figure 1: Existing Conditions and Drainage Area

Design Parameters	Site Value
Treated Drainage Area (acres), A	3.12
Percent Impervious Cover, I	51%
Rainfall Depth (inches), P	1
Volumetric Runoff Coefficient, R _v	0.52
Water Quality Volume (acre-feet), WQ_v	0.14
Water Quality Volume (cubic-feet), WQ_v	5,920

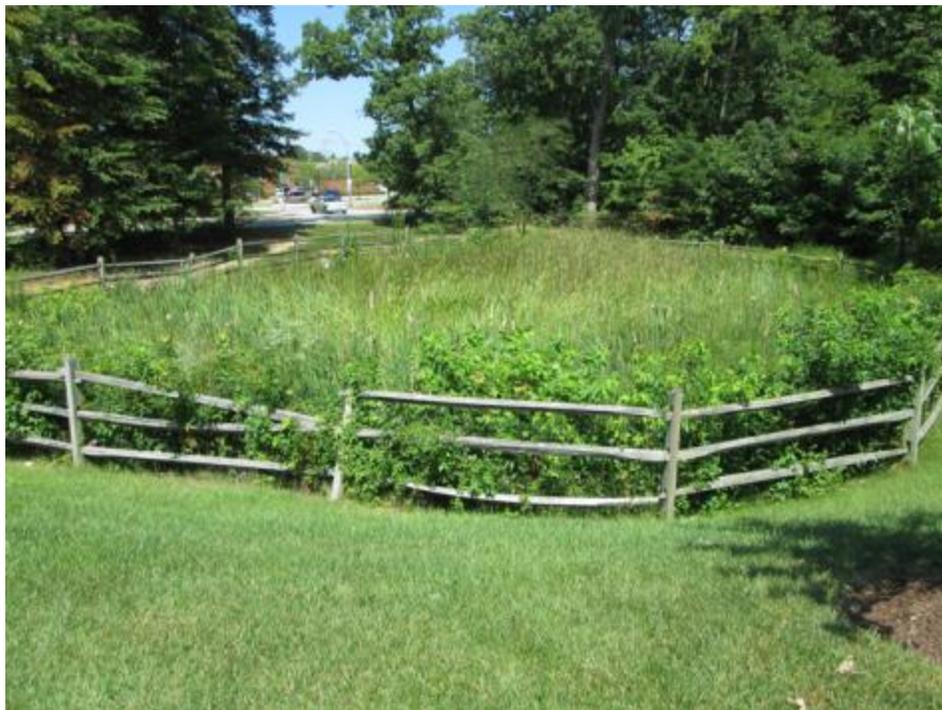
Existing pond near the intersection of Juliana Court East and Newtowne Drive

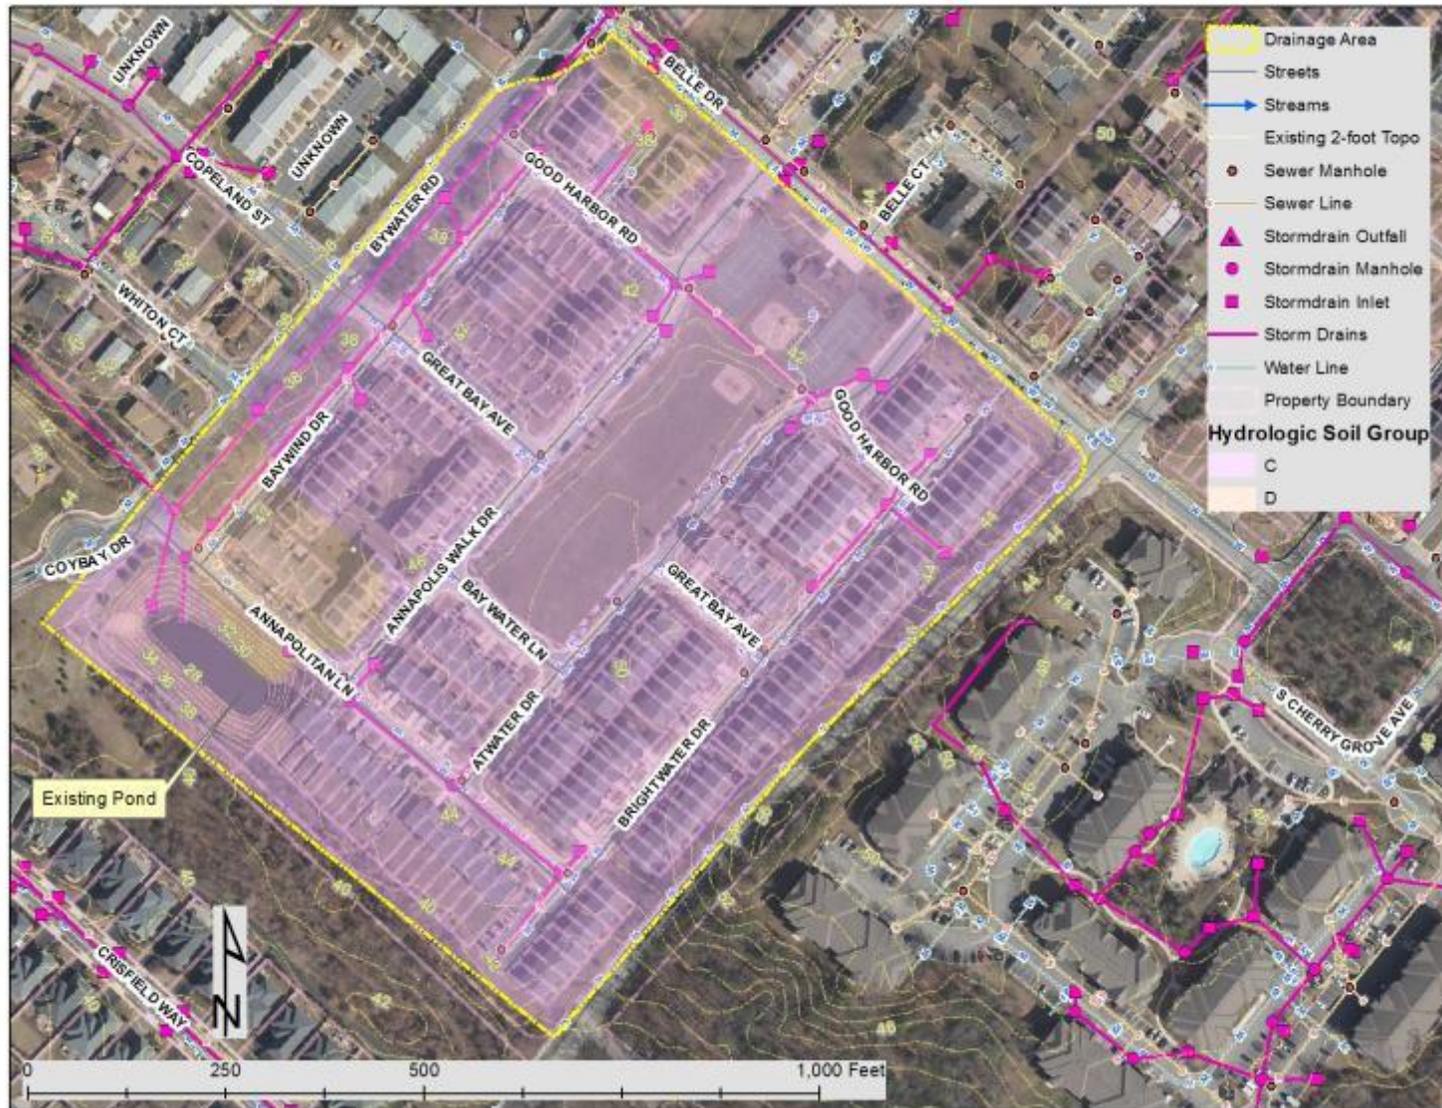
Figure 4: Existing Conditions and Drainage Area

Design Parameters	Site Value
Treated Drainage Area (ac), A	19.6
Percent Impervious Cover, I	48.5%
Rainfall Depth (inches), P	1
Volumetric Runoff Coefficient, R _v	0.49
Water Quality Volume (acre-feet), WQ_v	0.79
Water Quality Volume (cubic-feet), WQ_v	34,594

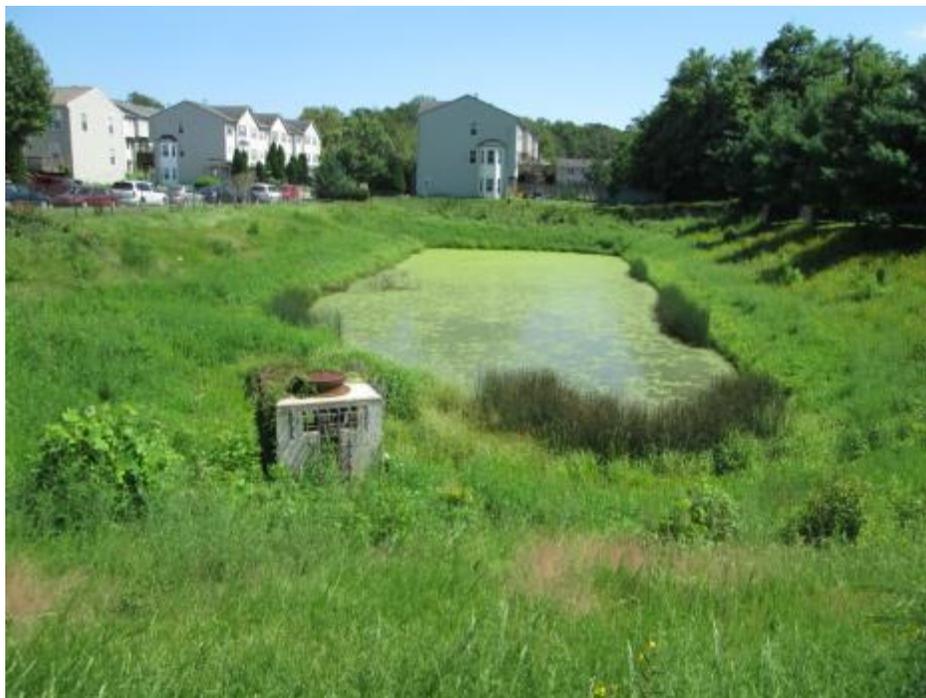
Existing Annapolis Walk Wet Pond (facing southeast)

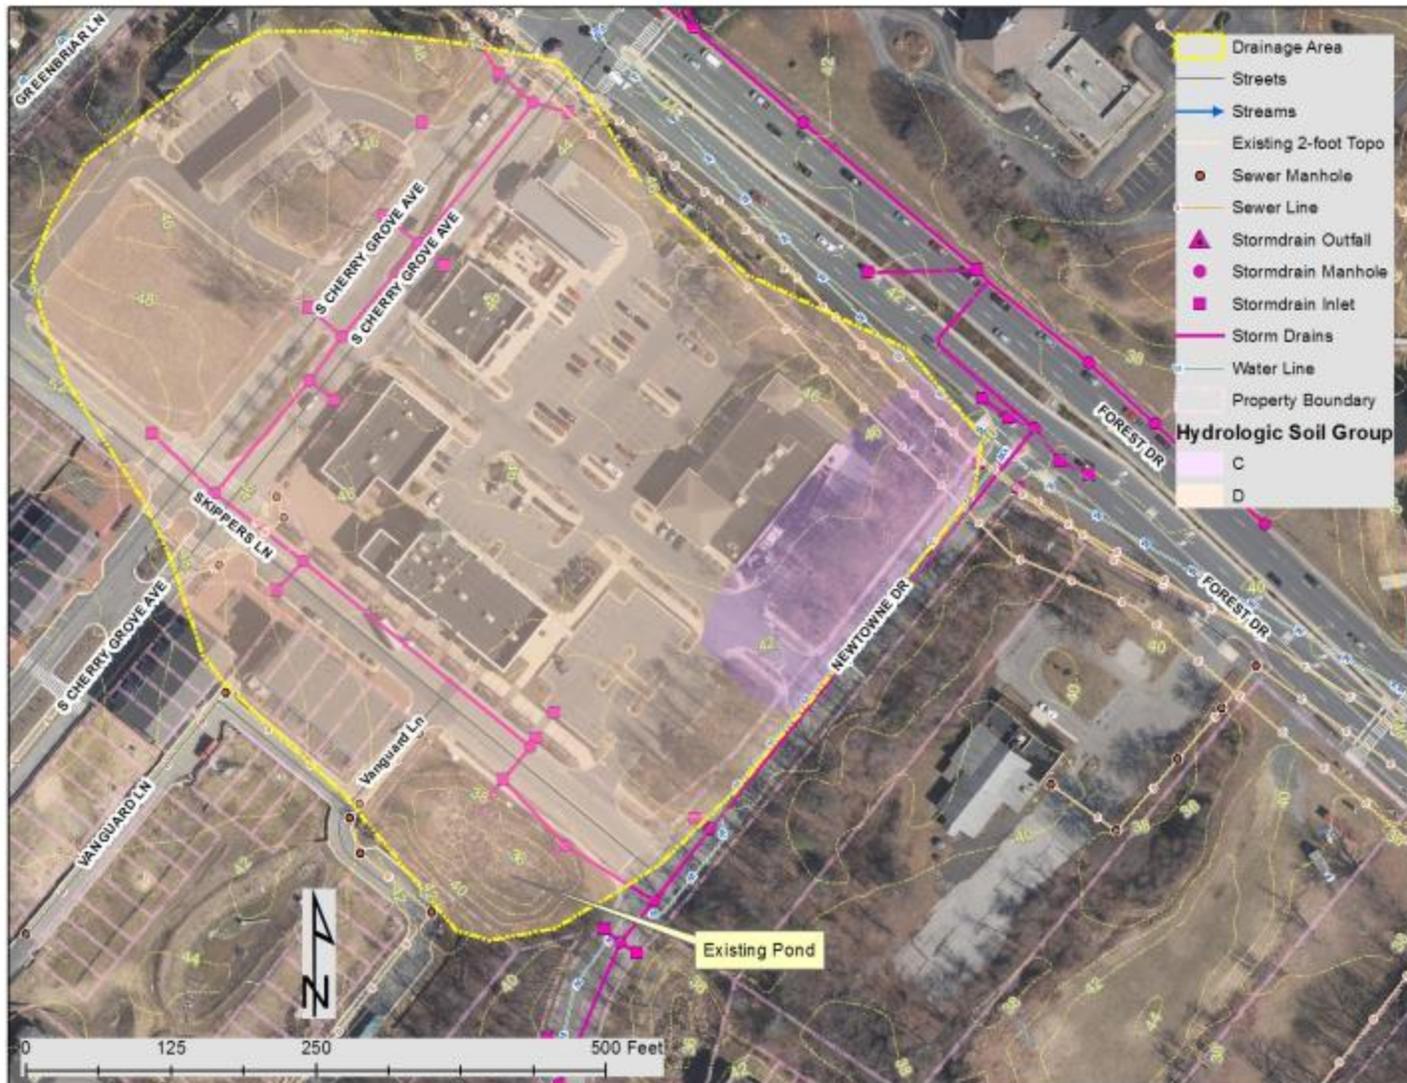
Figure 8: Existing Conditions and Drainage Area

Design Parameters	Site Value
Treated Drainage Area (ac), A	9.1
Percent Impervious Cover, I	57.1%
Rainfall Depth (inches), P	1
Volumetric Runoff Coefficient, R _v	0.56
Water Quality Volume (acre-feet), WQ_v	0.43
Water Quality Volume (cubic-feet), WQ_v	18,640

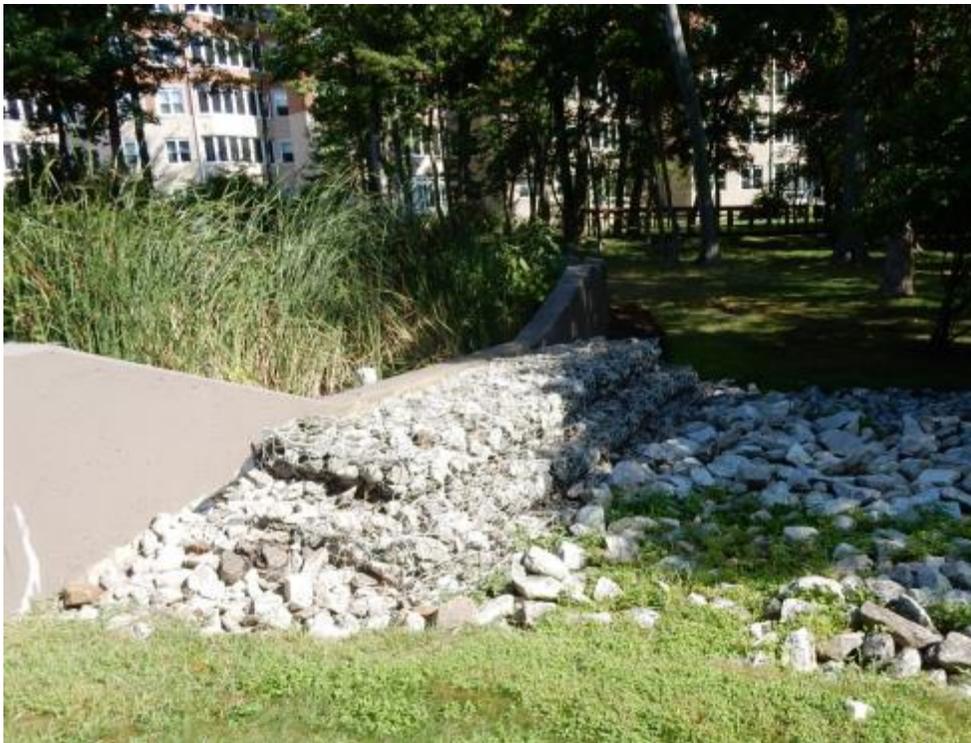
Existing Pond at BayWoods of Annapolis Overflow Weir and Outfall Protection (facing northwest)

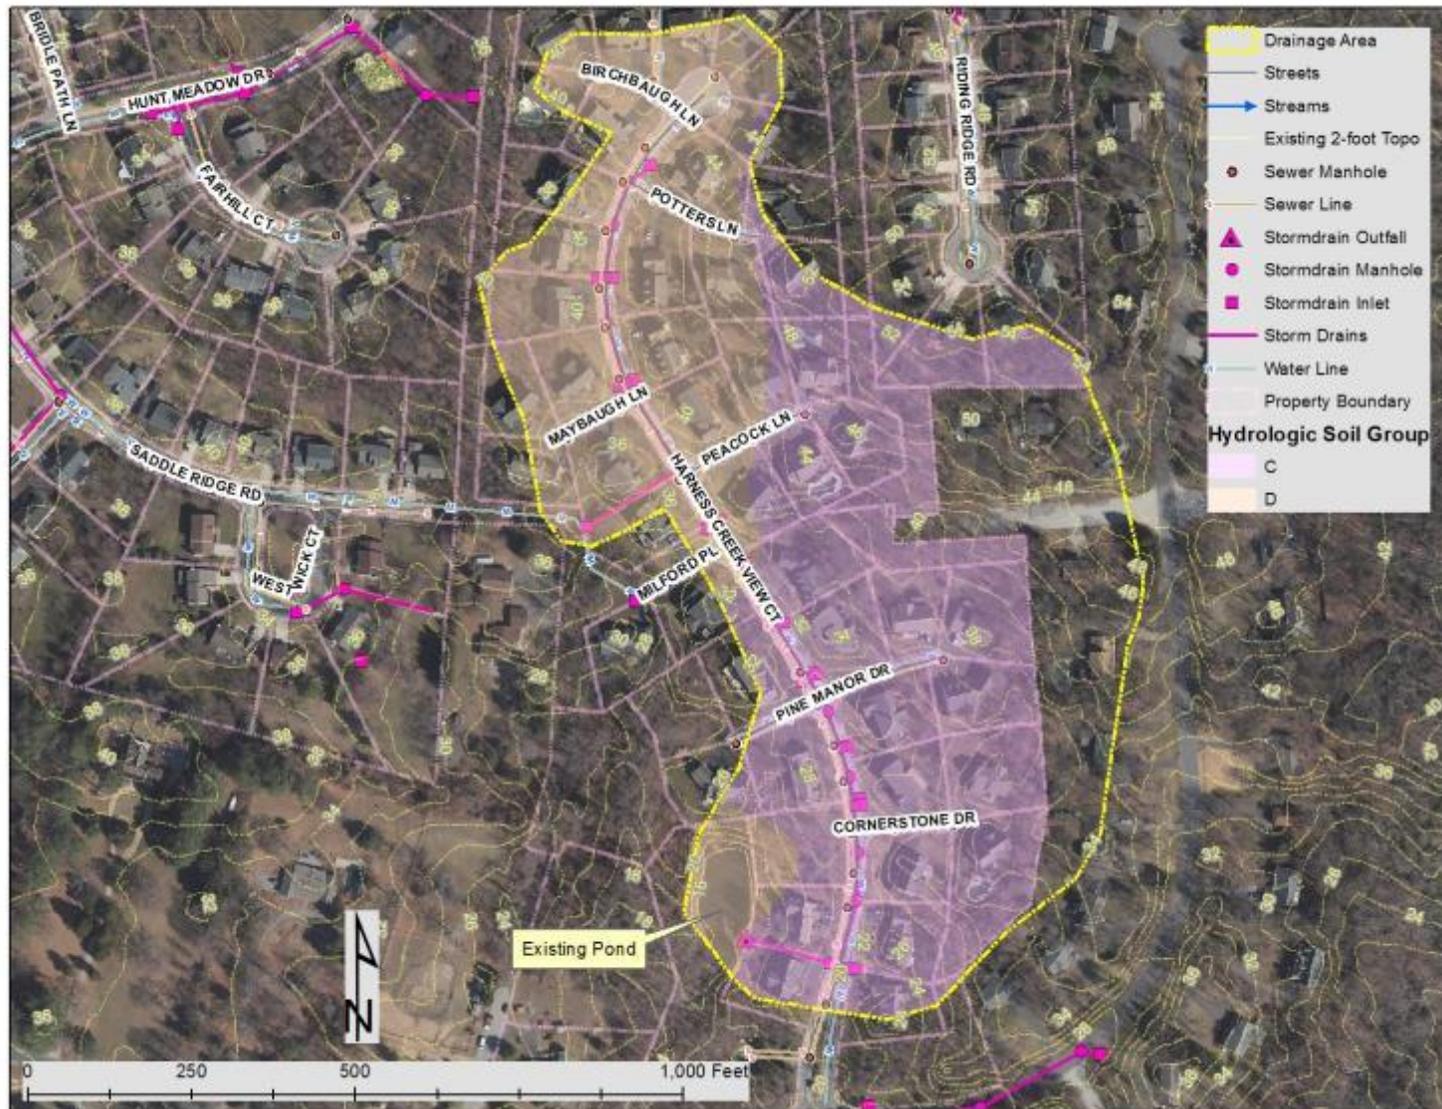
Figure 15: Existing Conditions and Drainage Area

Design Parameters	Site Value
Treated Drainage Area (ac), A	19.5
Percent Impervious Cover, I	25.6
Rainfall Depth (inches), P	1
Volumetric Runoff Coefficient, R _v	0.28
Water Quality Volume (acre-feet), WQ_v	0.46
Water Quality Volume (cubic-feet), WQ_v	19,874

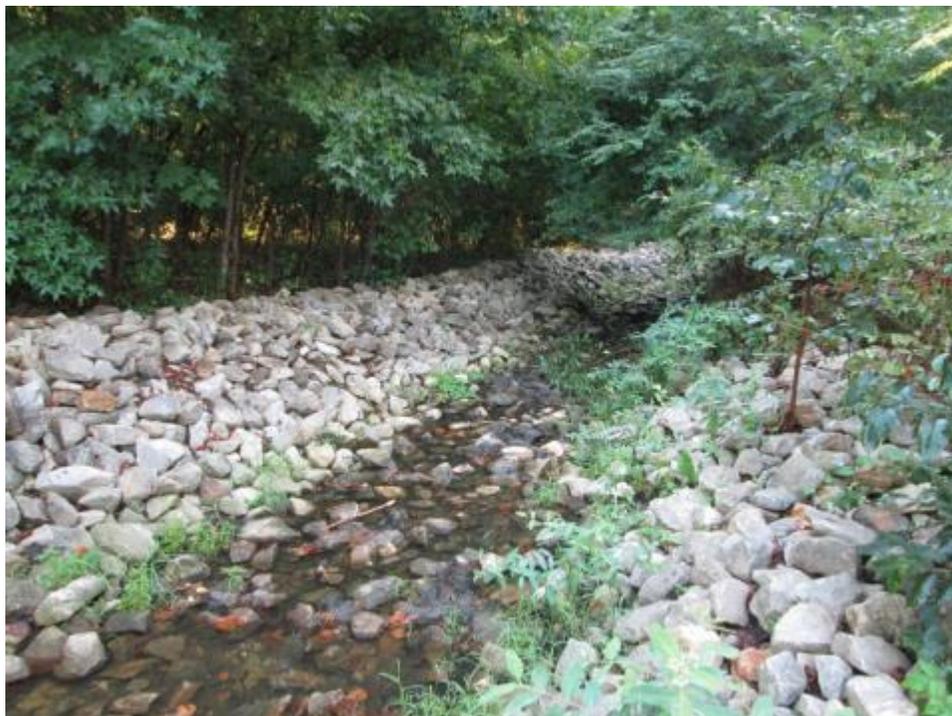
Existing Outfall for Harness Creek View Court Wet Pond
