City of Annapolis Stormwater Management Inventory and Watershed Improvement Plan

October 2016

Stormwater Management Inventory and Watershed Improvement Plan

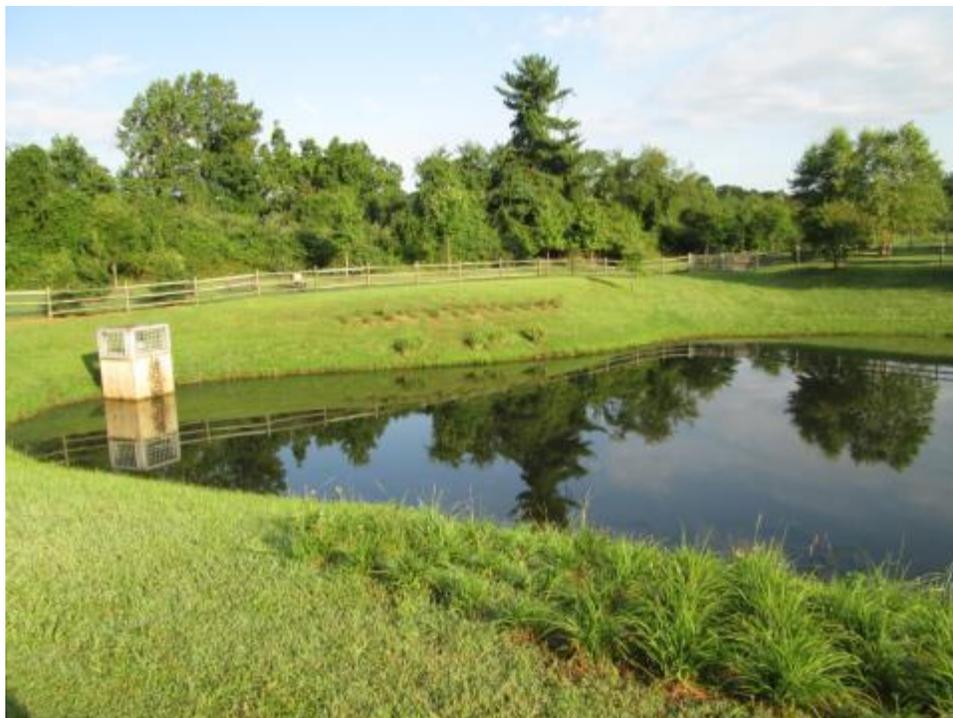
Existing Riser Structure

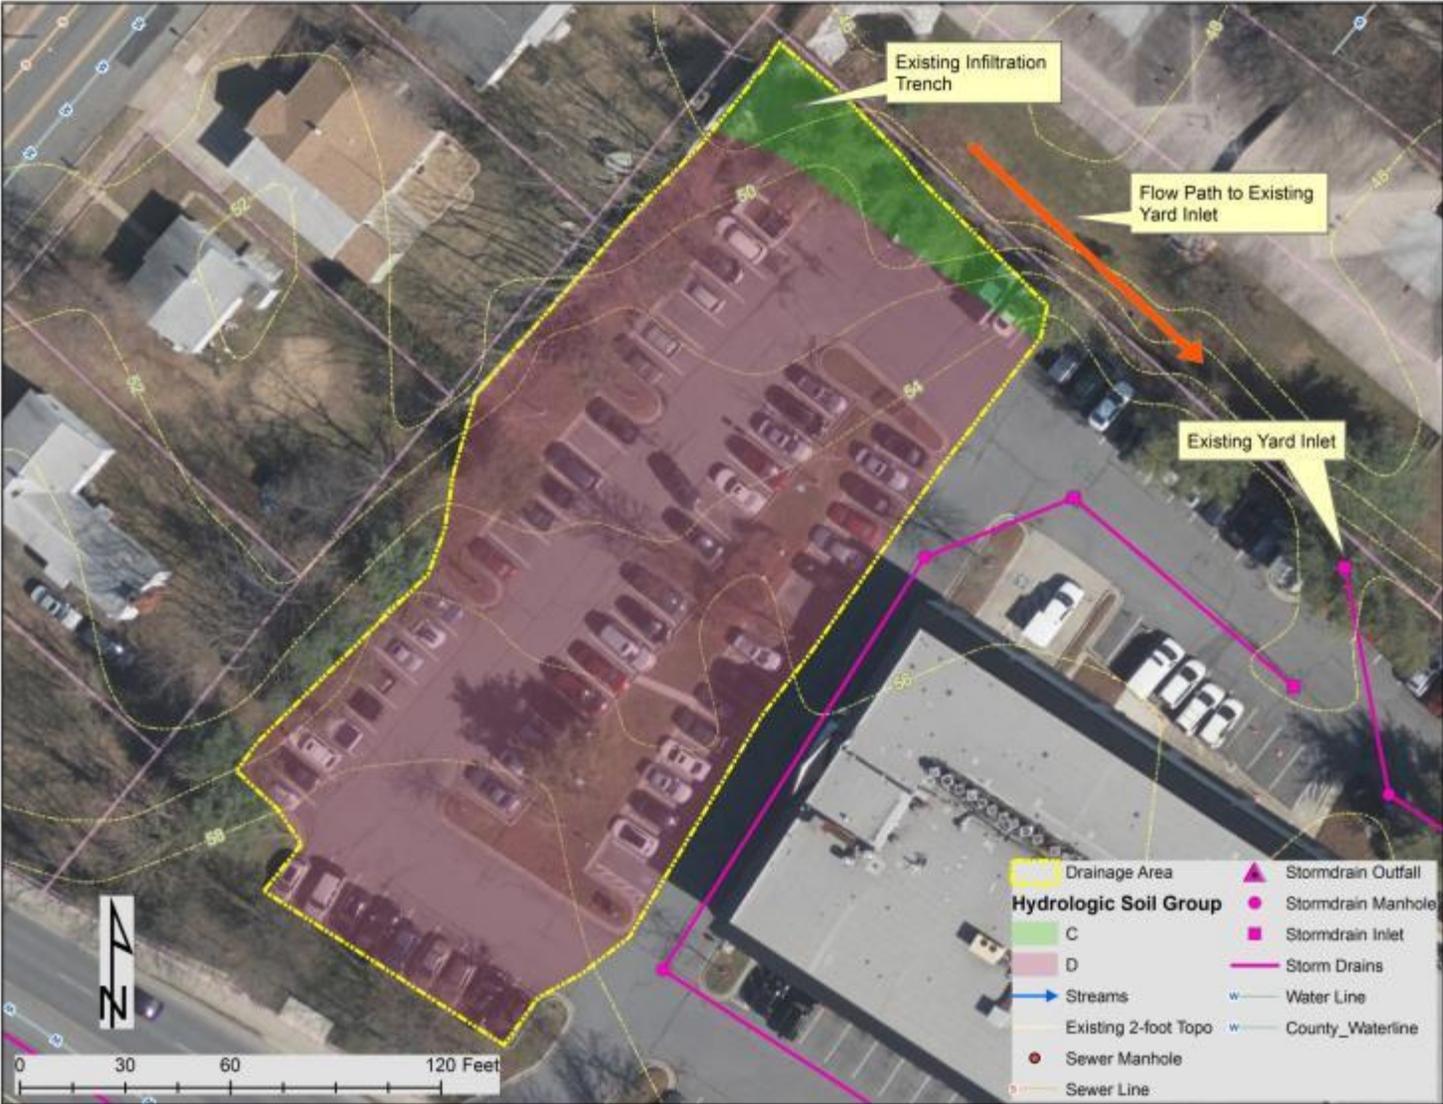
Figure 22: Existing Conditions and Drainage Area

Design Parameters	Site Value
Treated Drainage Area (acres), A	0.69
Percent Impervious Cover, I	68%
Rainfall Depth (inches), P	1
Volumetric Runoff Coefficient, R _v	0.66
Water Quality Volume (acre-feet), WQ_v	0.04
Water Quality Volume (cubic-feet), WQ_v	1,647

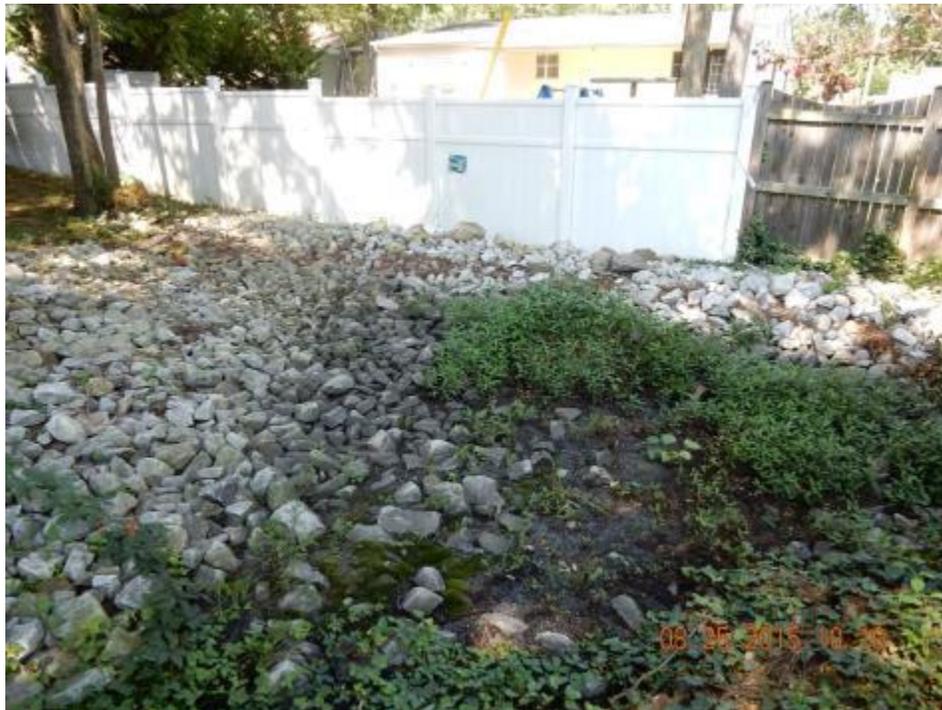
Existing Infiltration Trench at the North End of Georgetown Plaza

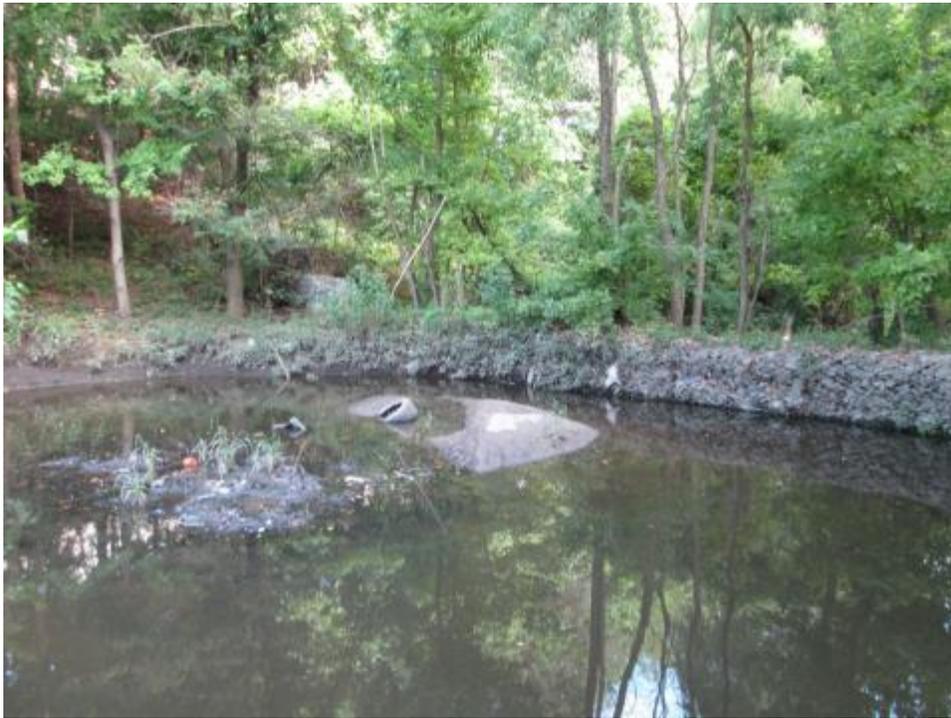
Existing Wet Pond Gabion Outlet Structure

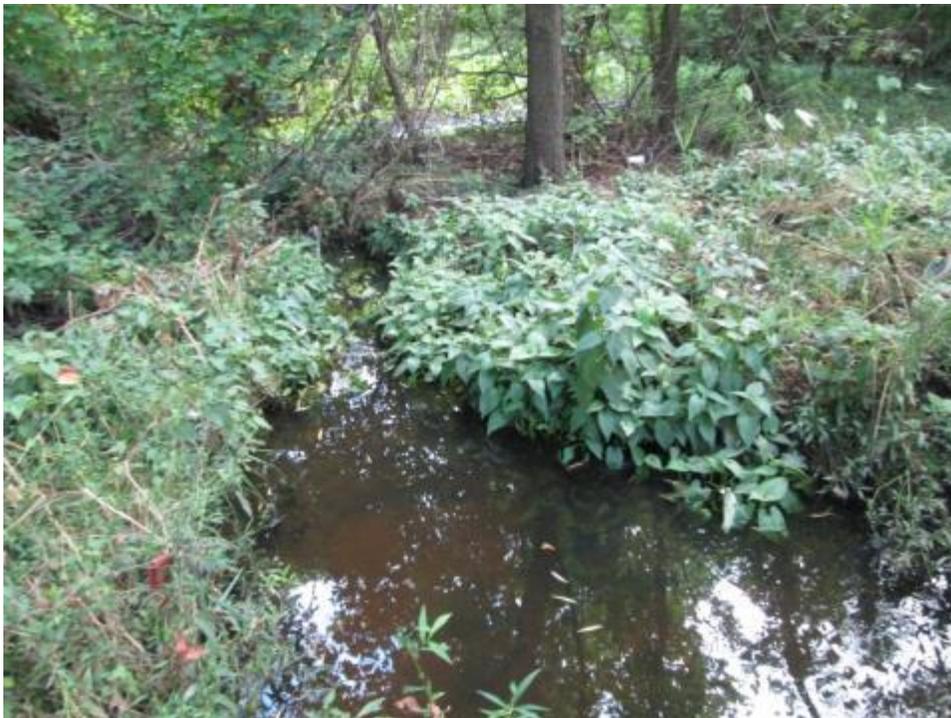
Existing Pond Outfall

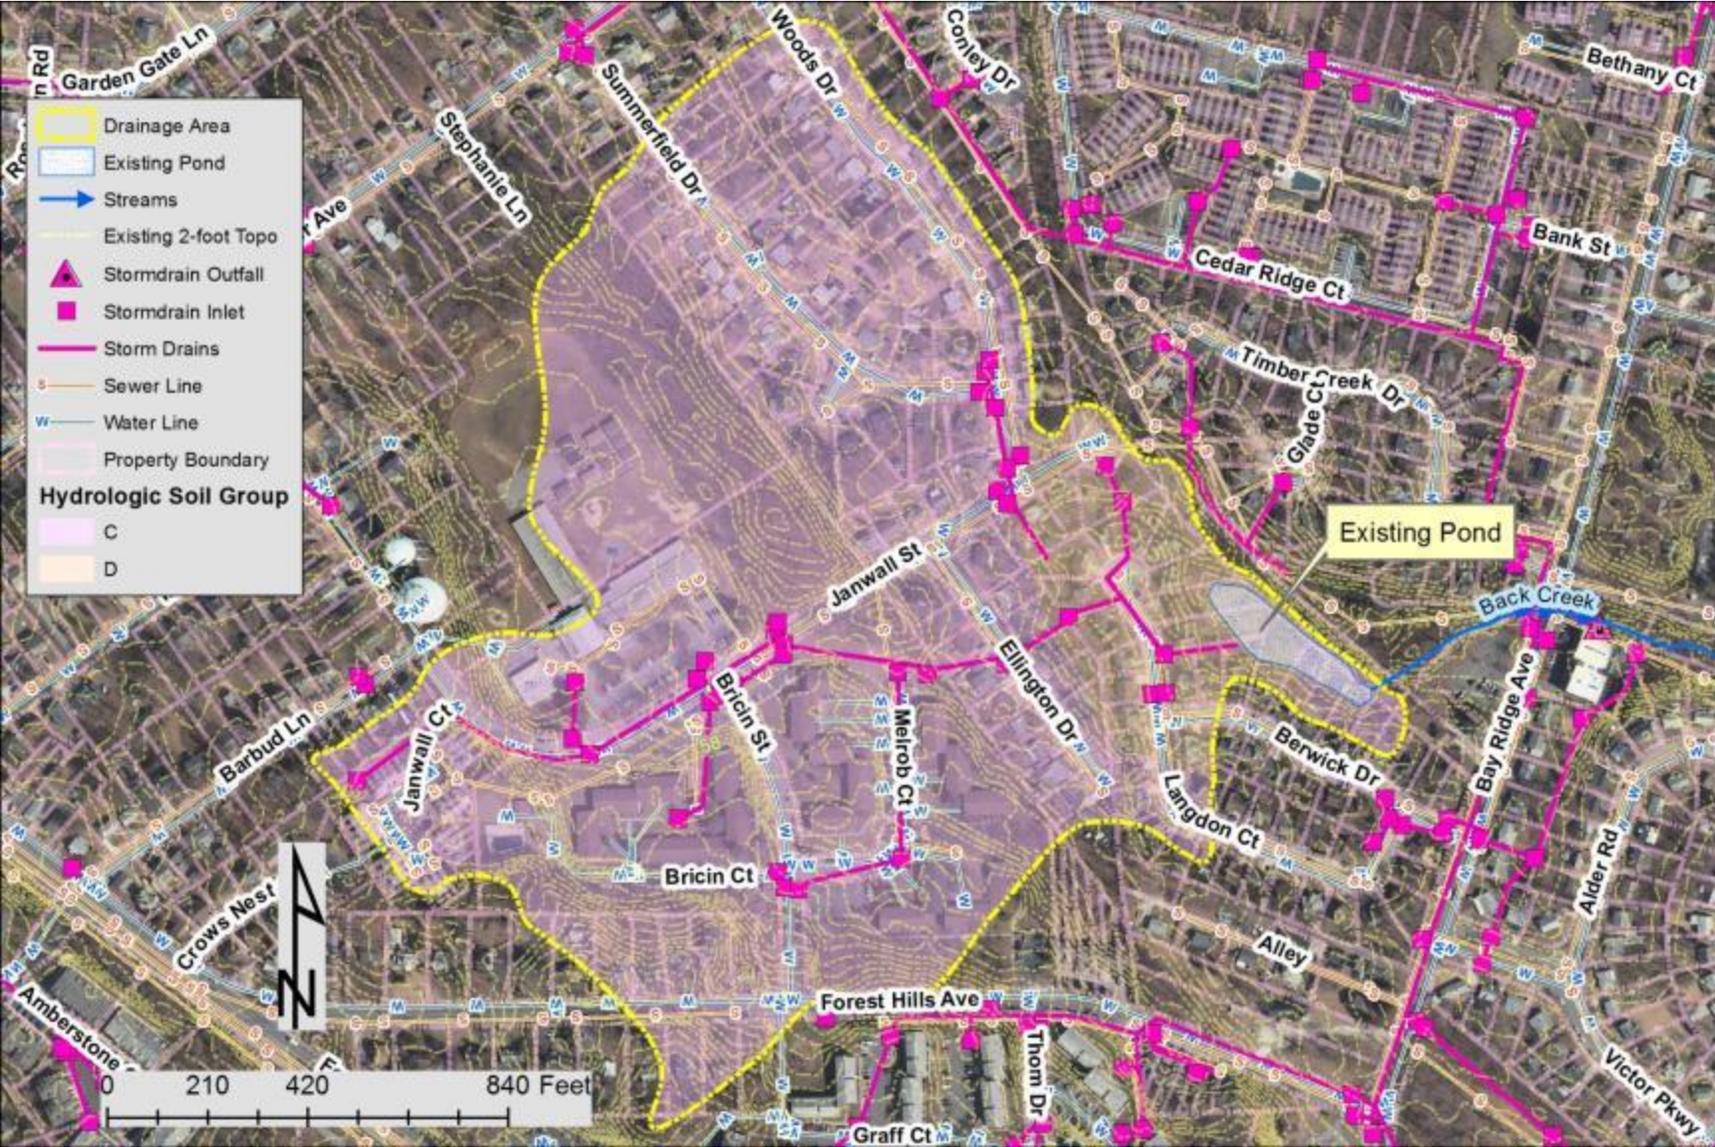
Figure 28: Existing Conditions and Drainage Area

Design Parameters	Site Value
Treated Drainage Area (acres), A	55.6
Percent Impervious Cover, I	35%
Rainfall Depth (inches), P	1.0
Volumetric Runoff Coefficient, R _v	0.36
Water Quality Volume (acre-feet), WQ_v	1.67
Water Quality Volume (cubic-feet), WQ_v	72,700

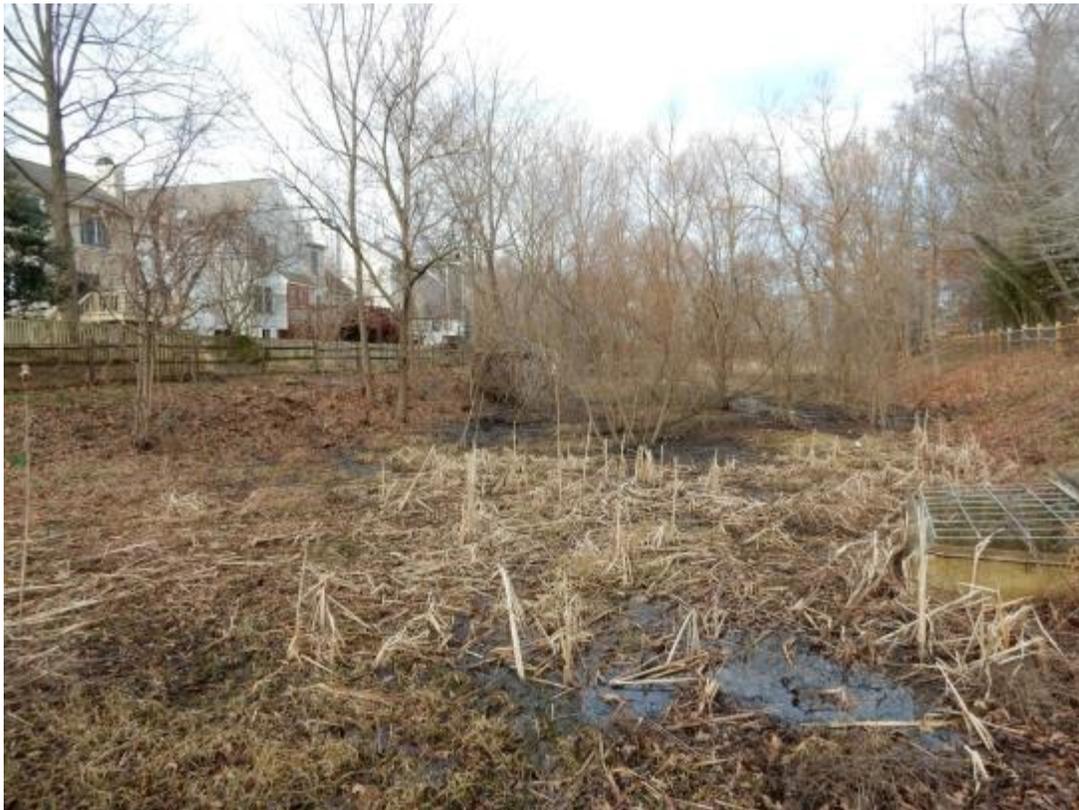
Existing Ambridge Pond (including Emergency Spillway Riser)

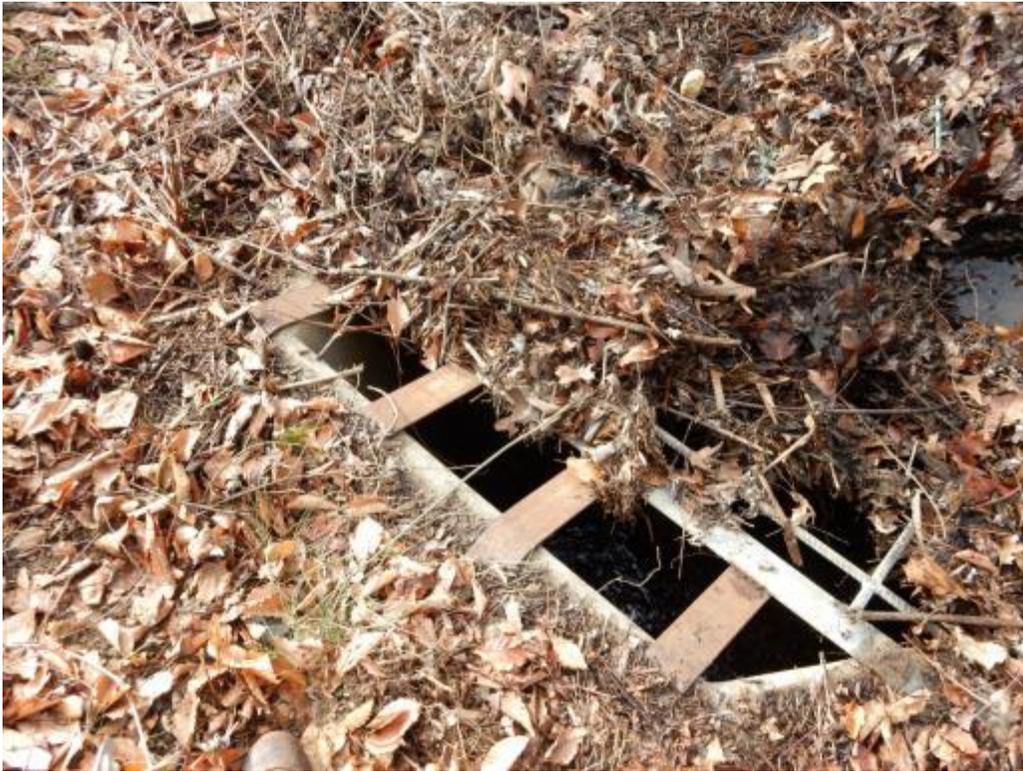
Existing Ambridge Pond Principal Spillway (with 36-inch pipe through embankment)

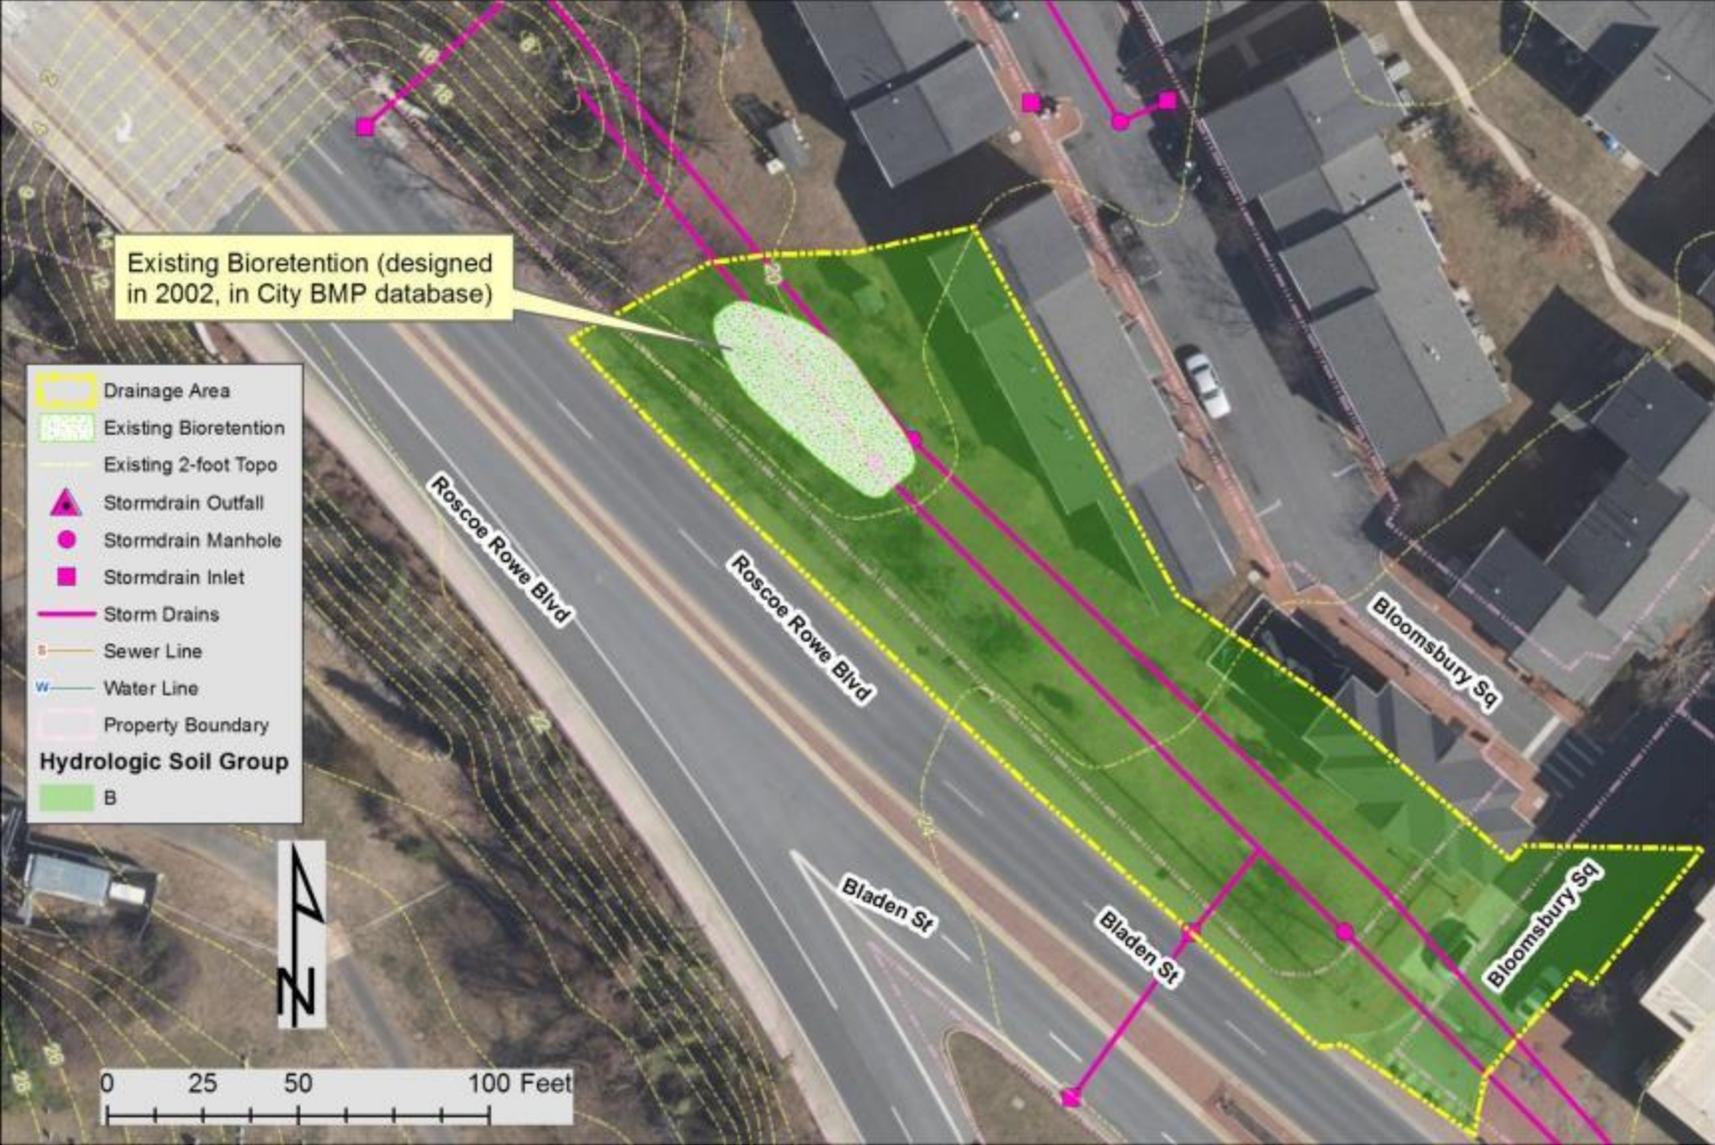
Figure 31: Existing Conditions and Drainage Area

Design Parameters	Site Value
Treated Drainage Area (acres), A	0.51
Percent Impervious Cover, I	31%
Rainfall Depth Treated by Existing Bioretention (inches),	1
Rainfall Depth Treated by Proposed Bio-Swale (inches)	0.5
Total Rainfall Depth Treated	1.5
Volumetric Runoff Coefficient, R _v	0.52
Water Quality Volume (acre-feet), WQ_v	0.021
Water Quality Volume (cubic-feet), WQ_v	920

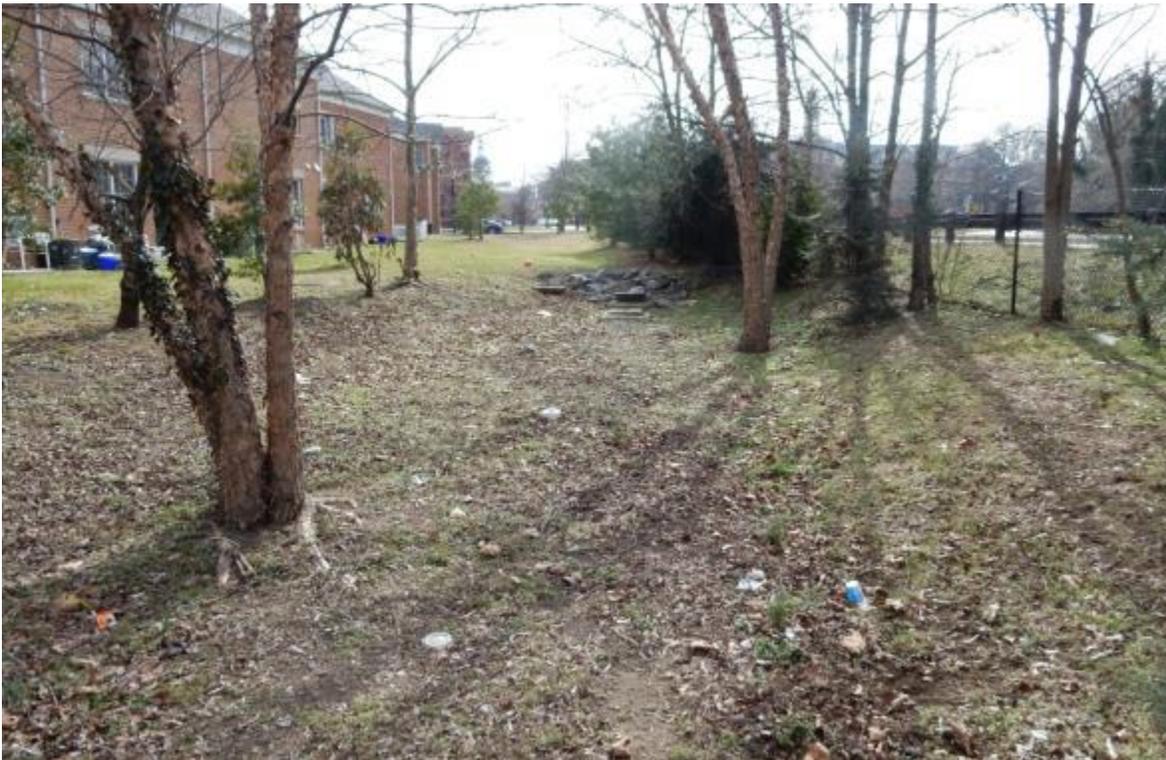
Existing Bioretention between Bloomsbury Square and Rowe Boulevard

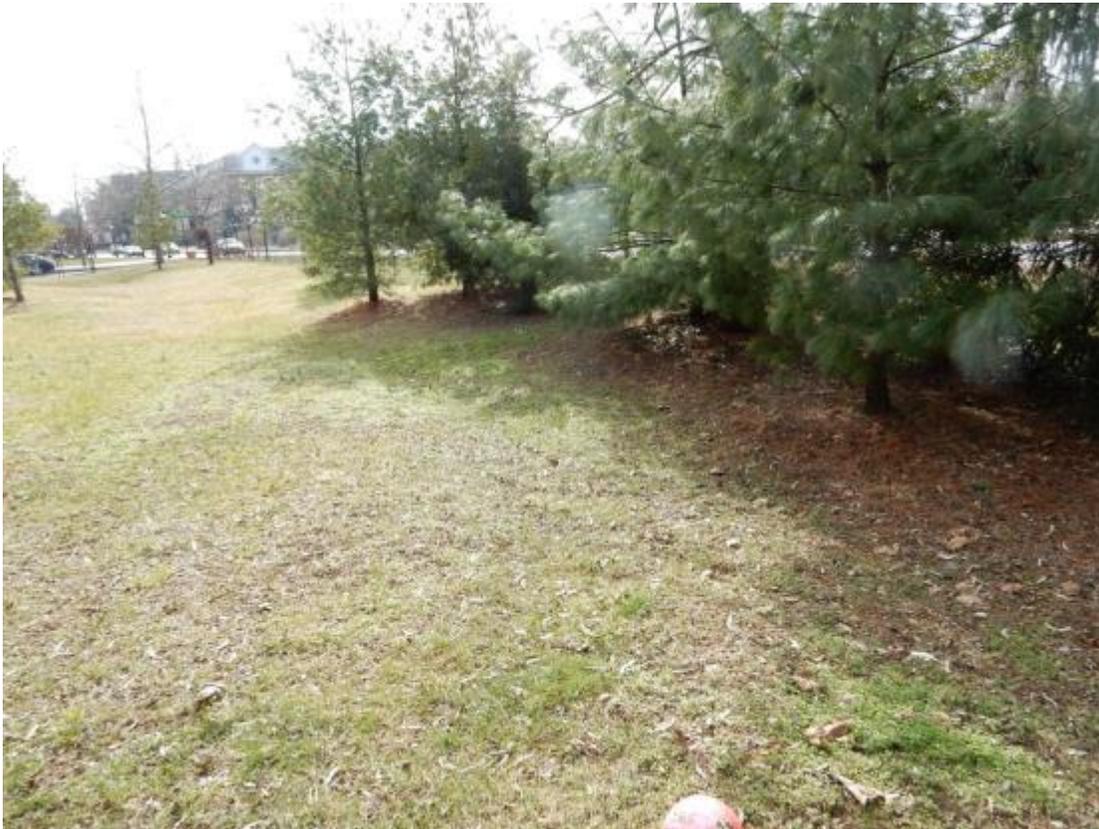
Existing Grass Swale Upstream of Existing Bioretention

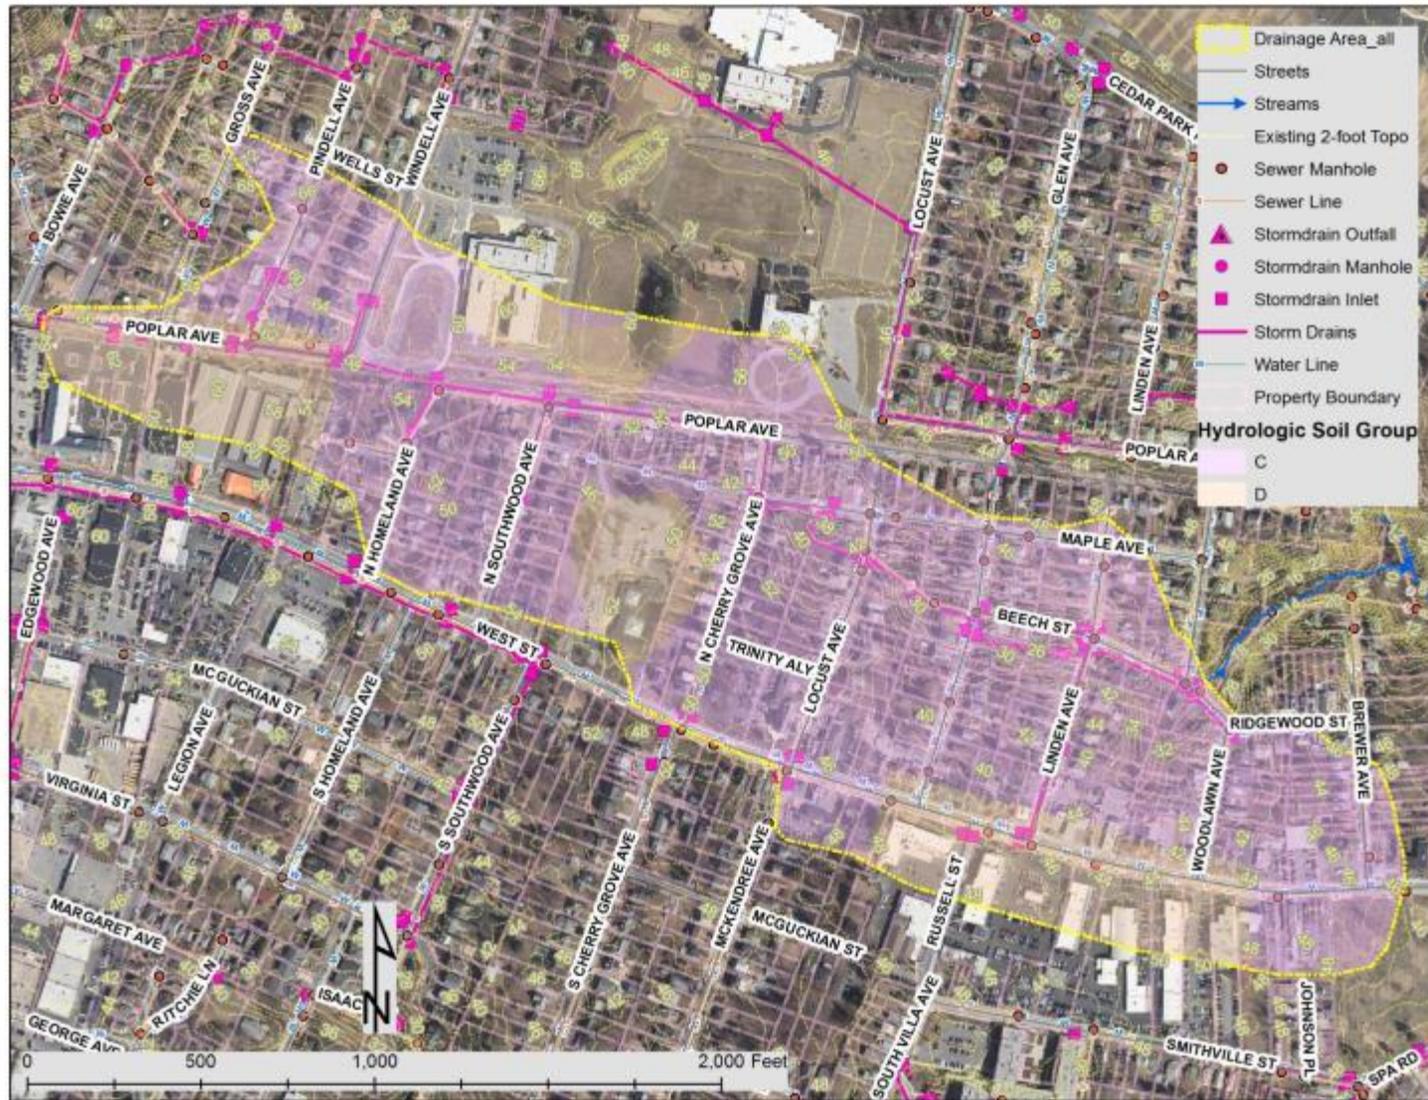
Figure 34: Existing Conditions and Drainage Area

Design Parameters	Site Value
Treated Drainage Area (ac), A	82.1
Percent Impervious Cover, I	49%
Rainfall Depth (inches), P	1
Volumetric Runoff Coefficient, R _v	0.49
Water Quality Volume (acre-feet), WQ_v	3.34
Water Quality Volume (cubic-feet), WQ_v	145,581

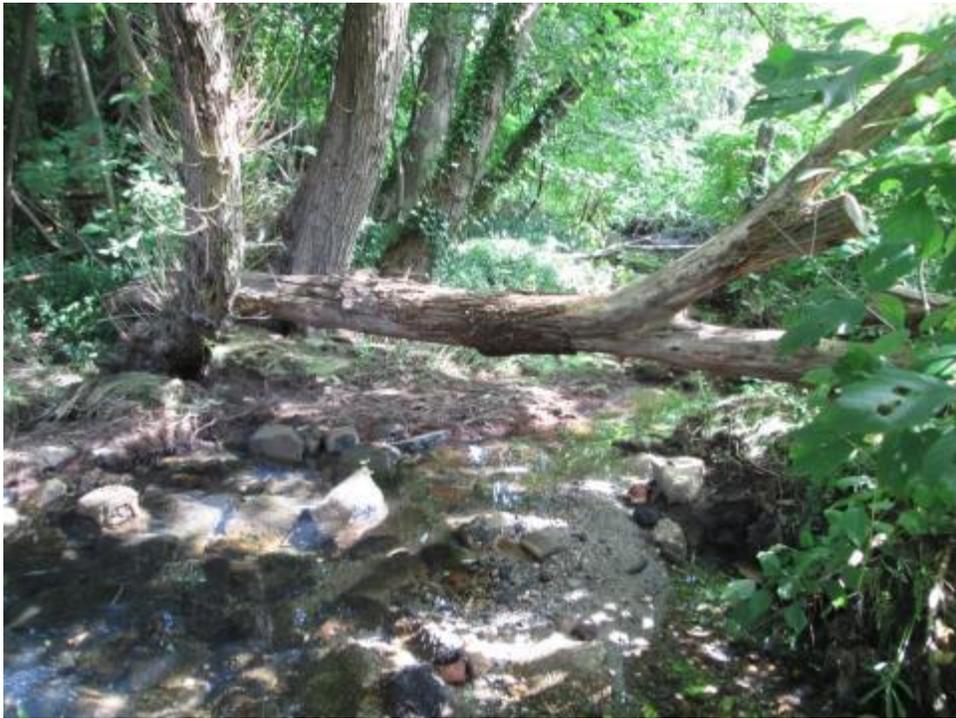
Tributary to College Creek Northwest of the Intersection of Ridgewood Street and Woodlawn Avenue

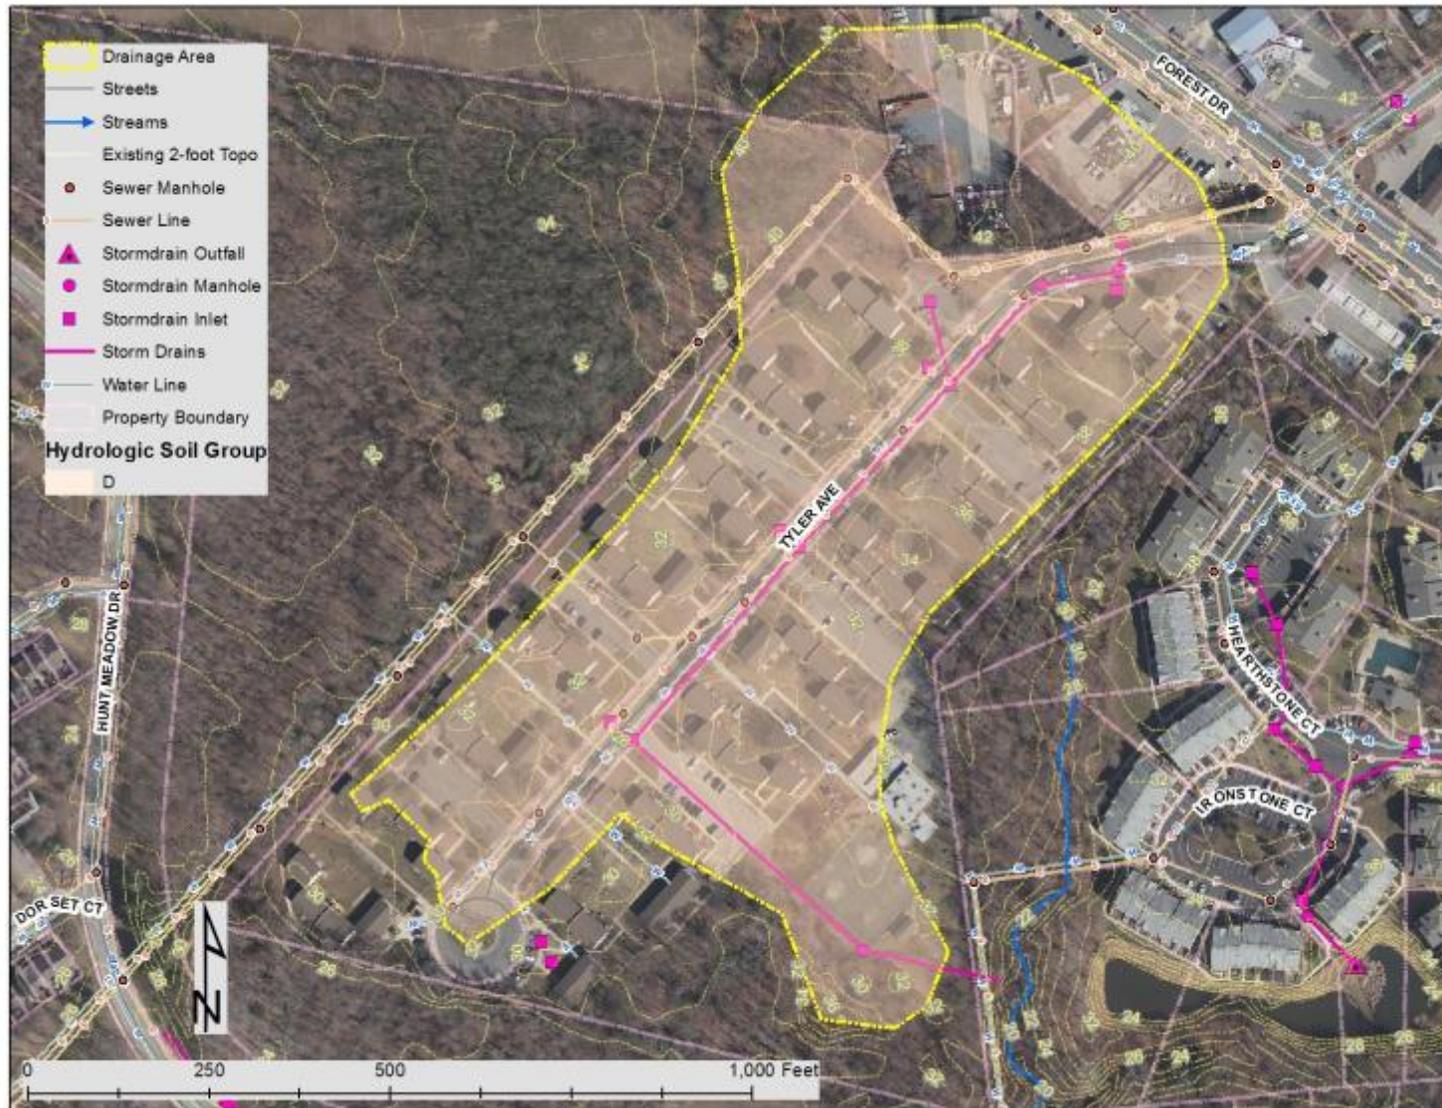
Figure 37: Existing Conditions and Drainage Area

Design Parameters	Site Value
Treated Drainage Area (ac), A	16.7
Percent Impervious Cover, I	44.3
Rainfall Depth (inches), P	1
Volumetric Runoff Coefficient, R _v	0.45
Water Quality Volume (acre-feet), WQ_v	0.62
Water Quality Volume (cubic-feet), WQ_v	27,207

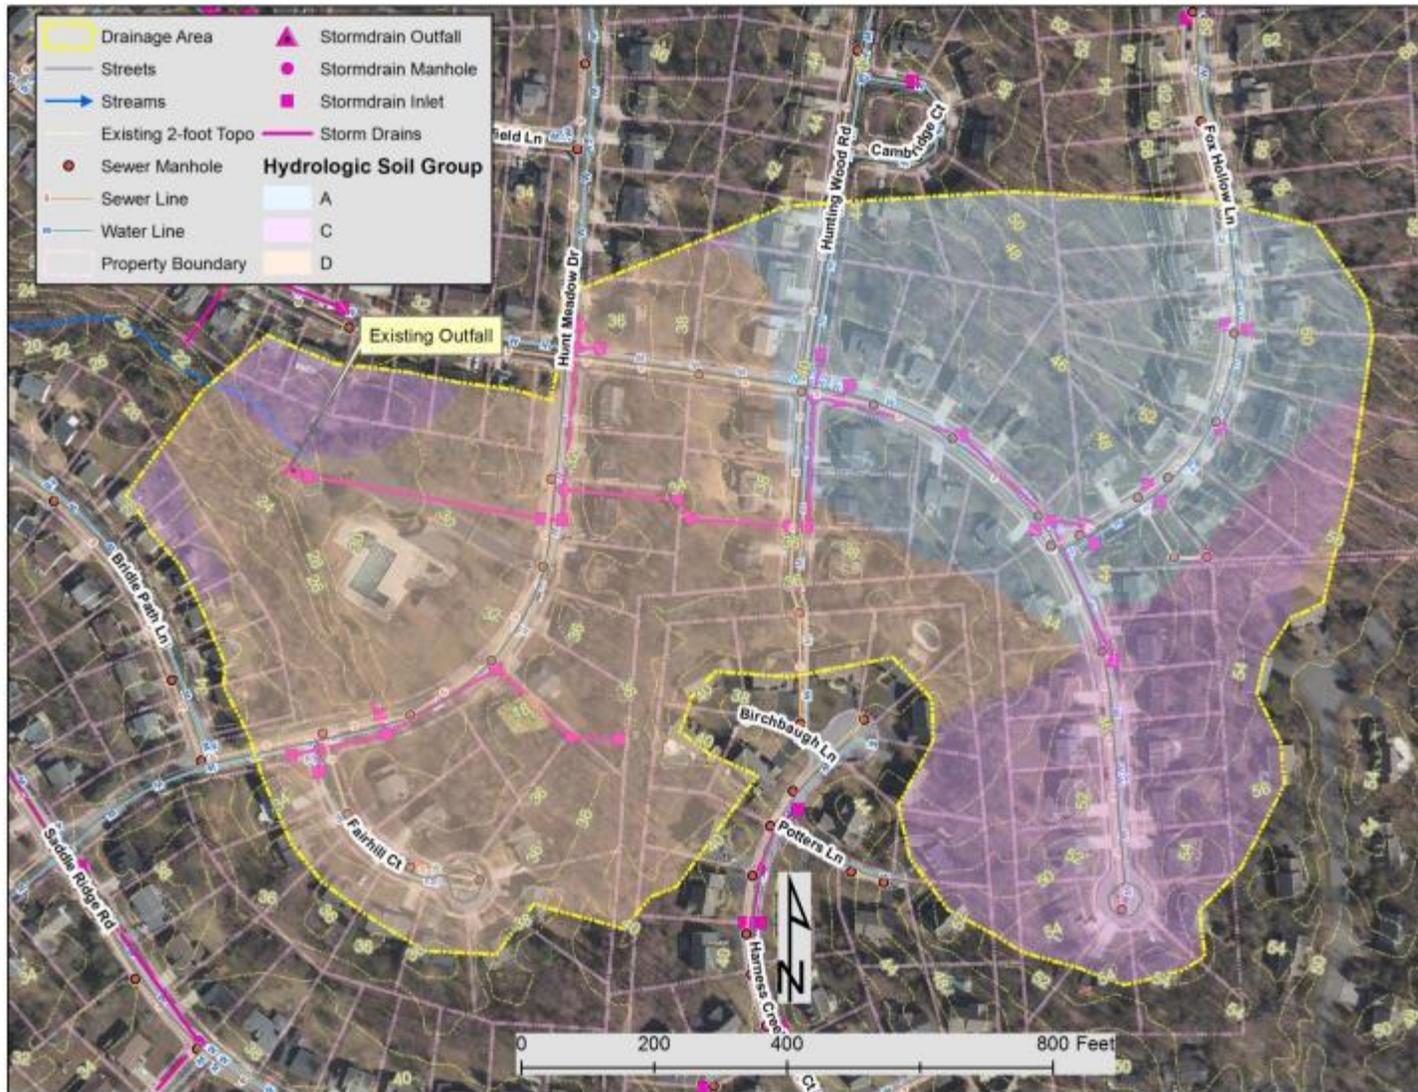
Figure 40: Existing Conditions and Drainage Area

Design Parameters	Site Value
Treated Drainage Area (ac), A	34.8
Percent Impervious Cover, I	26.3
Rainfall Depth (inches), P	1
Volumetric Runoff Coefficient, R _v	0.29
Water Quality Volume (acre-feet), WQ_v	0.83
Water Quality Volume (cubic-feet), WQ_v	36,300

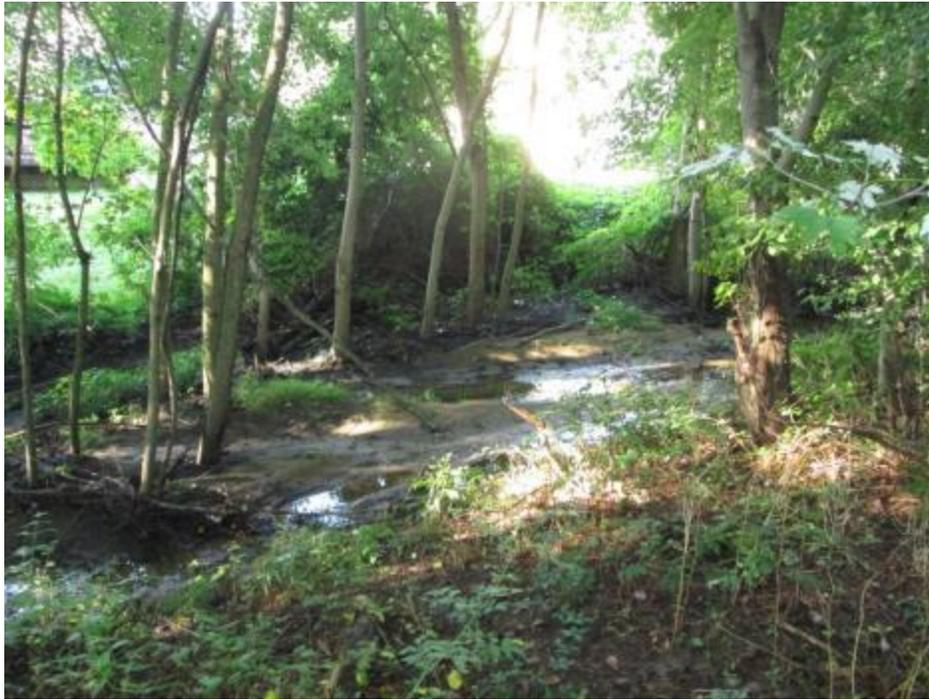
Sedimentation Downstream from Outfall

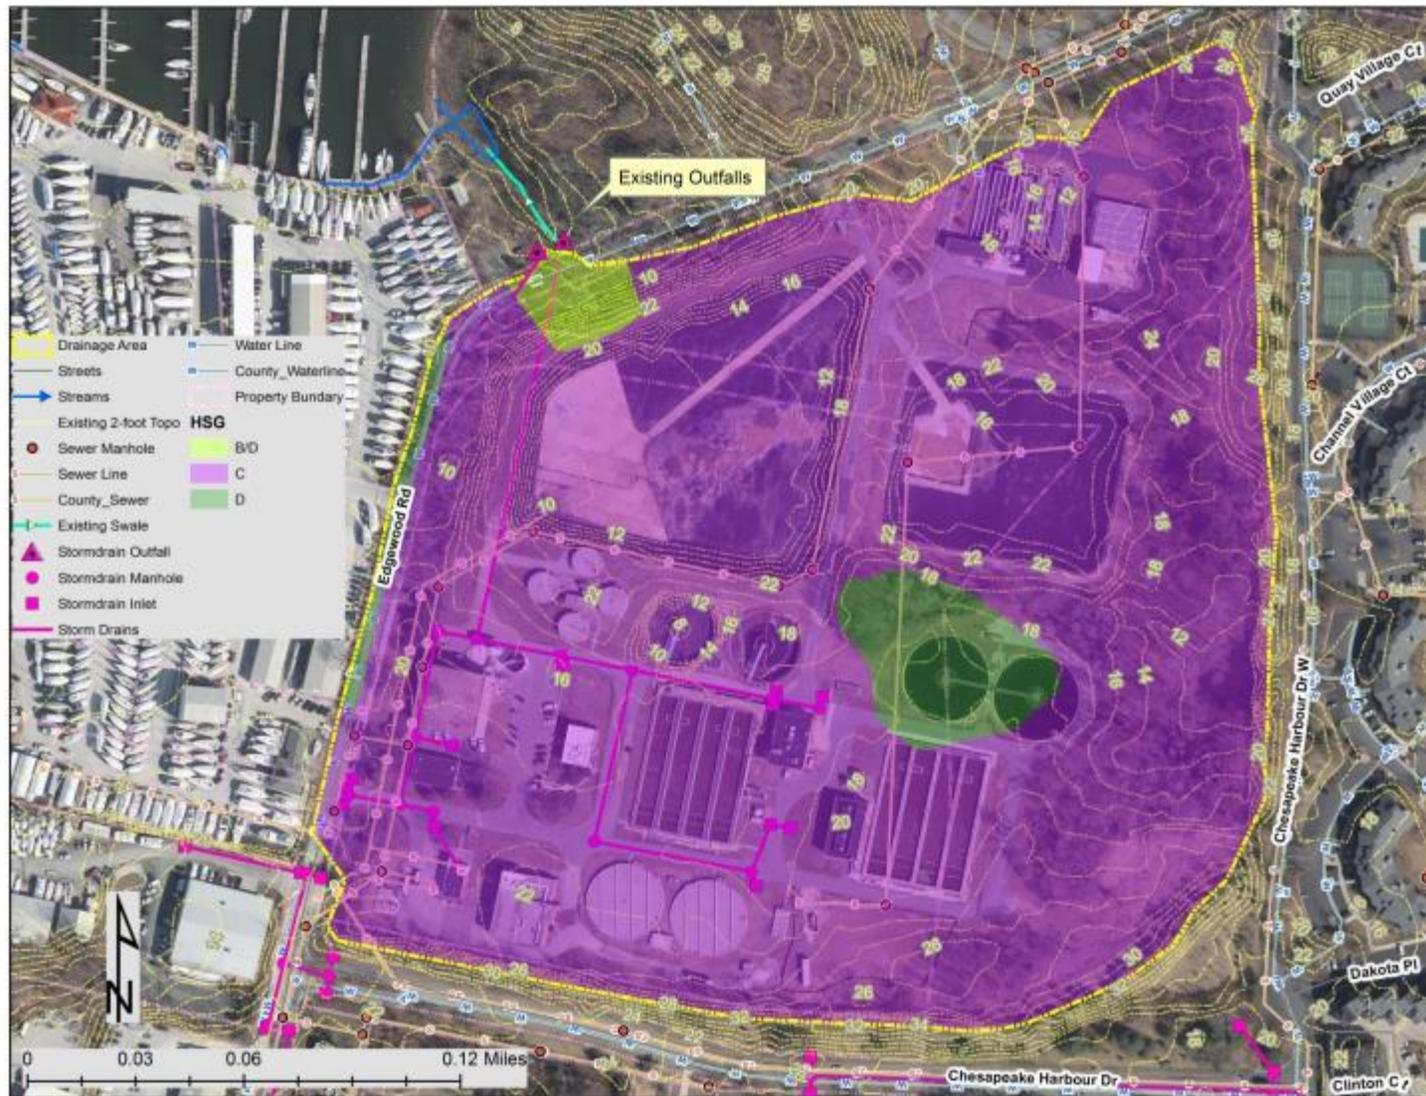
Figure 43: Existing Conditions and Drainage Area

Design Parameters	Site Value
Treated Drainage Area (ac), A	34.6
Percent Impervious Cover, I	44%
Rainfall Depth (inches), P	1
Volumetric Runoff Coefficient, R _v	0.44
Water Quality Volume (acre-feet), WQ_v	1.27
Water Quality Volume (cubic-feet), WQ_v	55,471

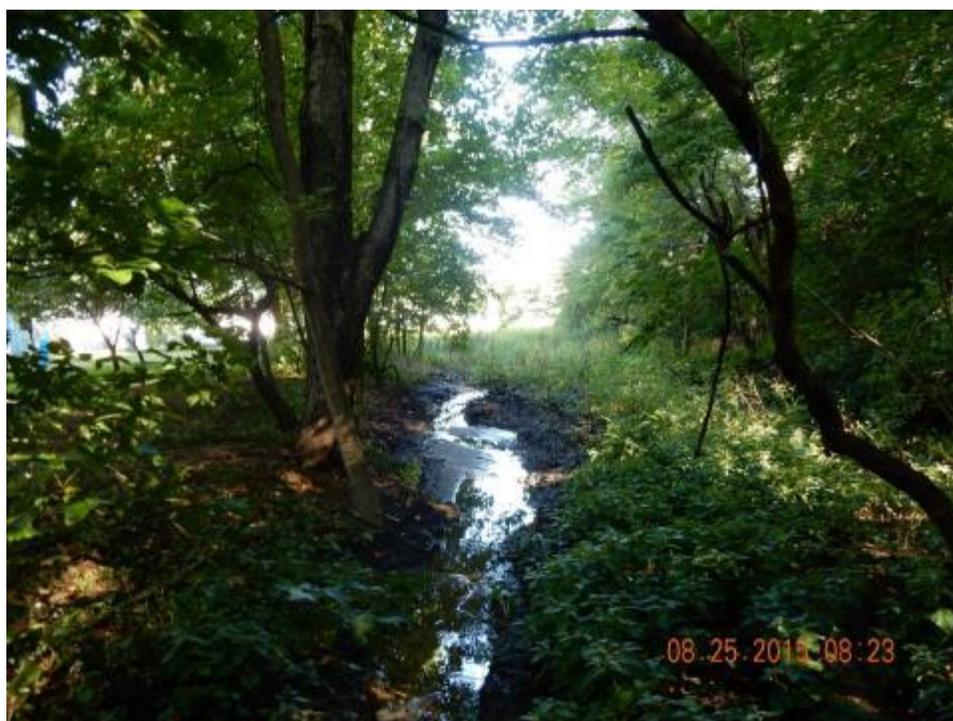
Downstream of Outfalls

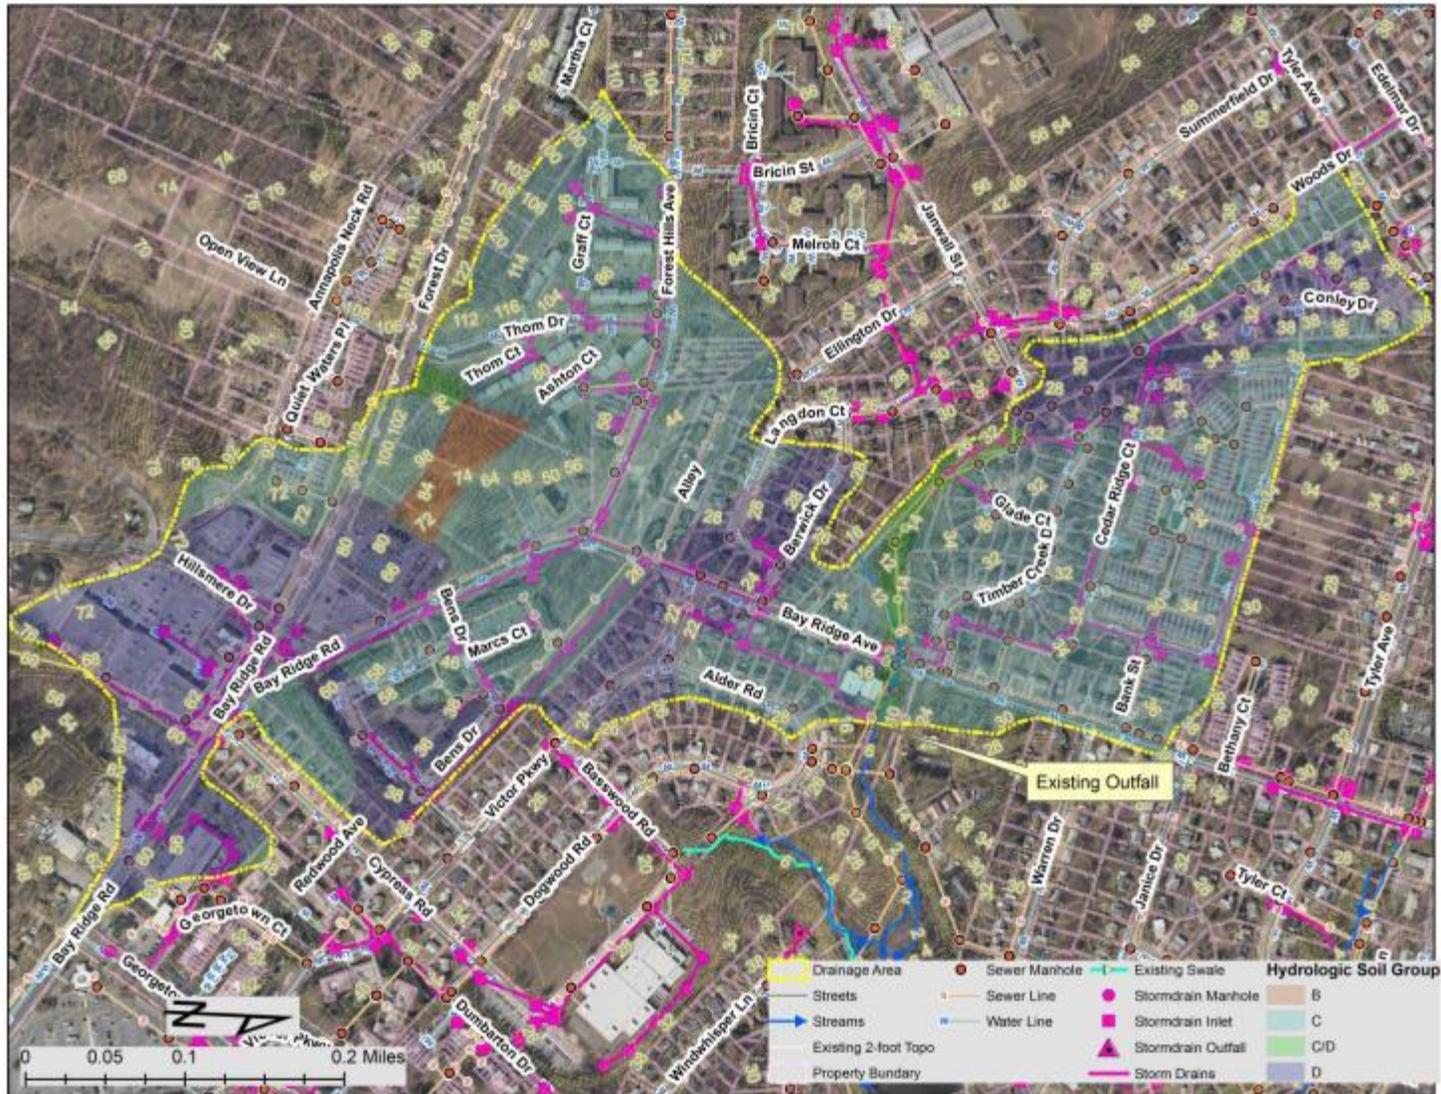
Figure 46: Existing Conditions and Drainage Area

Design Parameters	Site Value
Treated Drainage Area (ac), A	120.7
Percent Impervious Cover, I	45.2
Rainfall Depth (inches), P	1
Volumetric Runoff Coefficient, R _v	0.46
Water Quality Volume (acre-feet), WQ_v	4.60
Water Quality Volume (cubic-feet), WQ_v	200,323

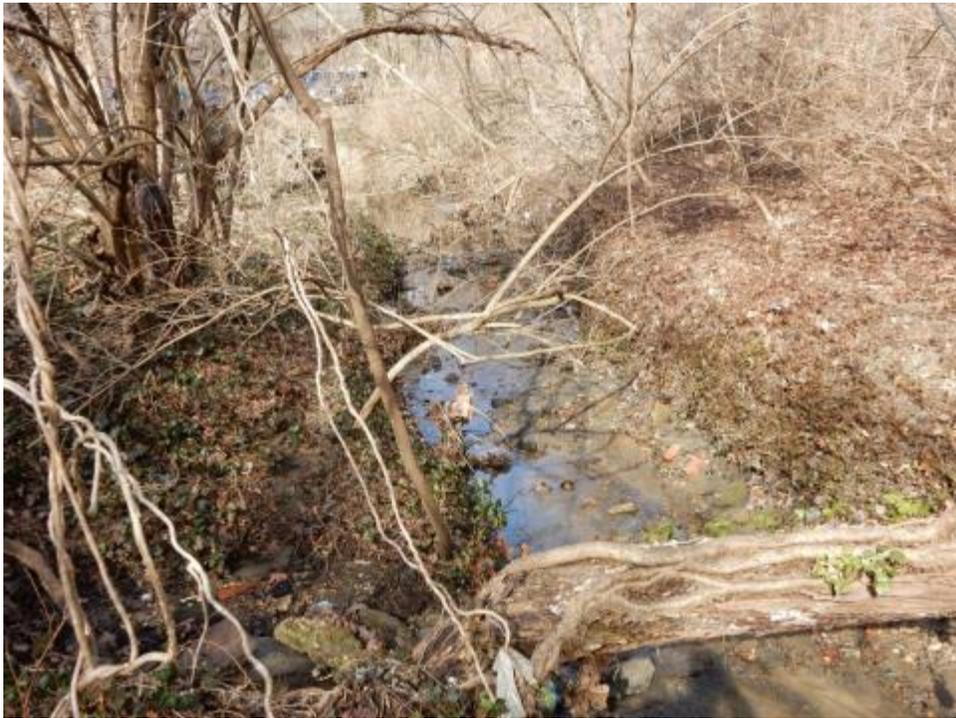
Downstream of Outfall 04
