City of Annapolis Stormwater Management Inventory and Watershed Improvement Plan

October 2016

Stormwater Management Inventory and Watershed Improvement Plan

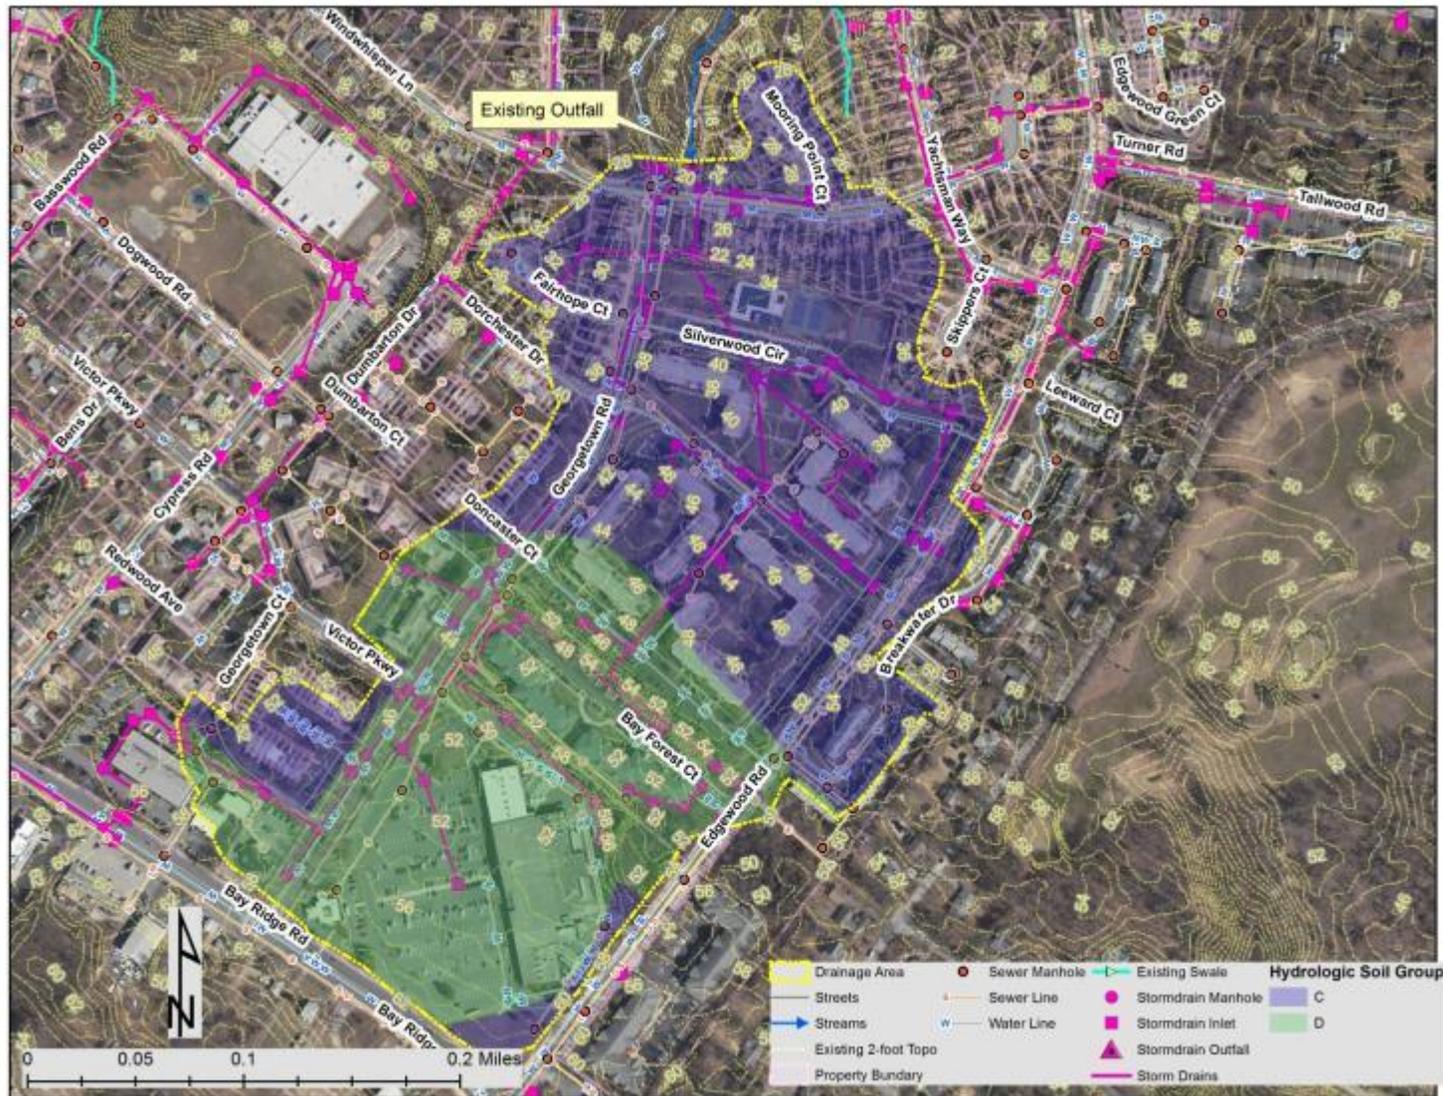
Figure 49: Existing Conditions and Drainage Area

Design Parameters	Site Value
Treated Drainage Area (ac), A	55
Percent Impervious Cover, I	54.9
Rainfall Depth (inches), P	1
Volumetric Runoff Coefficient, R _v	0.54
Water Quality Volume (acre-feet), WQ_v	2.50
Water Quality Volume (cubic-feet), WQ_v	108,704

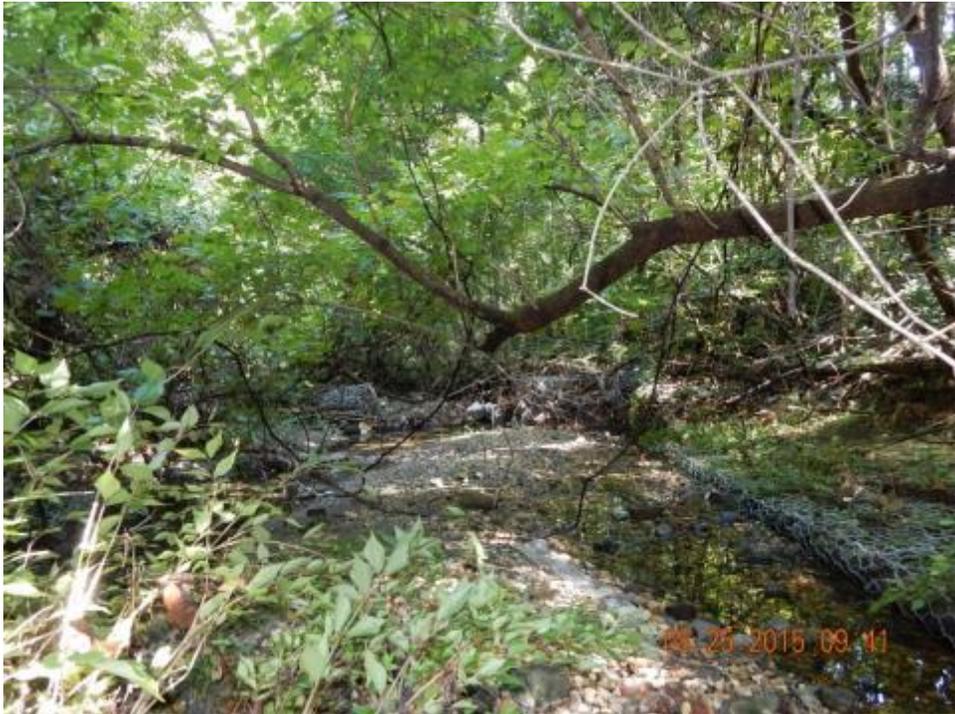
Downstream of Outfall 07
