# City of Annapolis Stormwater Management Inventory and Watershed Improvement Plan

October 2016

## Stormwater Management Inventory and Watershed Improvement Plan

AECOM  
12420 Milestone Center Drive  
Suite 150  
Germantown, MD 20876

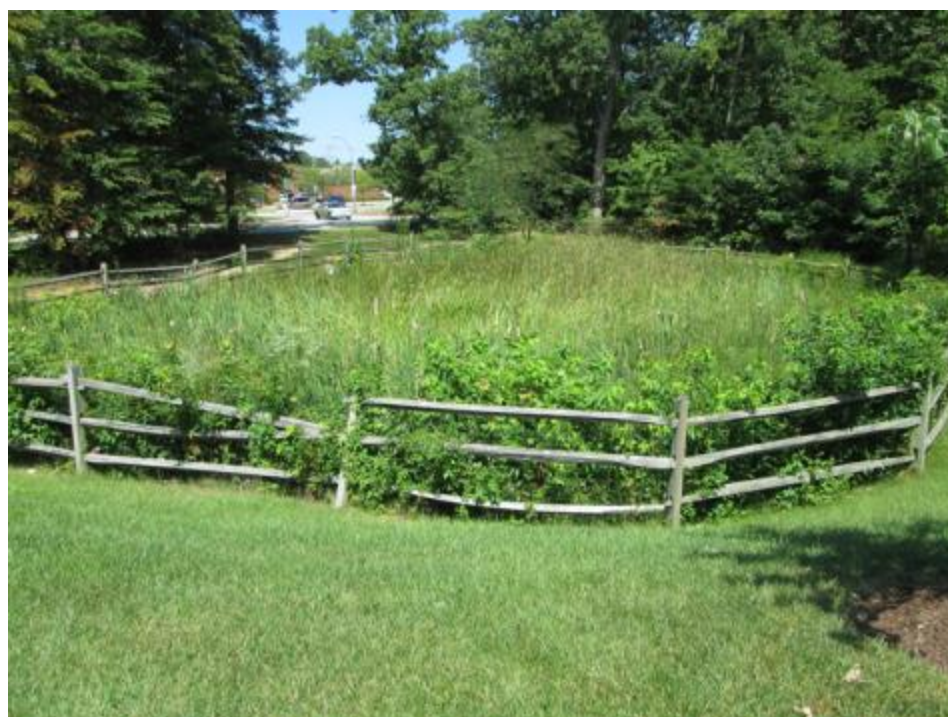
Existing pond near the intersection of Juliana Court East and Newtowne Drive

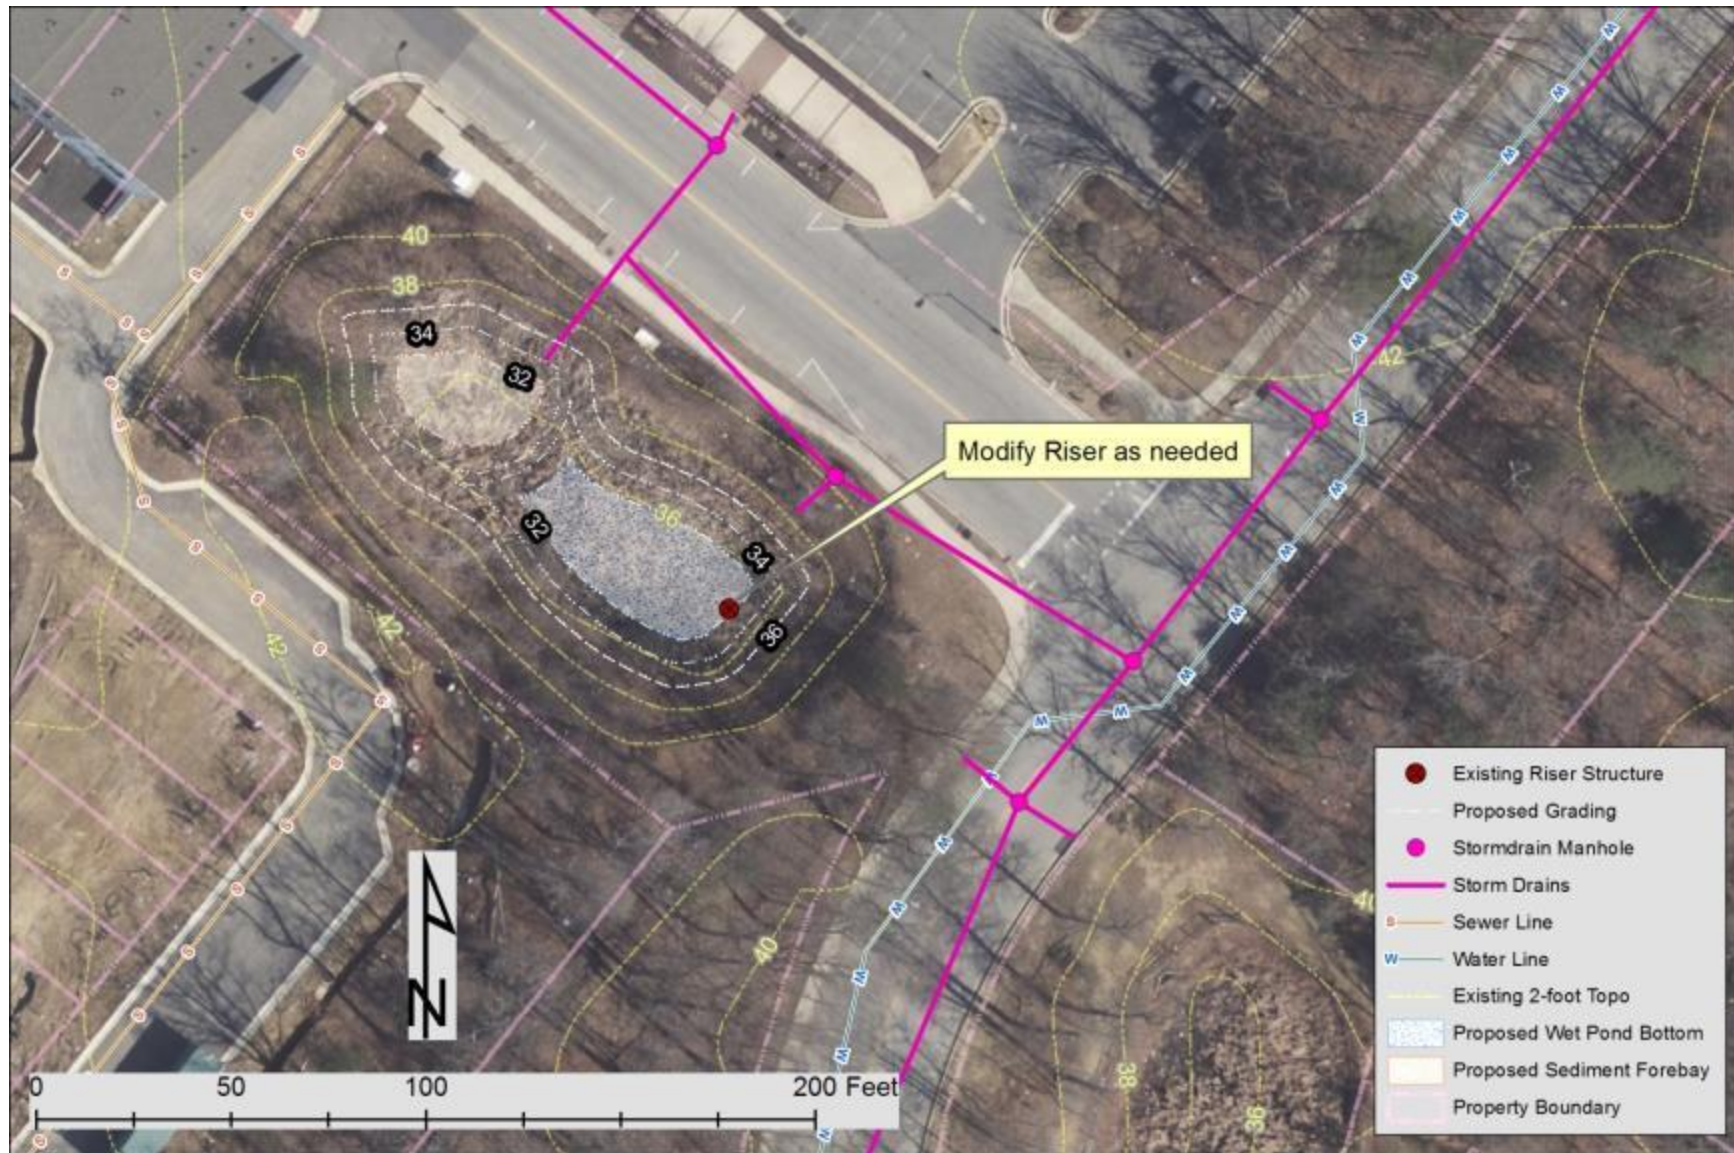
Figure 9: Proposed Retrofit Concept Design

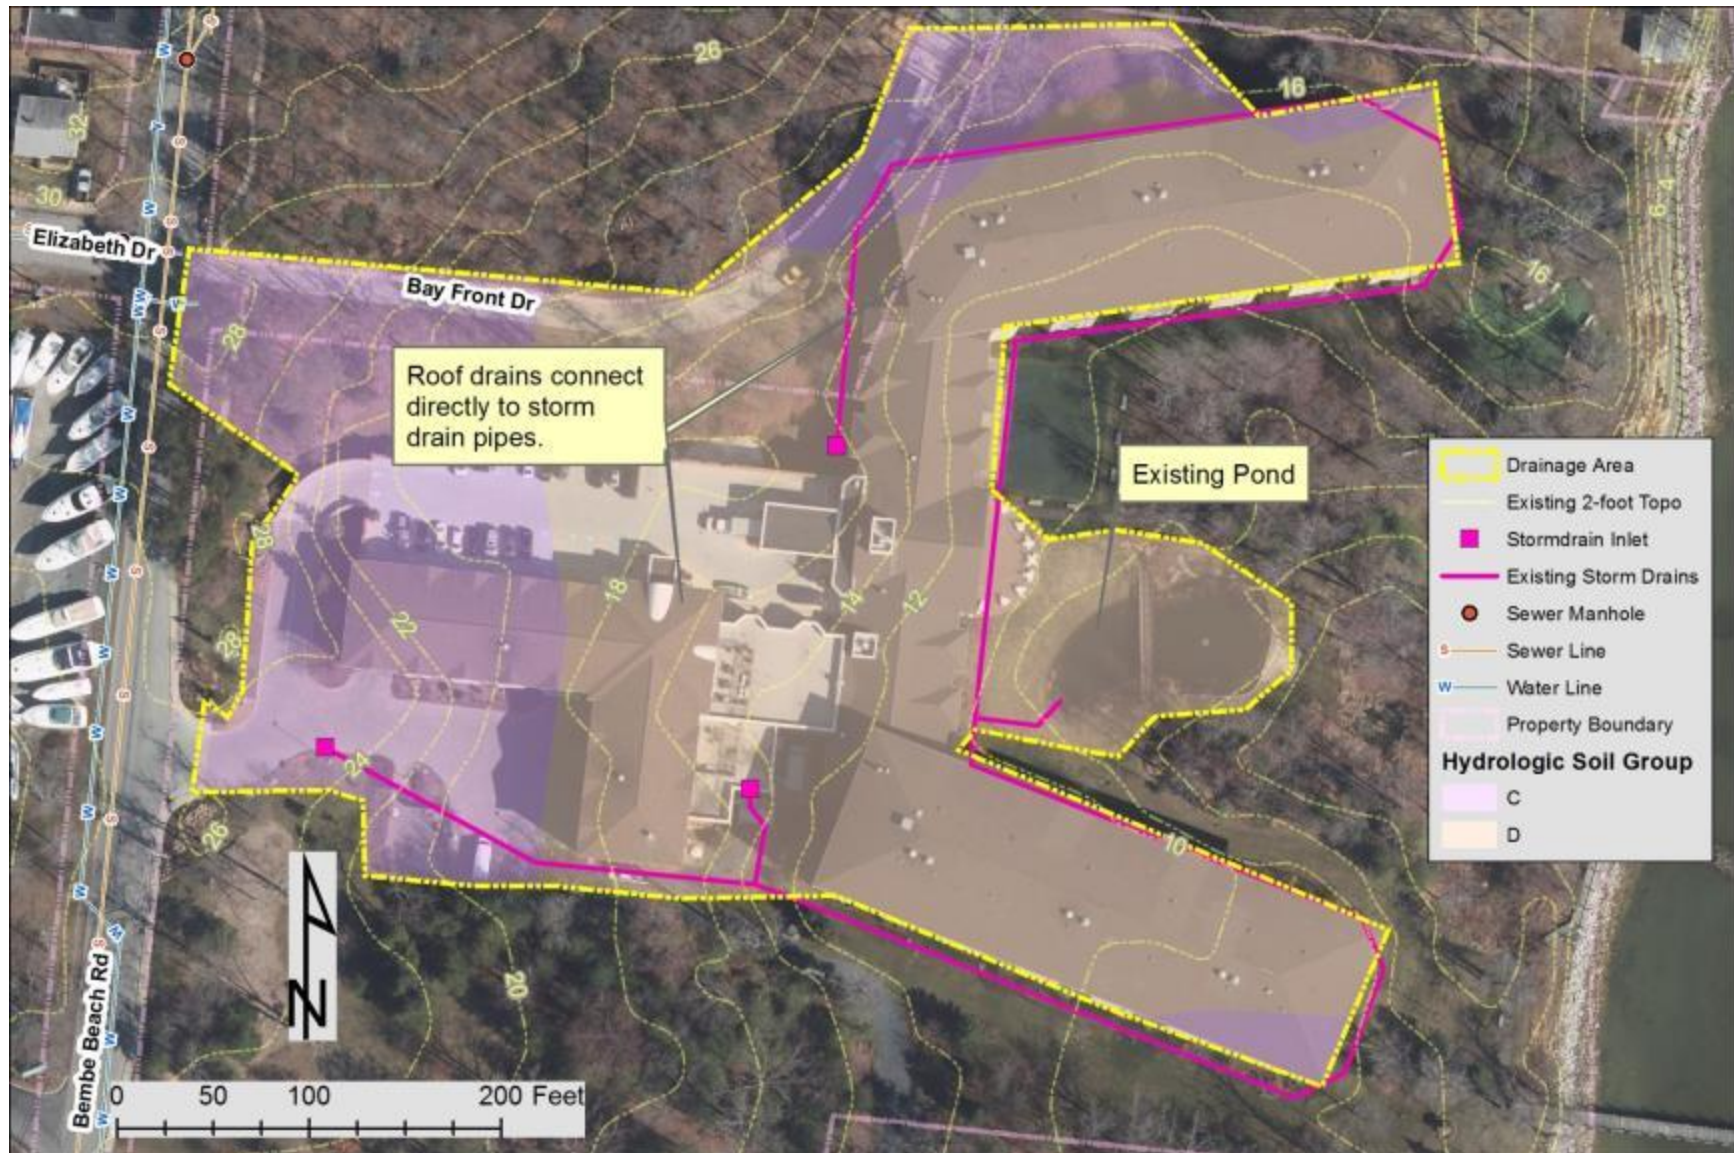
Figure 11: Existing Conditions and Drainage Area

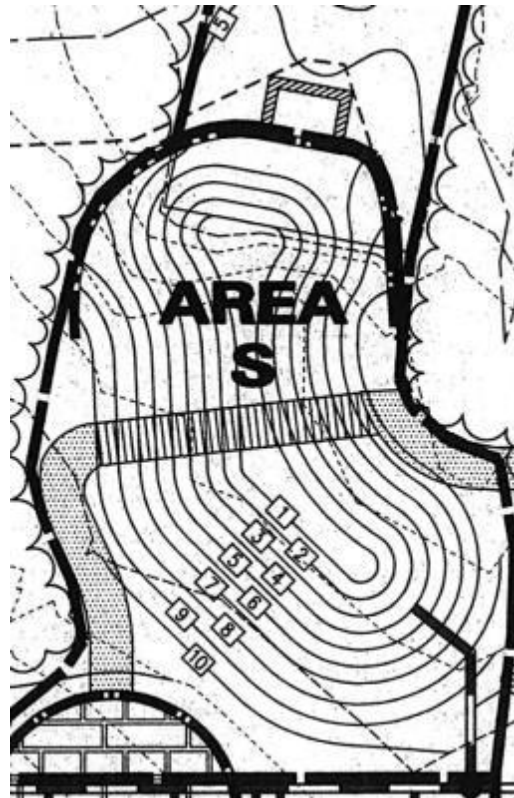
Figure 13: Site Grading from BayWoods of Annapolis 2000 Design Plans

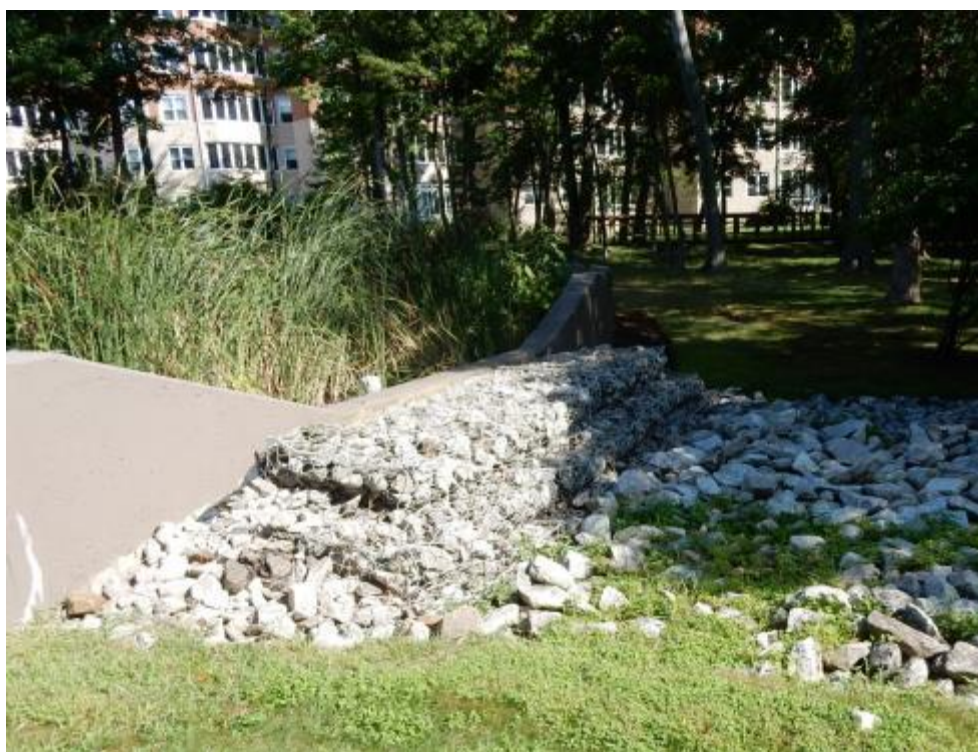
**Existing Pond at BayWoods of Annapolis Overflow Weir and Outfall Protection (facing northwest)**

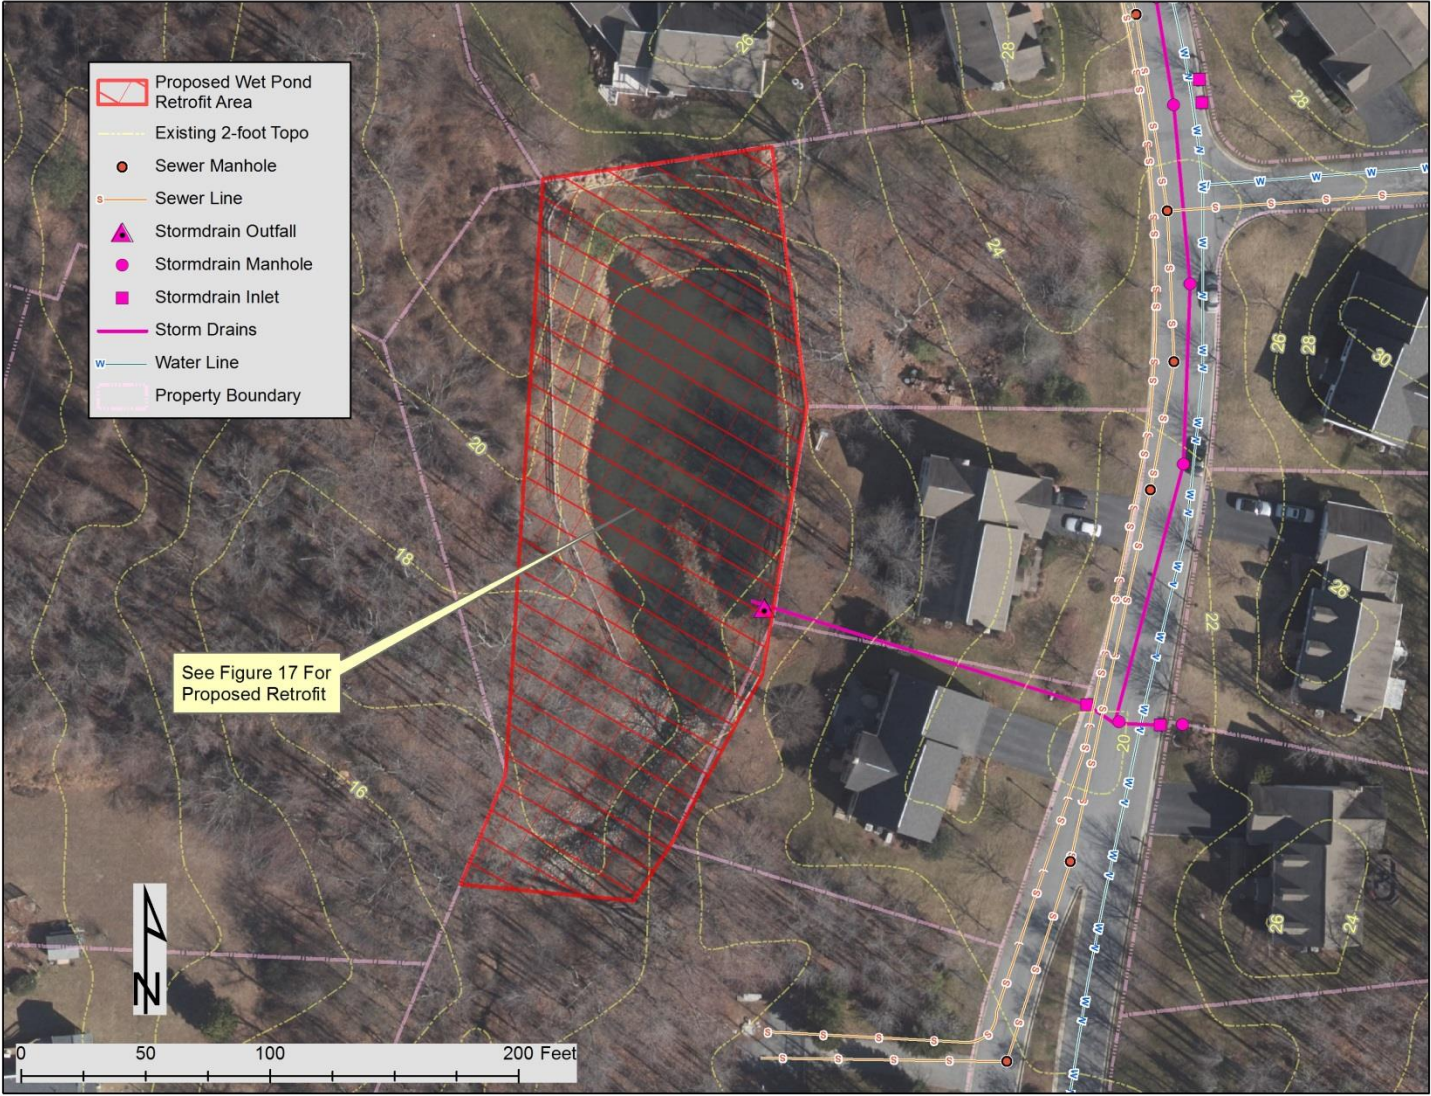
Figure 16: Proposed Retrofit Concept Design

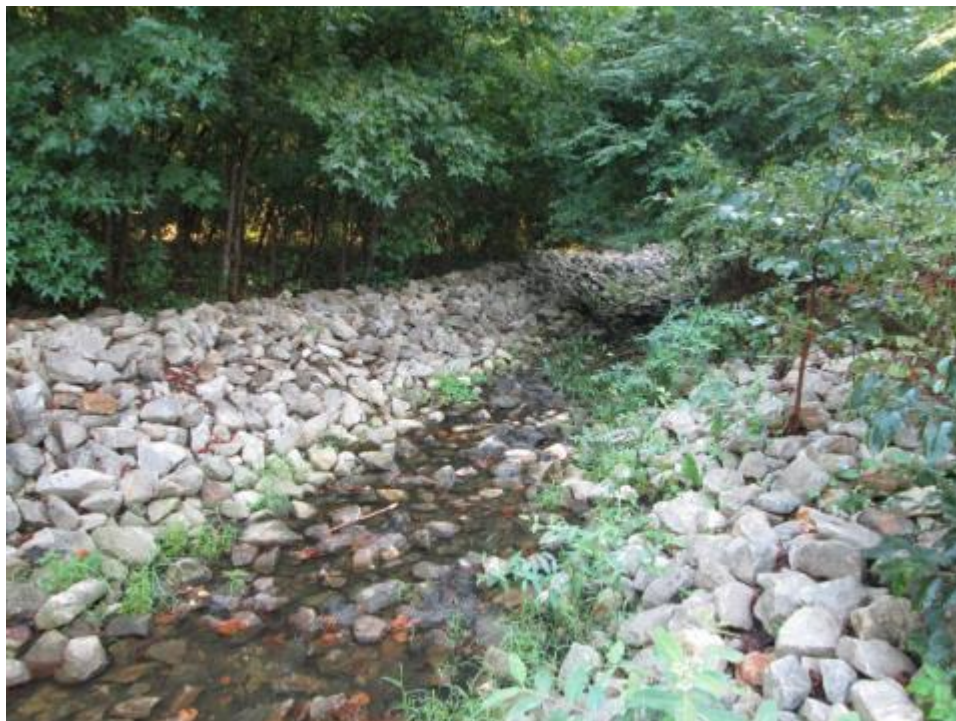
**Existing Outfall for Harness Creek View Court Wet Pond**

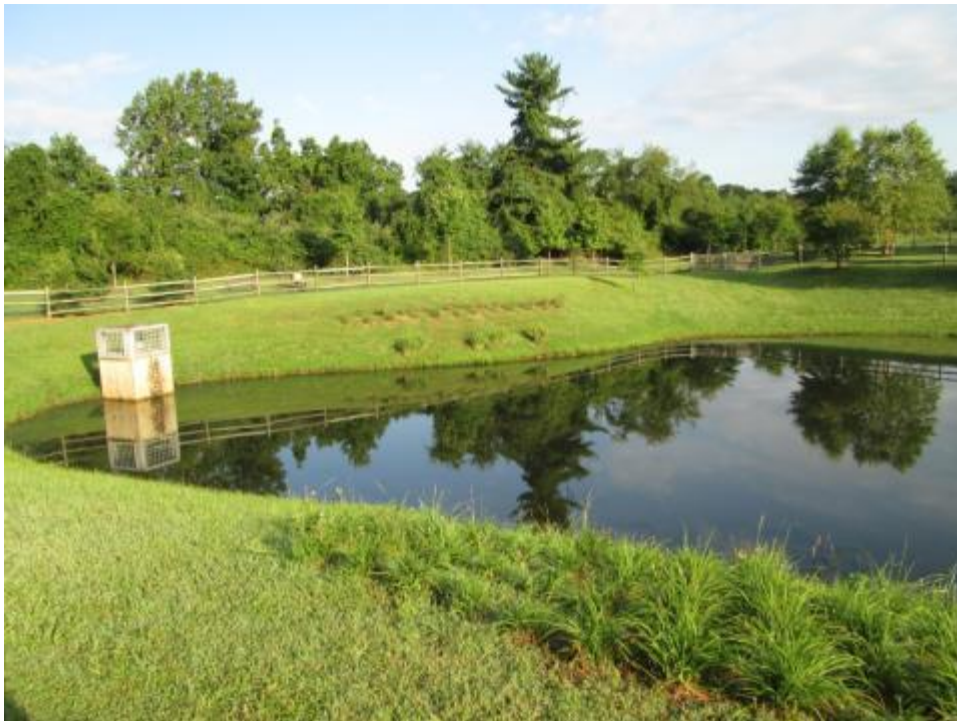
**Existing Riser Structure**

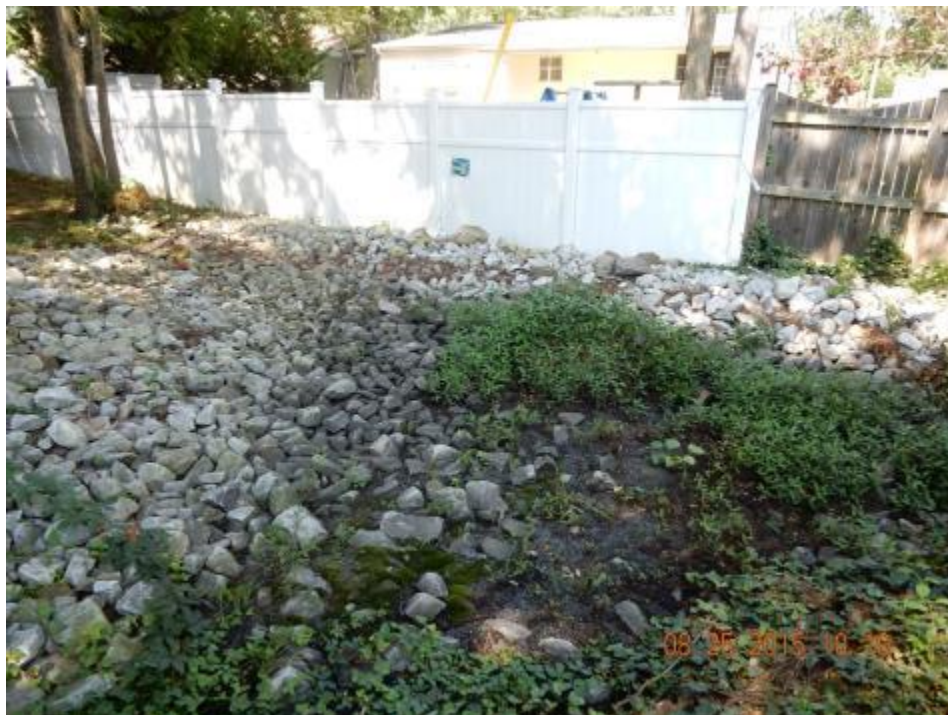
Existing Infiltration Trench at the North End of Georgetown Plaza

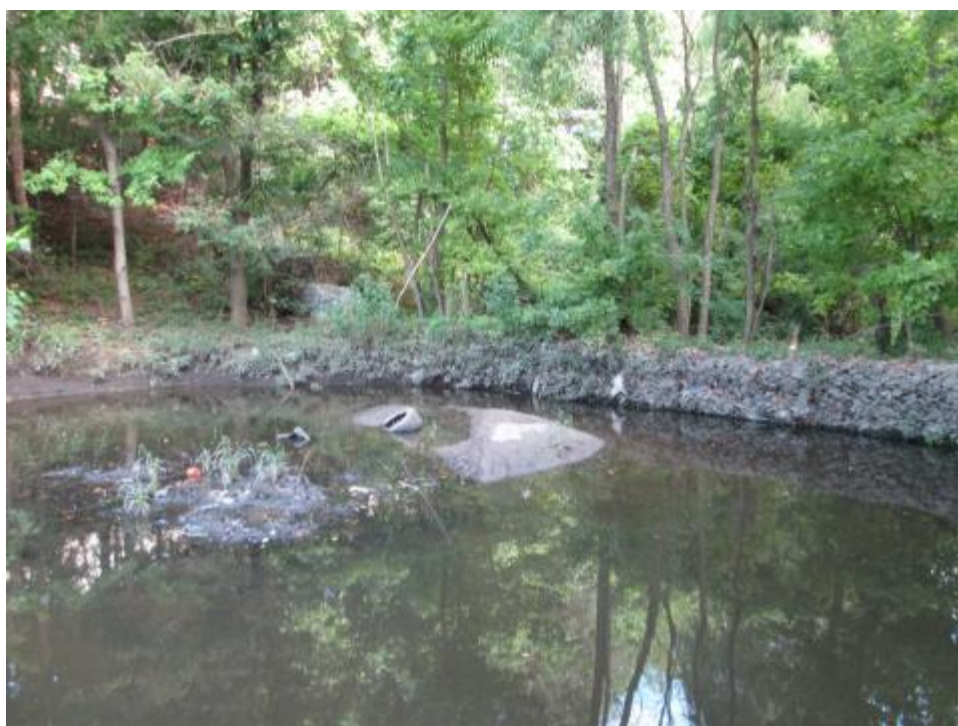
**Existing Wet Pond Gabion Outlet Structure**

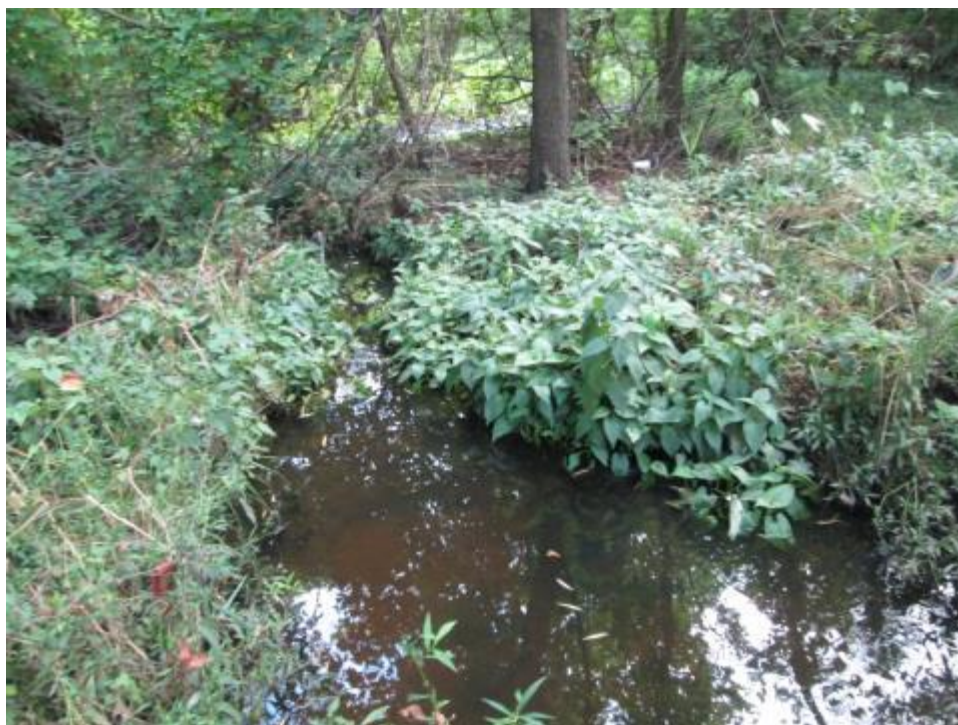
**Existing Pond Outfall**

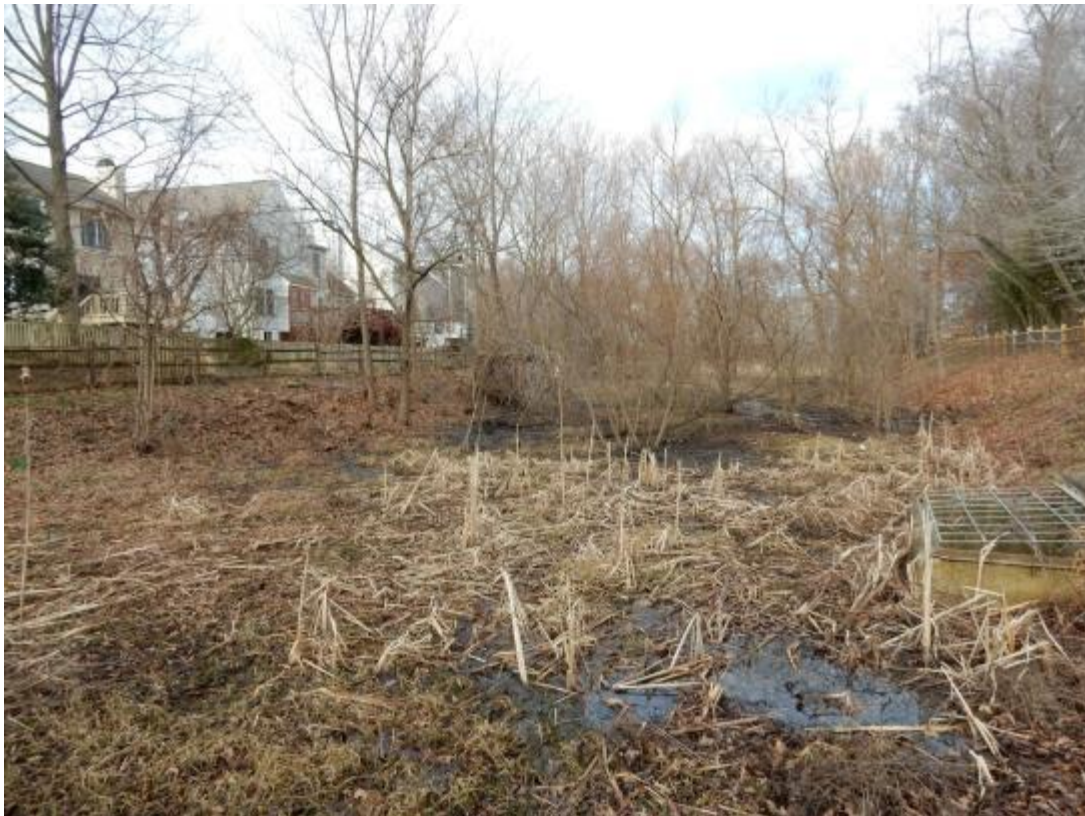
Existing Ambridge Pond (including Emergency Spillway Riser)

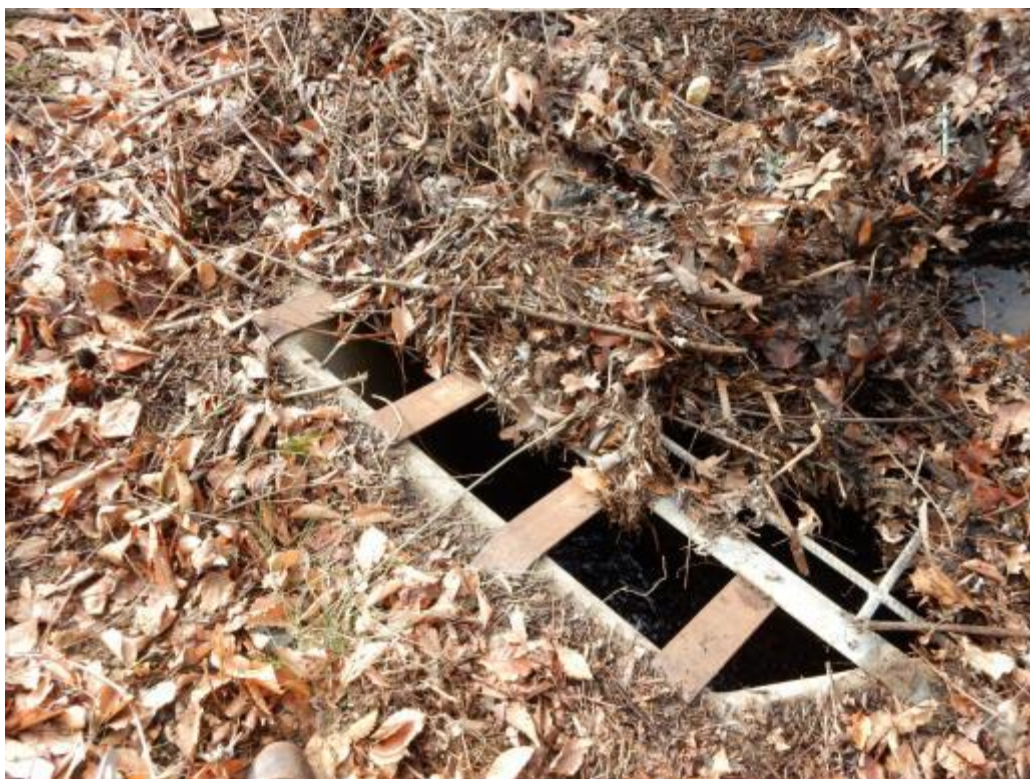
**Existing Ambridge Pond Principal Spillway (with 36-inch pipe through embankment)**

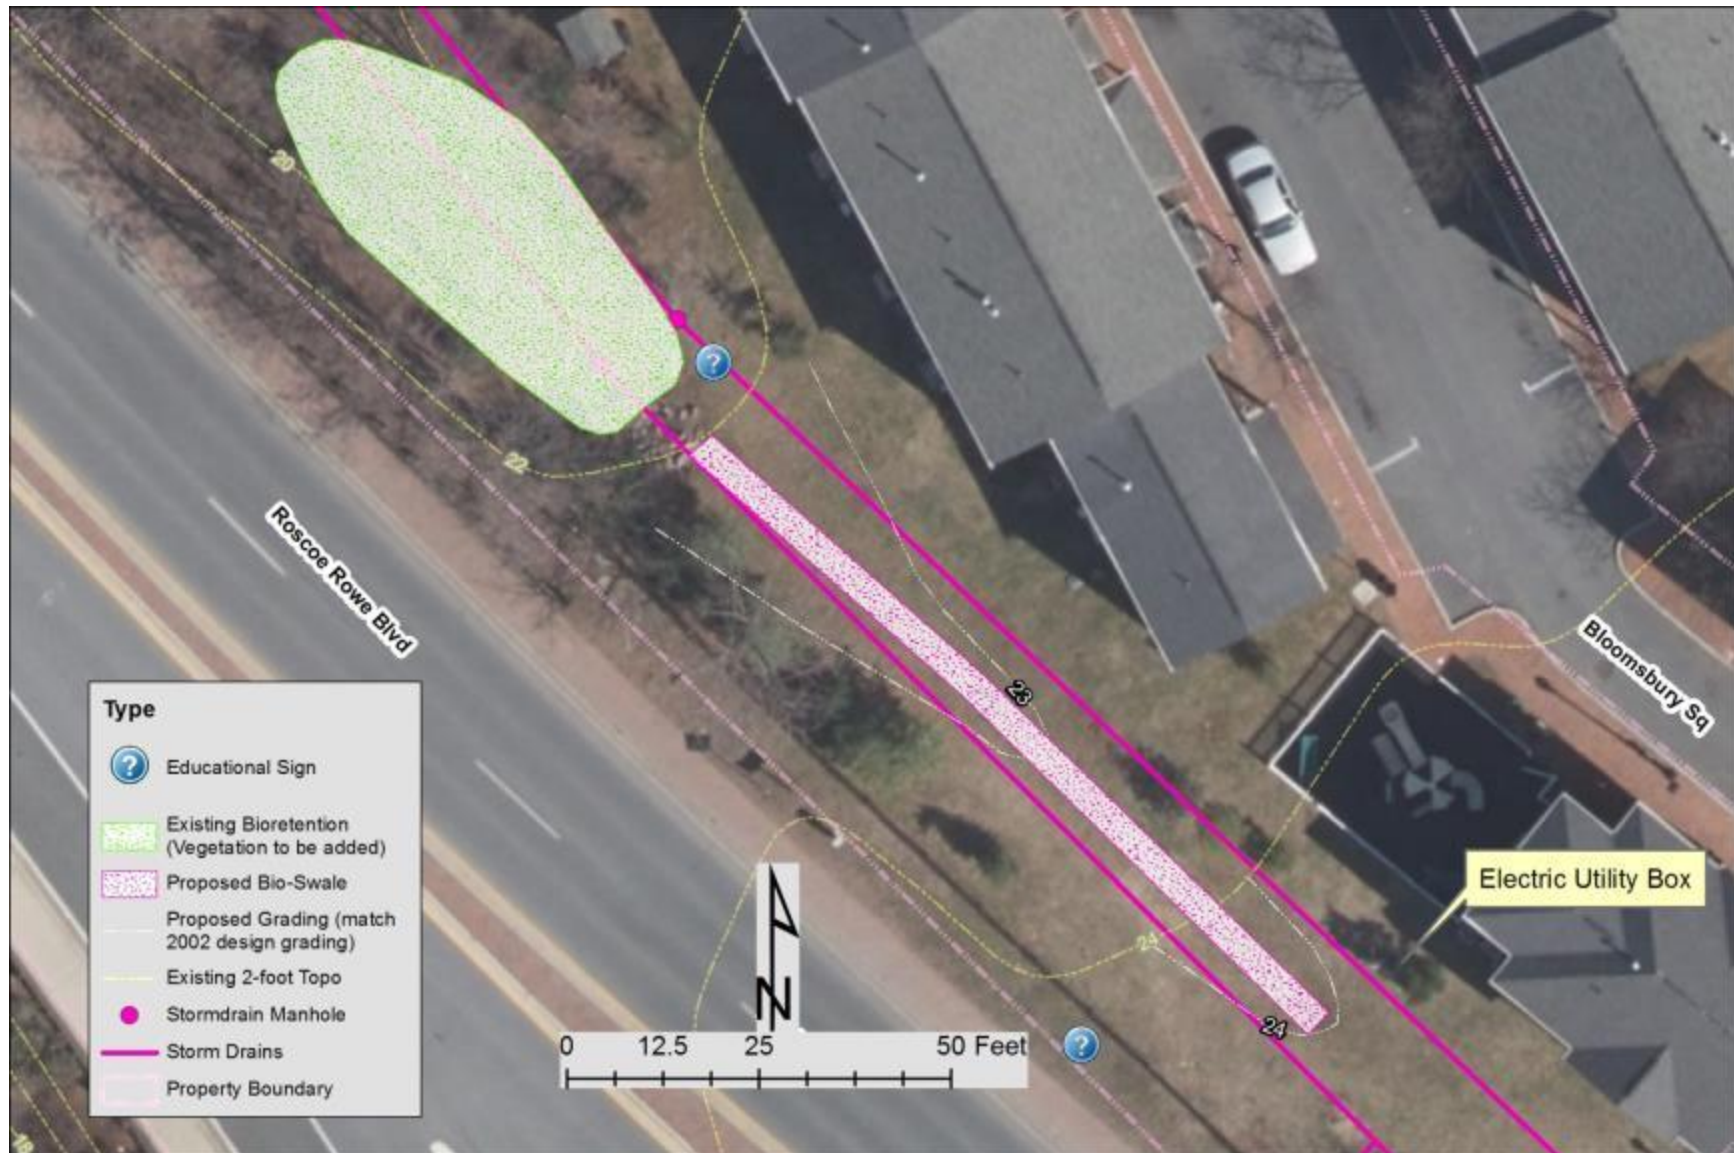
Figure 32: Proposed Retrofit Concept Design

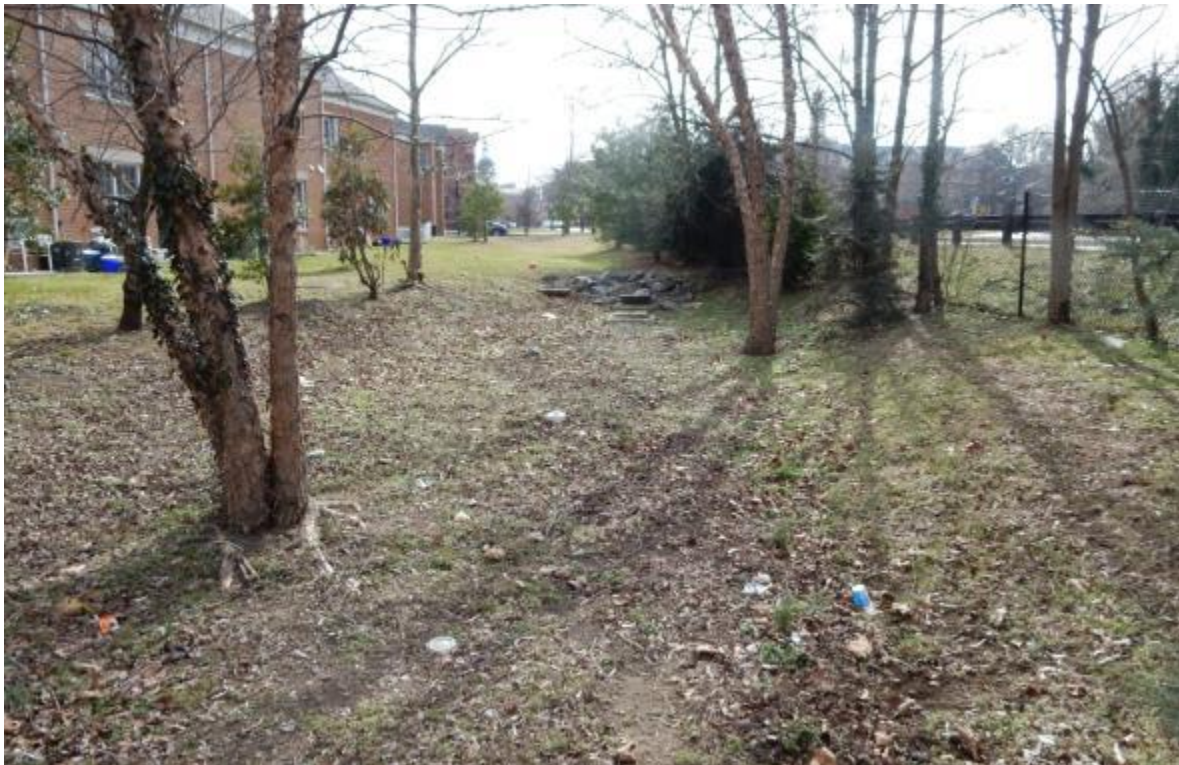
Existing Bioretention between Bloomsbury Square and Rowe Boulevard

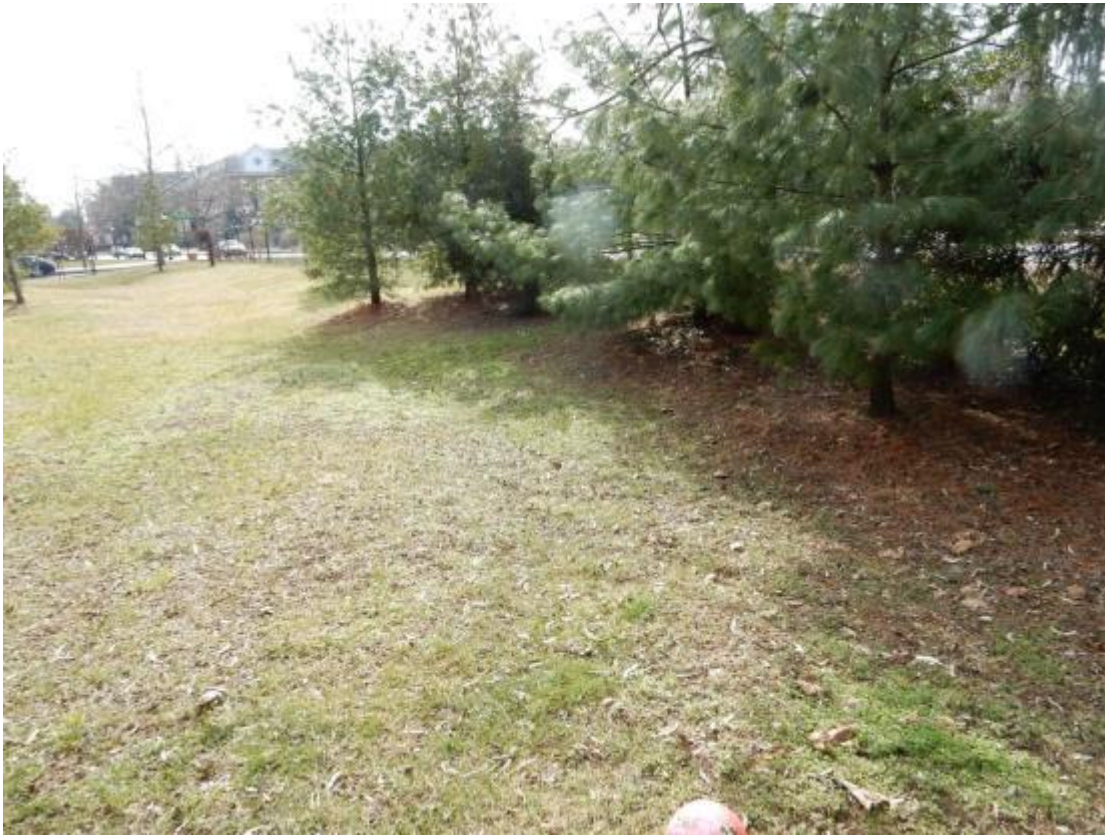
**Existing Grass Swale Upstream of Existing Bioretention**

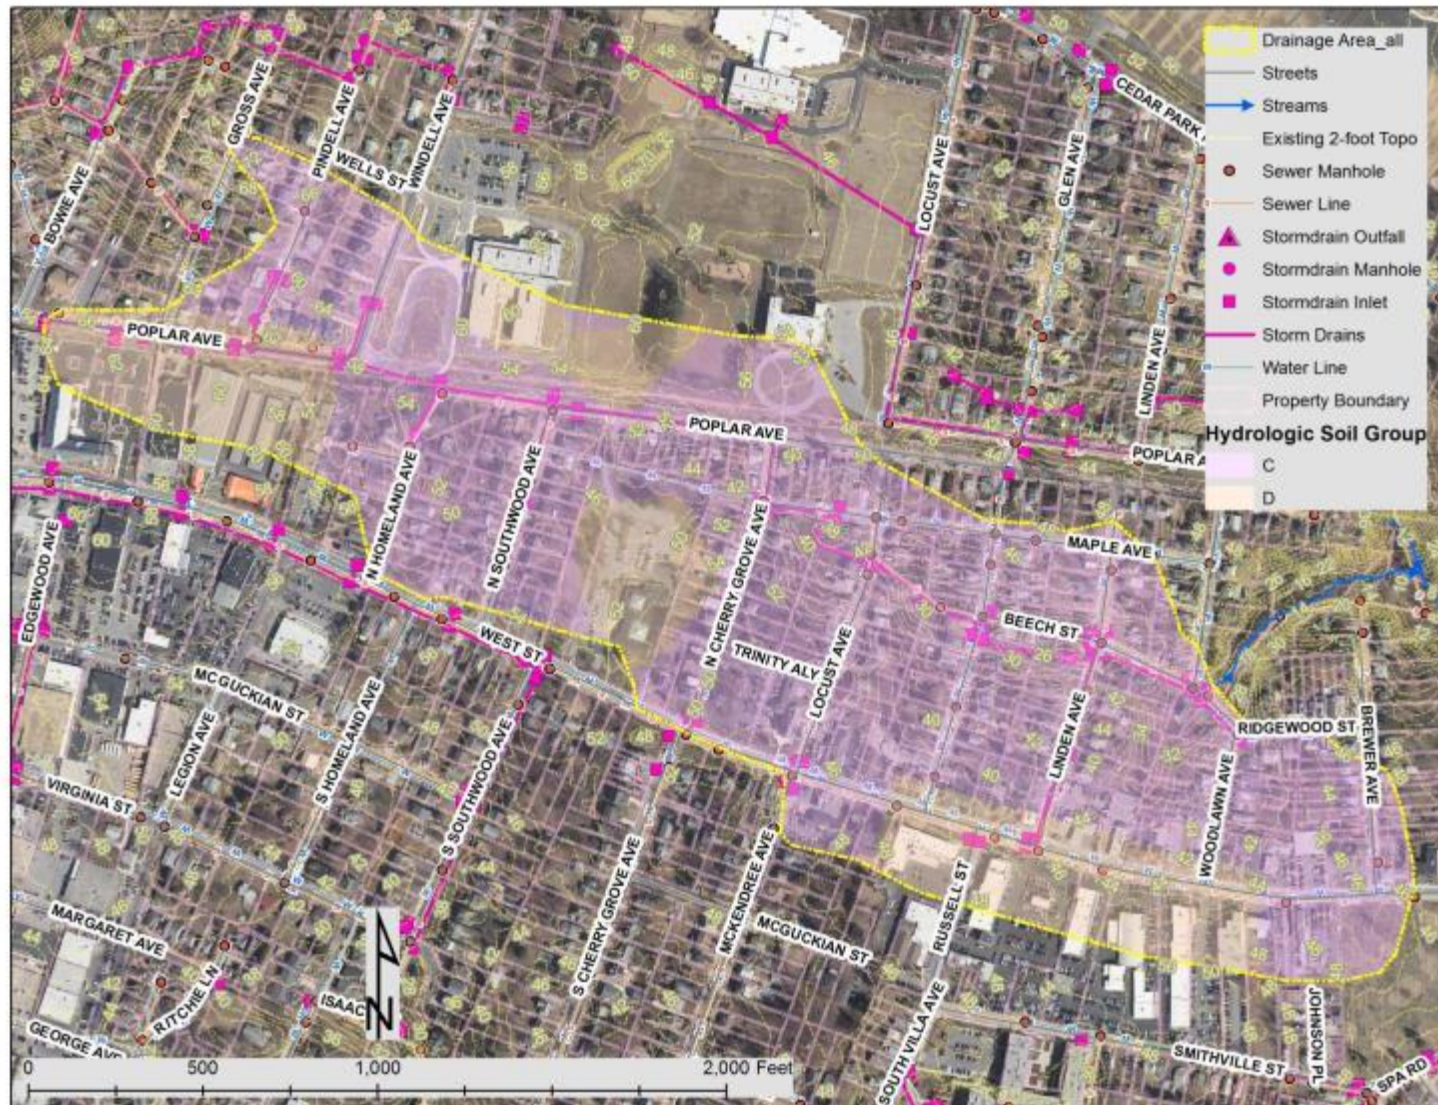
Figure 34: Existing Conditions and Drainage Area

<b>Design Parameters</b>	<b>Site Value</b>
Treated Drainage Area (ac), A	82.1
Percent Impervious Cover, I	49%
Rainfall Depth (inches), P	1
Volumetric Runoff Coefficient, R <sub>v</sub>	0.49
<b>Water Quality Volume (acre-feet), WQ<sub>v</sub></b>	<b>3.34</b>
<b>Water Quality Volume (cubic-feet), WQ<sub>v</sub></b>	<b>145,581</b>

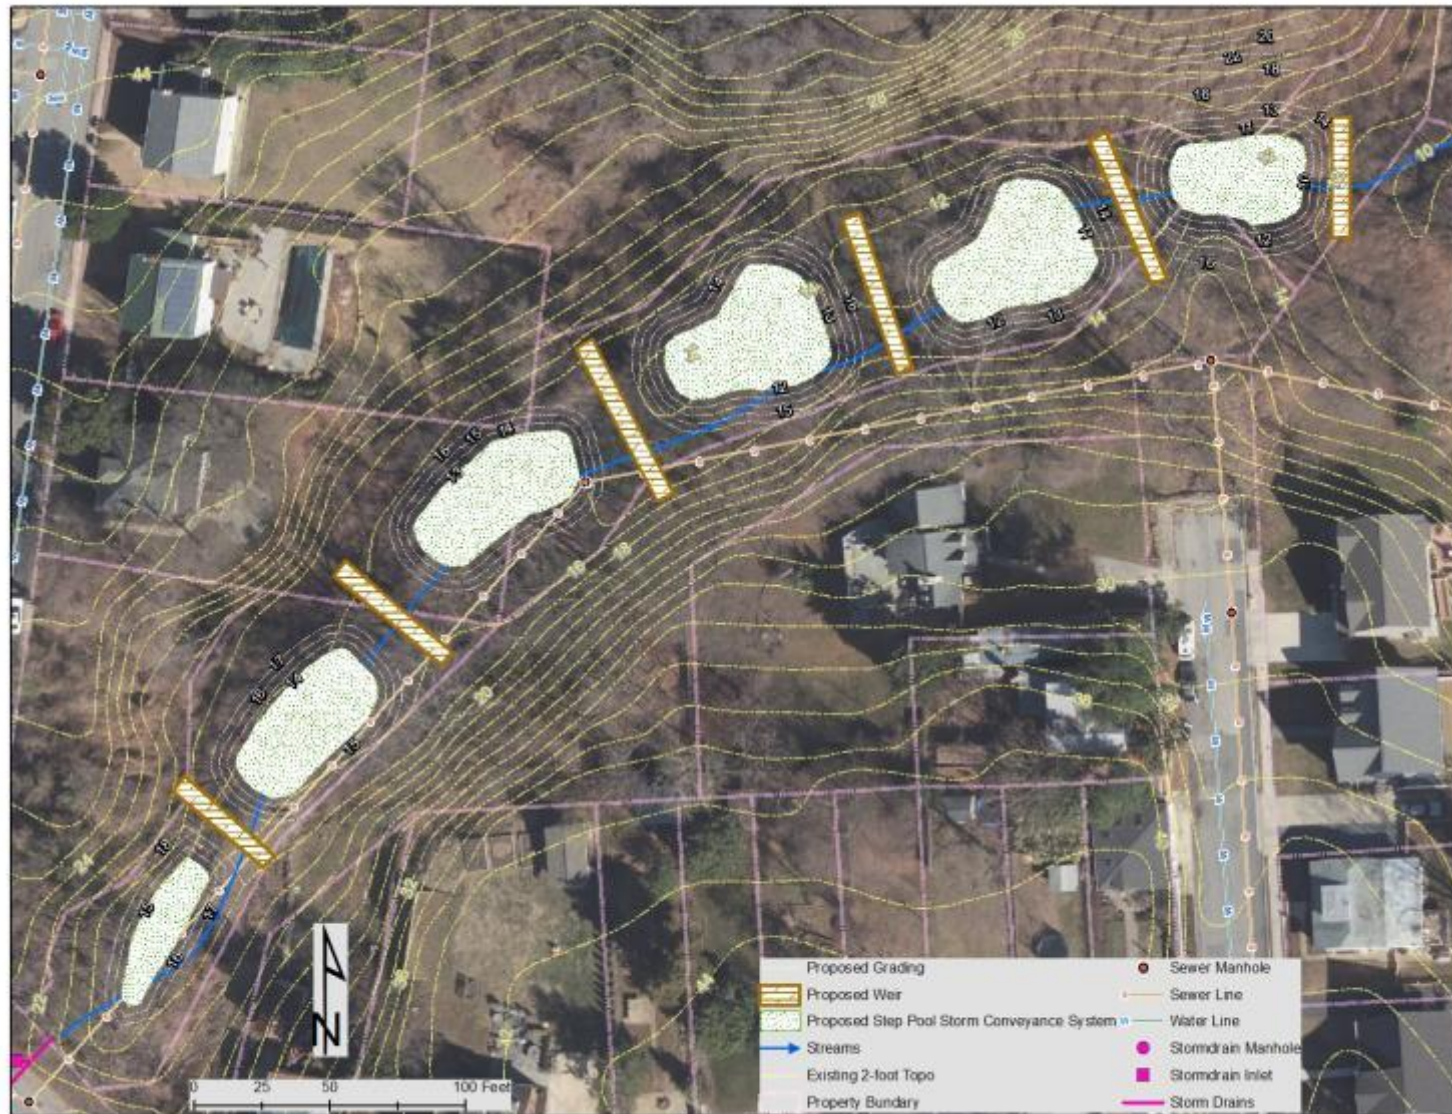
Figure 35: Proposed Retrofit Concept Design

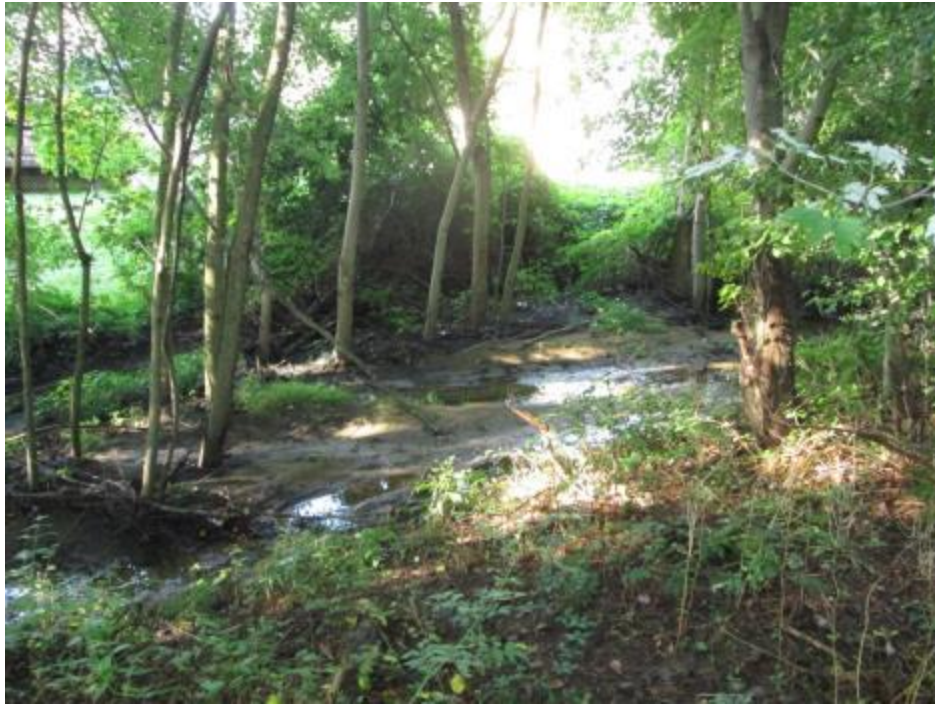
**Sedimentation Downstream from Outfall**

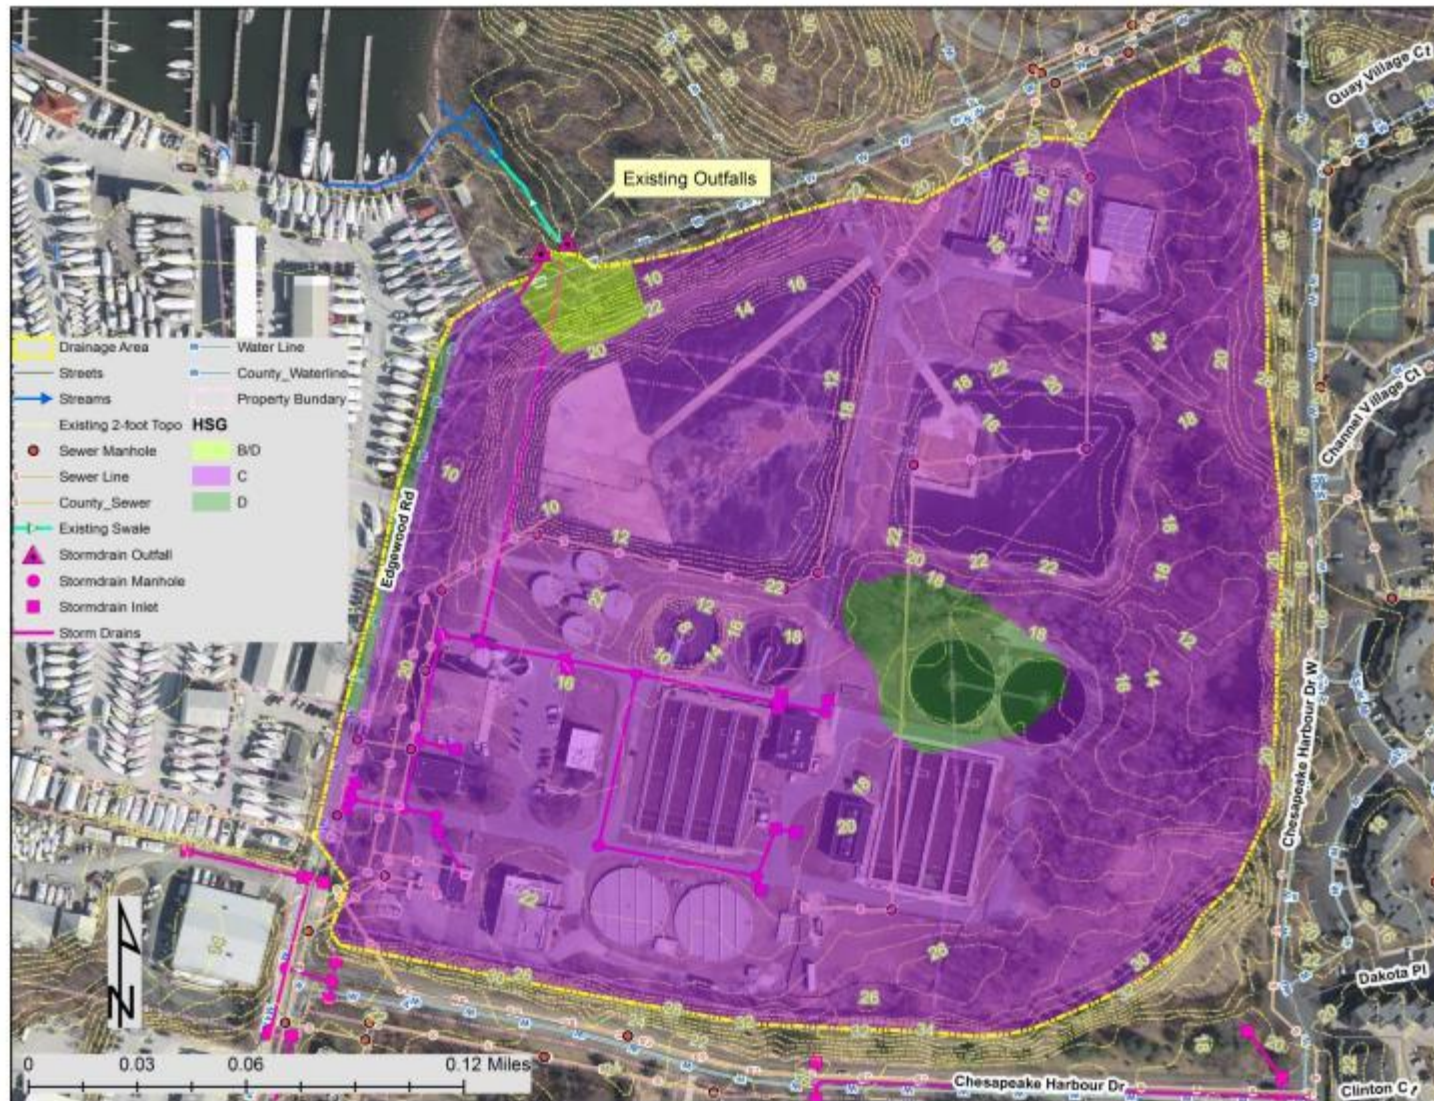
Figure 43: Existing Conditions and Drainage Area

<b>Design Parameters</b>	<b>Site Value</b>
Treated Drainage Area (ac), A	34.6
Percent Impervious Cover, I	44%
Rainfall Depth (inches), P	1
Volumetric Runoff Coefficient, R <sub>v</sub>	0.44
<b>Water Quality Volume (acre-feet), WQ<sub>v</sub></b>	<b>1.27</b>
<b>Water Quality Volume (cubic-feet), WQ<sub>v</sub></b>	<b>55,471</b>
