# City of Annapolis Stormwater Management Inventory and Watershed Improvement Plan

October 2016

## Stormwater Management Inventory and Watershed Improvement Plan

AECOM  
12420 Milestone Center Drive  
Suite 150  
Germantown, MD 20876

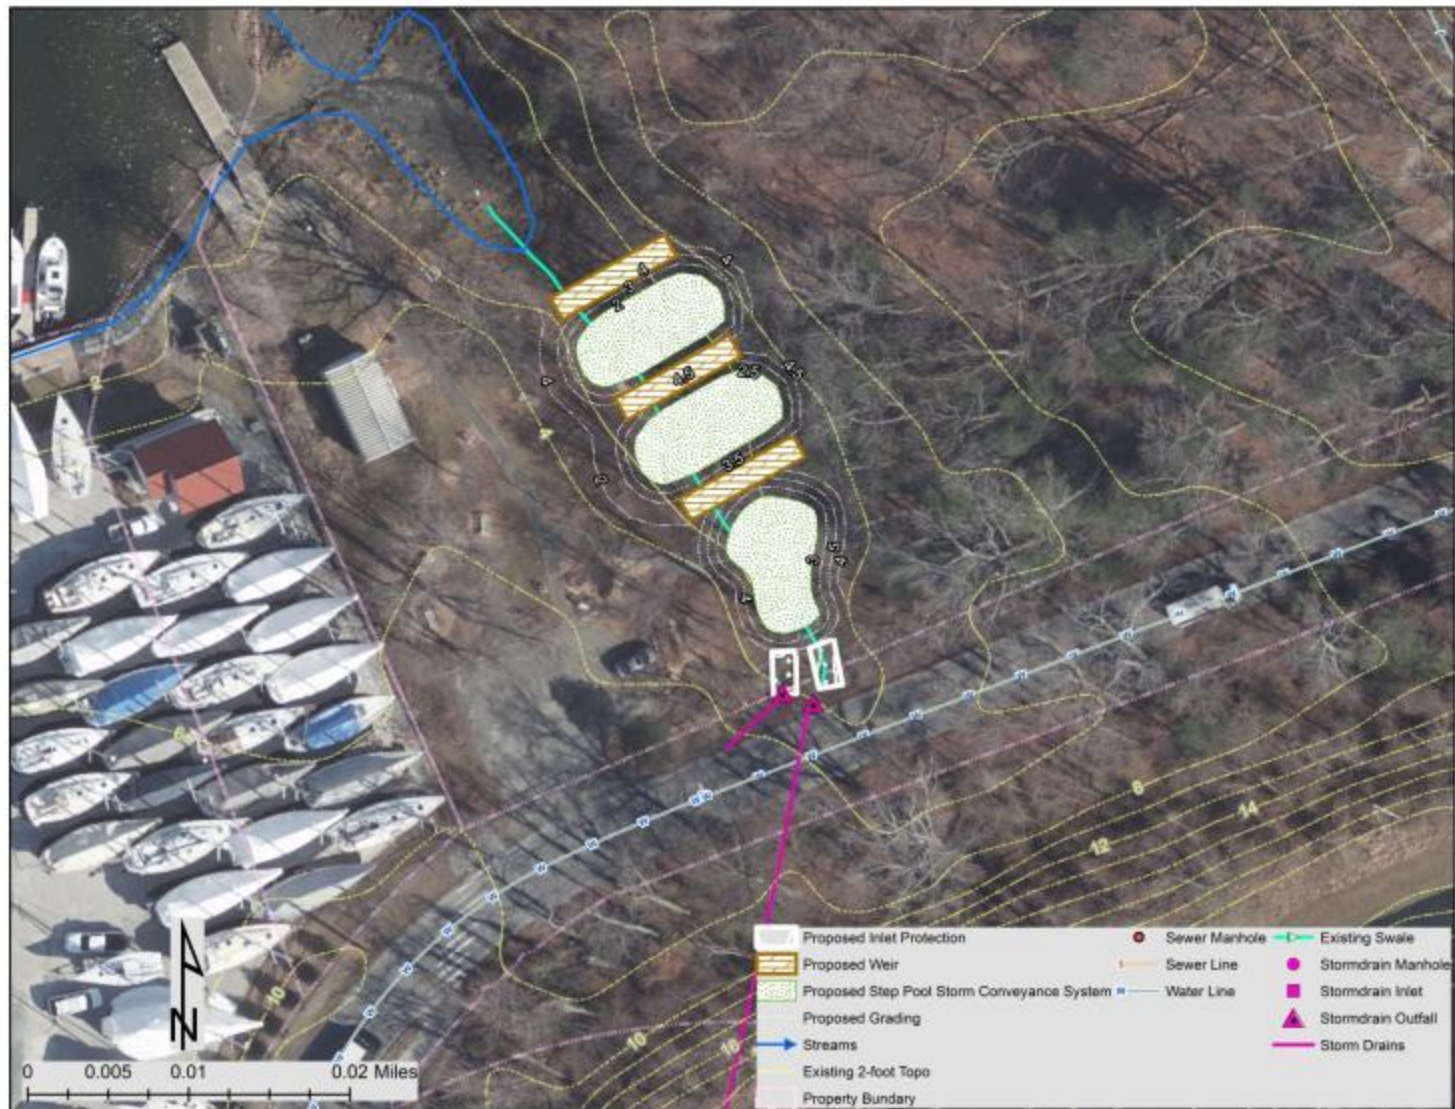
Figure 44: Proposed Retrofit Concept Design

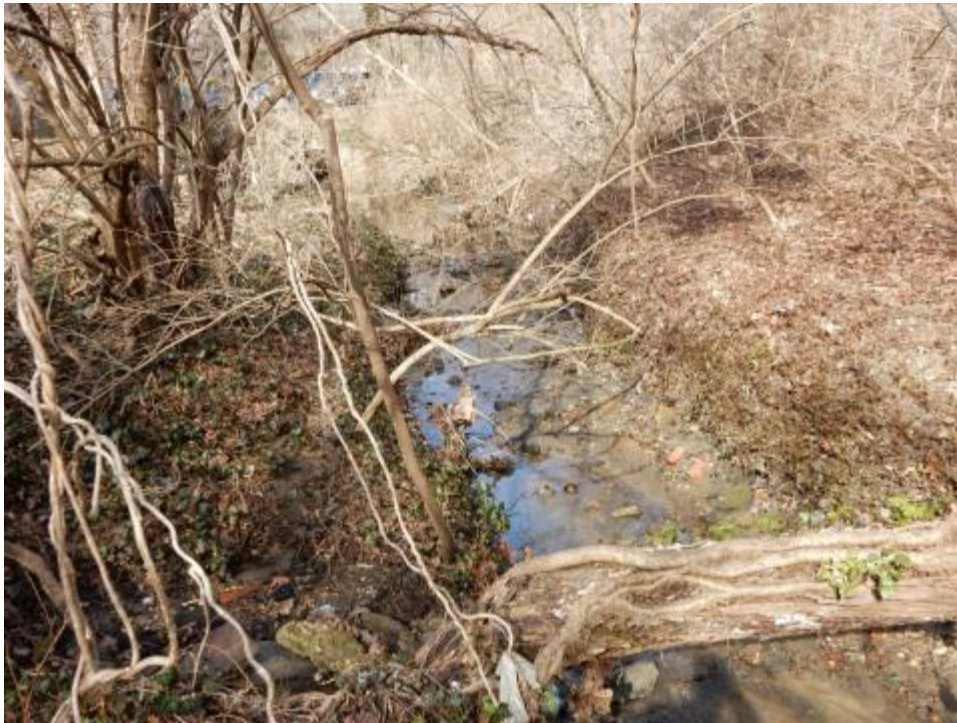
**Downstream of Outfall 04**

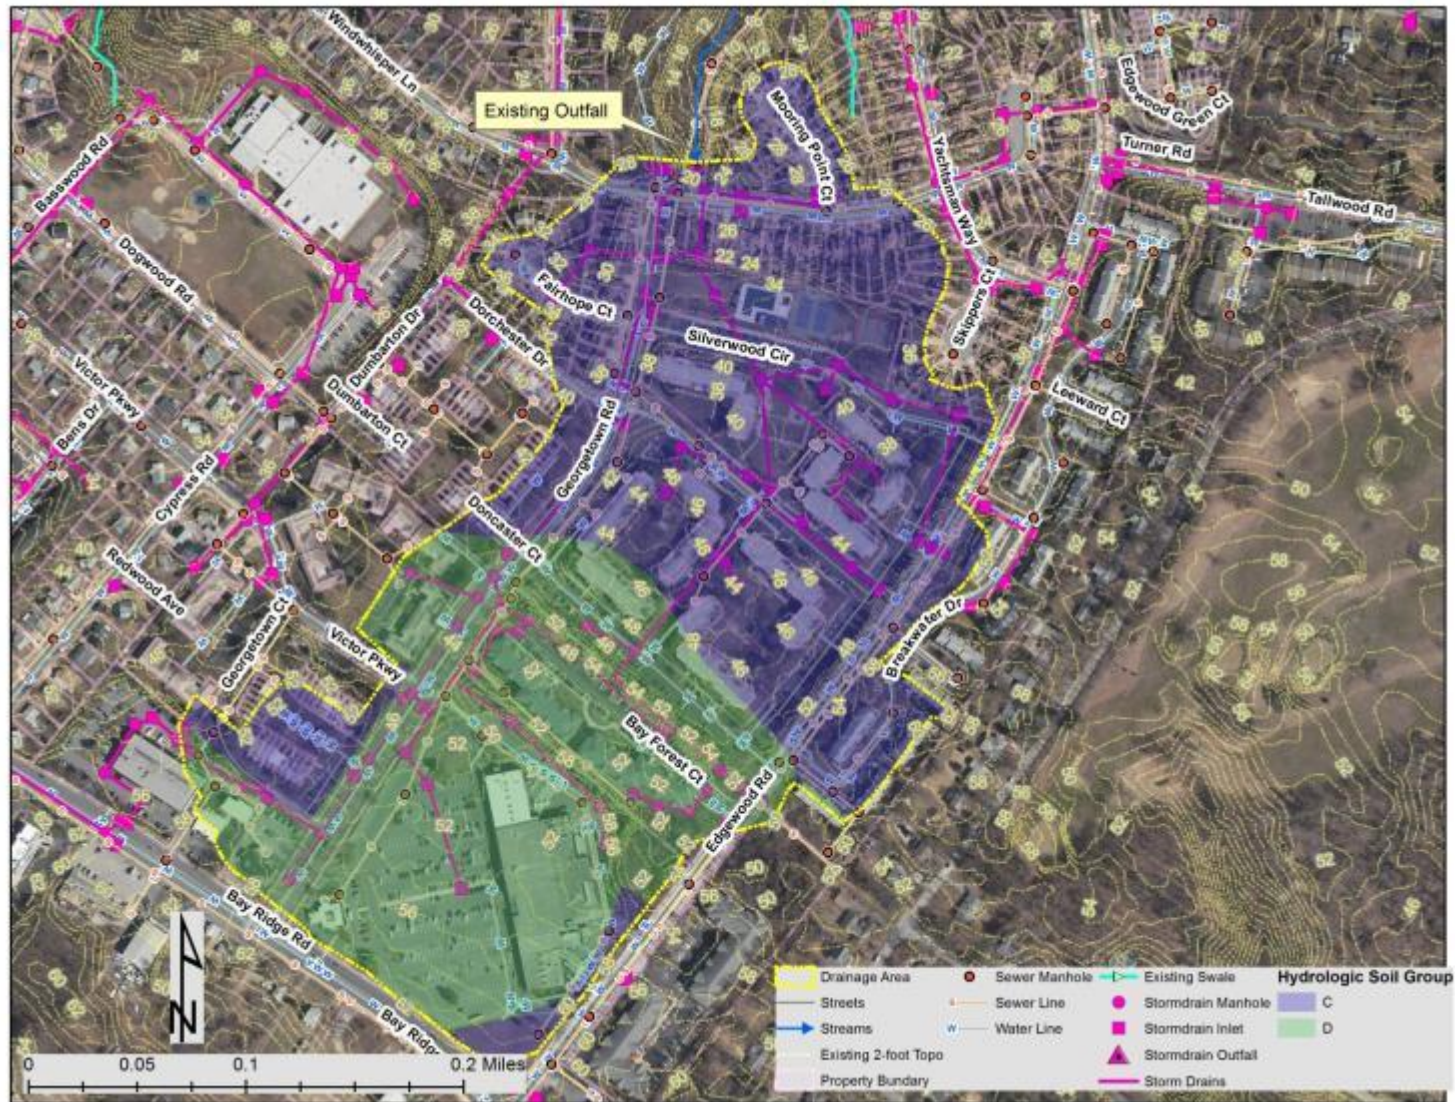
Figure 49: Existing Conditions and Drainage Area

<b>Design Parameters</b>	<b>Site Value</b>
Treated Drainage Area (ac), A	55
Percent Impervious Cover, I	54.9
Rainfall Depth (inches), P	1
Volumetric Runoff Coefficient, R <sub>v</sub>	0.54
<b>Water Quality Volume (acre-feet), WQ<sub>v</sub></b>	<b>2.50</b>
<b>Water Quality Volume (cubic-feet), WQ<sub>v</sub></b>	<b>108,704</b>

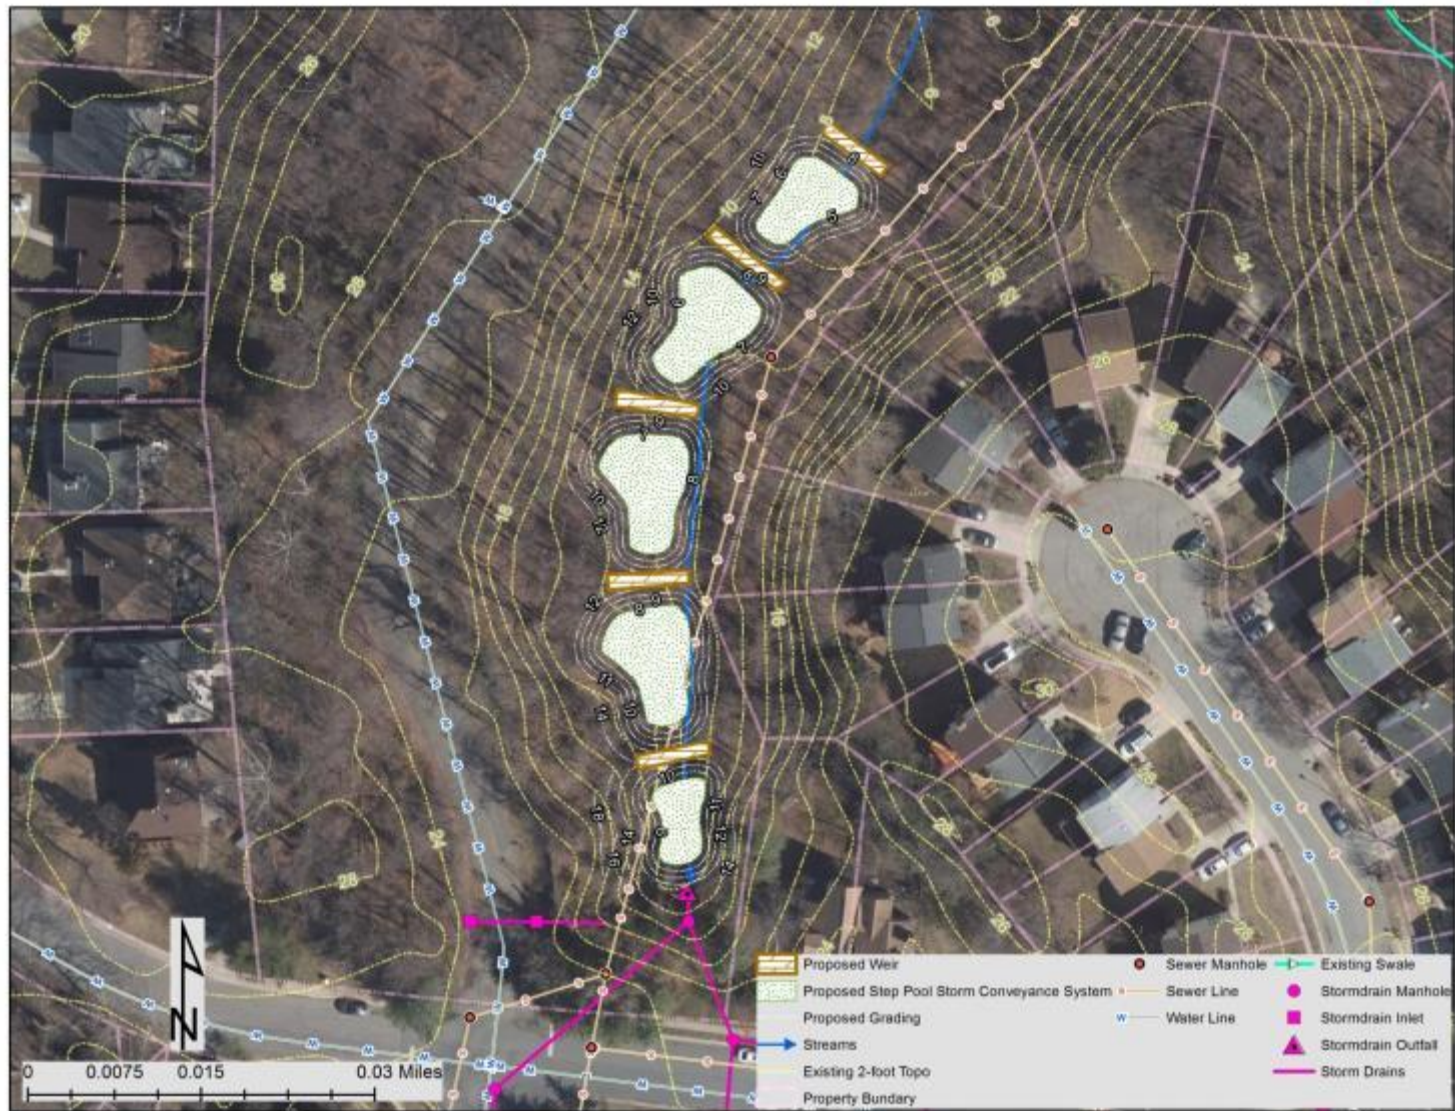
Figure 50: Proposed Retrofit Concept Design

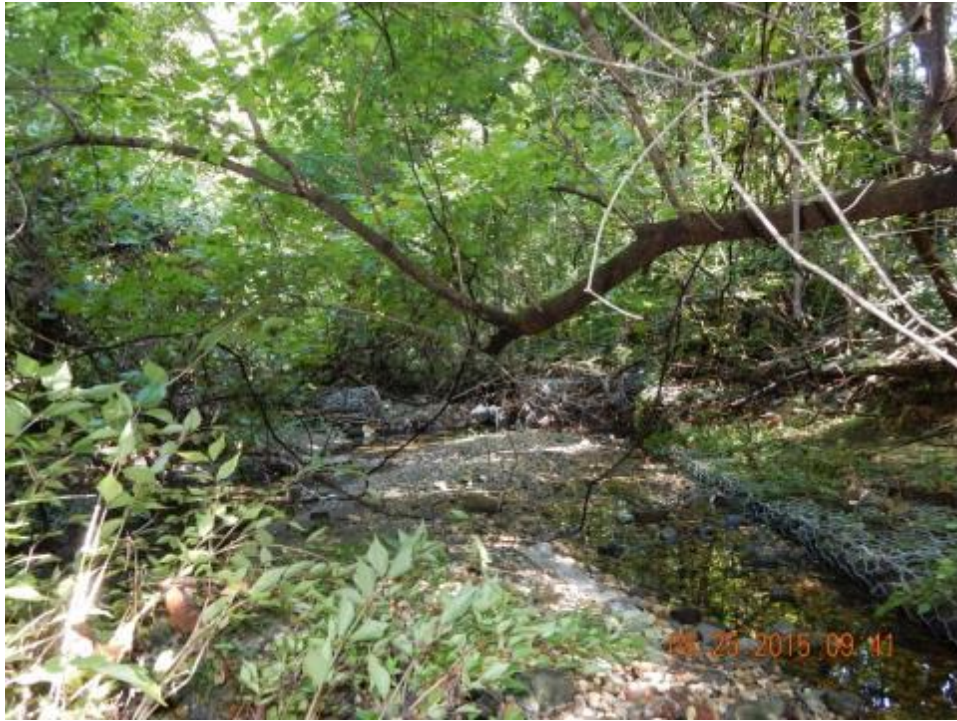
**Downstream of Outfall 07**
