This City of Annapolis Stormwater Management Inventory and Watershed Improvement Plan Interim Submittal (Scope Tasks 2, 3, and 6) summarizes the initial evaluation and selection of potential Best Management Practices (BMPs) for continued evaluation. The BMPs will help the City to meet the water quality and load reduction requirements of the National Pollutant Discharge Elimination System (NPDES) Municipal Separate Storm Sewer System (MS4) permit and the Chesapeake Bay Total Maximum Daily Load (TMDL). The primary goal of these tasks is to perform preliminary analyses to identify potential new and retrofit BMPs for further analyses.

Figure 1: City of Annapolis Locations Evaluated During Field Investigation

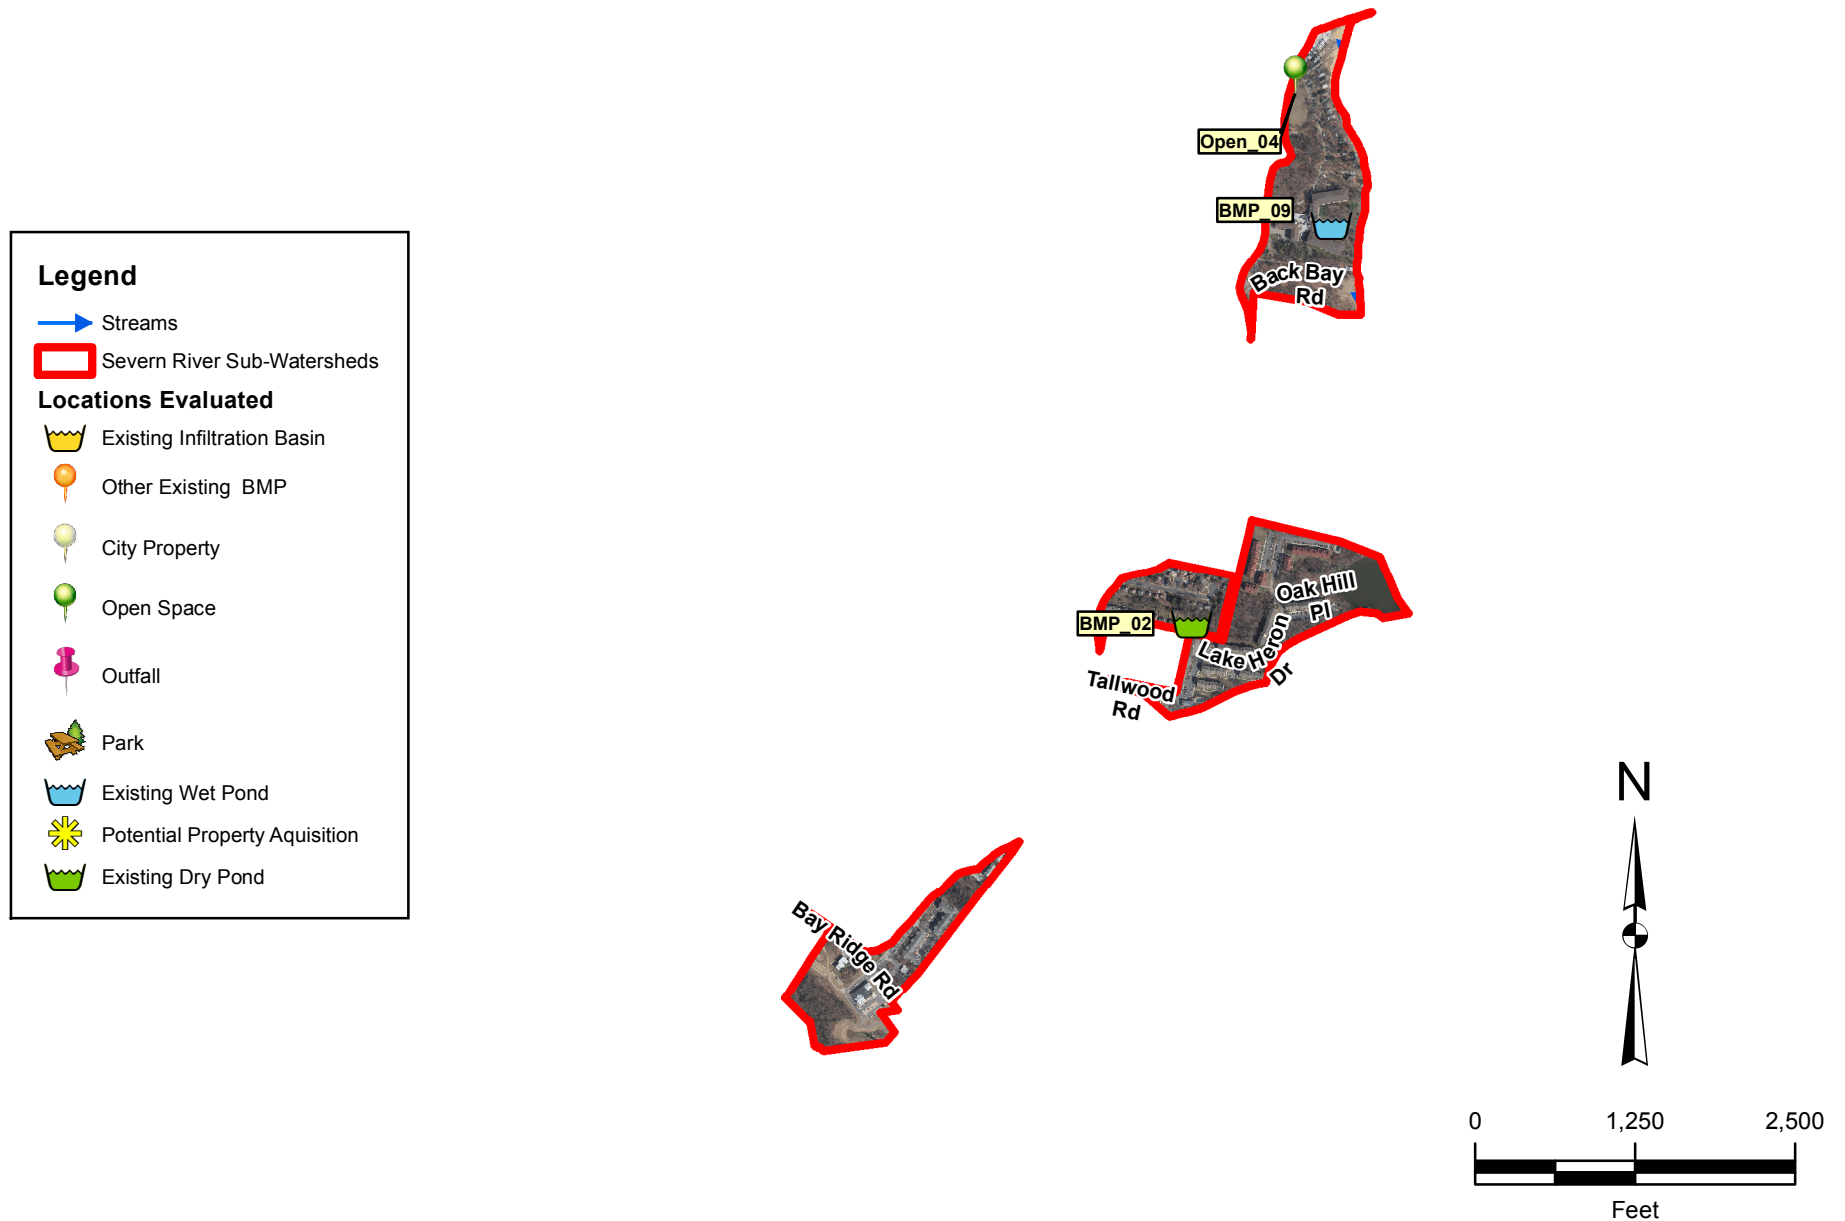
**Figure 4: City of Annapolis Severn River Sub-Watersheds (South)
Locations Evaluated During Field Investigation**
